## Accident

<b>Aircraft Type and Registration:</b>	Quik GT450, G-CEVW	
<b>No &amp; Type of Engines:</b>	1 Rotax 912ULS piston engine	
<b>Year of Manufacture:</b>	2007 (Serial no: 8314)	
<b>Date &amp; Time (UTC):</b>	17 May 2023 at 1215 hrs	
<b>Location:</b>	Lundy Island Airfield, Bristol Channel	
<b>Type of Flight:</b>	Private	
<b>Persons on Board:</b>	Crew – 1	Passengers – None
<b>Injuries:</b>	Crew – Minor	Passengers – N/A
<b>Nature of Damage:</b>	Extensive damage to wing and airframe	
<b>Commander's Licence:</b>	National Private Pilot's Licence	
<b>Commander's Age:</b>	59 years	
<b>Commander's Flying Experience:</b>	134 hours (of which 107 were on type) Last 90 days – 11 hours Last 28 days – 9 hours	
<b>Information Source:</b>	AAIB Field Investigation

## Synopsis

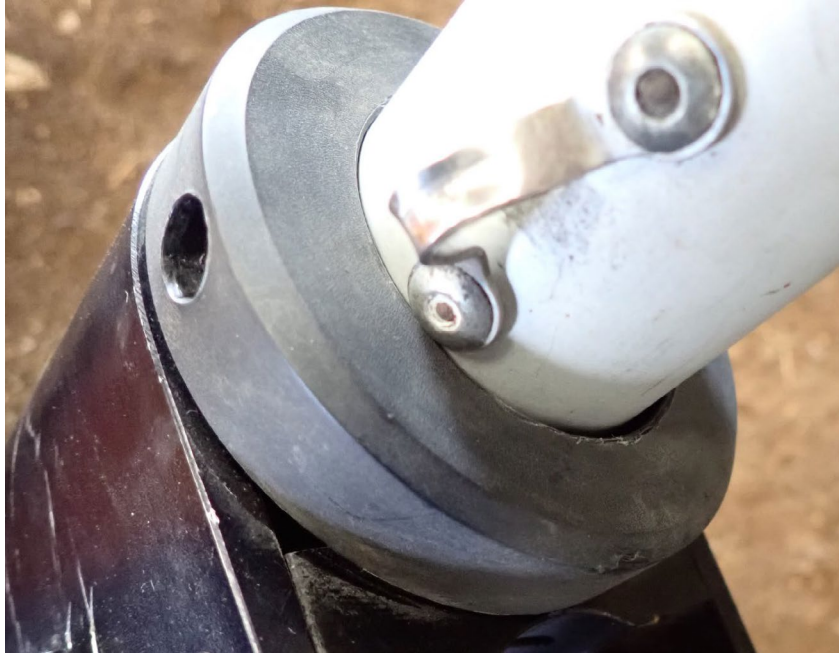
**Figure 9**

Roll bracket bearing showing witness marking from contact with trim bracket
