Incident

Aircraft Type and Registration:	Pilatus PC-24, D-CMSL	
No & Type of Engines:	2 Williams International FJ44-4A turbofan engines	
Year of Manufacture:	2022 (Serial no: 266)	
Date & Time (UTC):	9 December 2022 at 1425 hrs	
Location:	8 nm south-east of Liverpool Airport	
Type of Flight:	Commercial Air Transport (Non-revenue)	
Persons on Board:	Crew – 2	Passengers – None
Injuries:	Crew – None	Passengers – N/A
Nature of Damage:	None	
Commander's Licence:	Airline Transport Pilot's Licence	
Commander's Age:	43 years	
Commander's Flying Experience:	6,500 hours (of which 781 were on type) Last 90 days – 146 hours Last 28 days – 33 hours	
Information Source:	AAIB Field Investigation

Synopsis

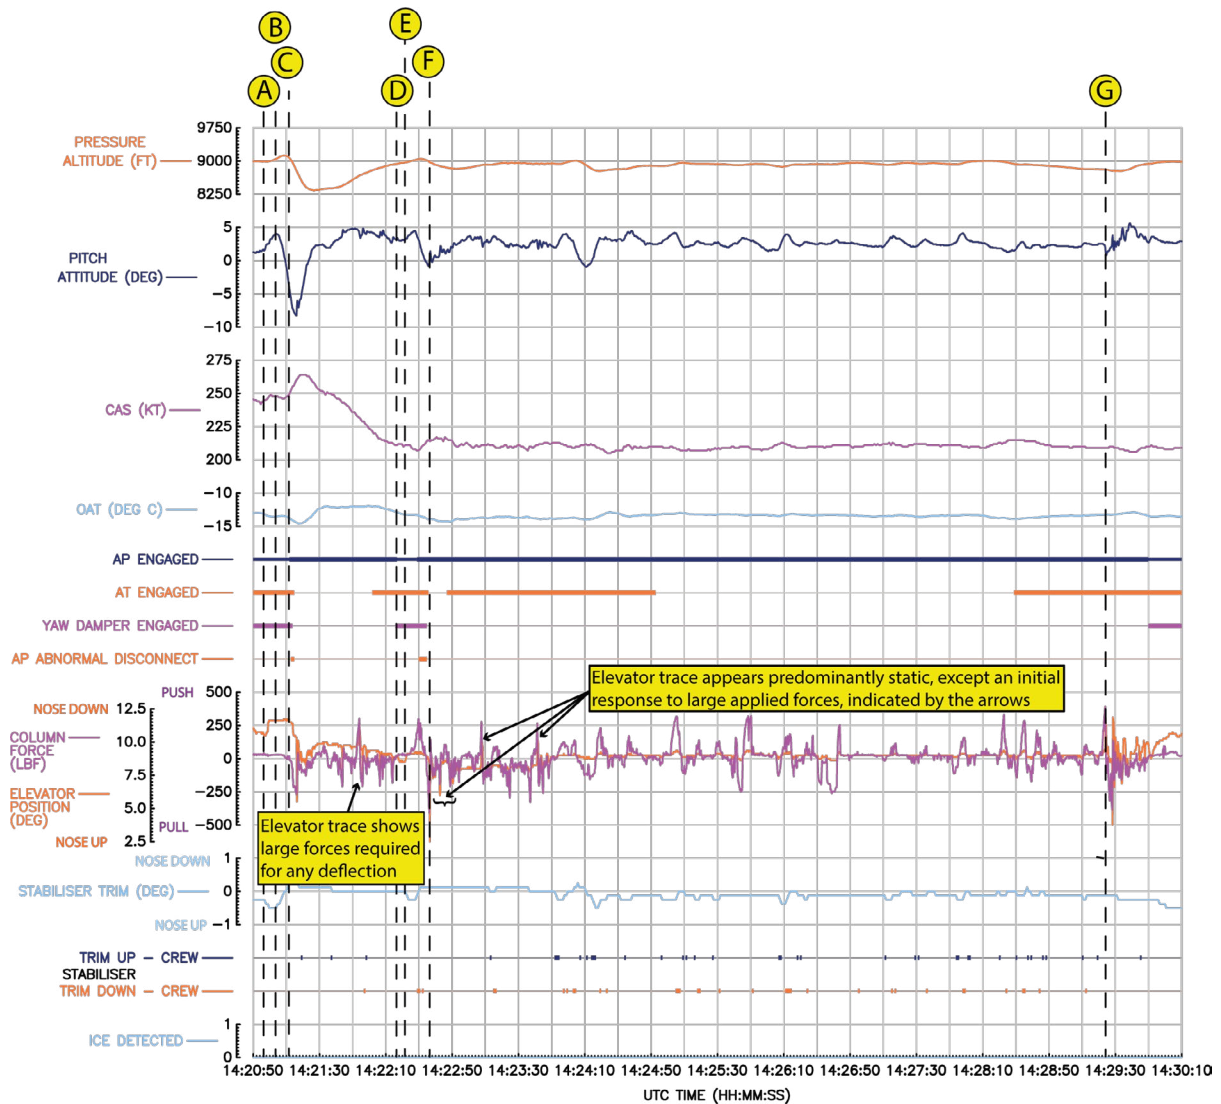
Figure 3

- D-CMSL was initially level at FL90 and 245 kt, with the autopilot (AP), autothrottle (A/T) and yaw damper (YD) engaged. The OAT was -13°C . The aircraft's dual ice detectors did not record the presence of ice at any point during the flight.
- At point A, a nose-up movement of the stabiliser is recorded and D-CMSL pitched up; no stabiliser trim changes were commanded by the crew. Simultaneously and, despite no force (measured at the base of the control column) being applied, the data shows a nose-down movement of the

elevator, following which the position of the elevator remained static for several seconds.

- At point B, the horizontal stabiliser also moved nose-down and D-CMSL pitched down to -8° , entering a descent during which 800 ft of altitude was lost and the airspeed increased to 264 kt.

- Eight seconds later, with an increasing rearwards force applied to the control column the AP disconnected, at point C, which was recorded in the data as an 'abnormal disconnect'. This was followed by the disconnection of the A/T and YD. As the pull force applied to the control column increased, the elevator moved nose-up. However, the FDR data showed that large column forces were needed for even small deflections of the elevator and, at times, the elevator position was recorded as static despite a force being applied to the control column.

- The crew had recovered the aircraft to FL90, by point D, using stabiliser trim inputs and column movements. The A/T, A/P and YD were also re-engaged.

- After a few seconds, D-CMSL pitched up again (point E) with a nose-up movement of the stabiliser recorded before the aircraft pitched down. The AP disengaged, which was recorded as an 'abnormal disconnect,' followed by the A/T and YD. Other than an initial movement of the elevator, in response to a pull on the column of 407.5 lbf² (the largest recorded force – point F) and slight movements in response to other large inputs, the elevator trace now appeared static.

- The AP and YD remained disengaged, although the crew re-engaged the A/T for periods, and the aircraft was manoeuvred using the stabiliser trim until the elevator once again responded to crew input approximately seven minutes later at point G.

FDR data for the cruise portion of the incident flight

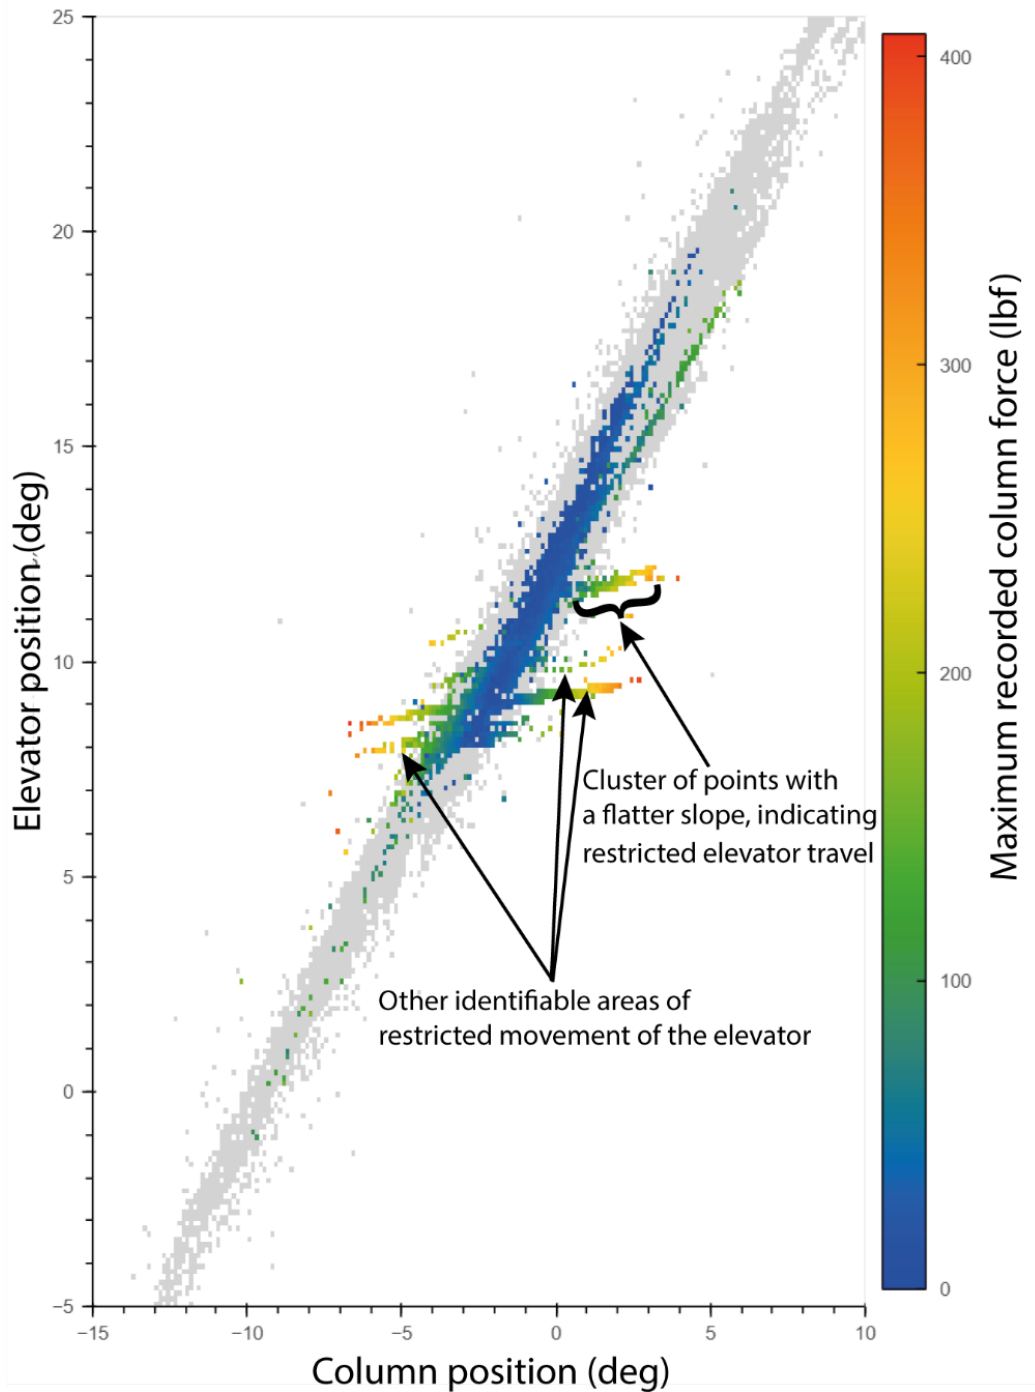
Figure 4

A plot of elevator position against column position³ (Figure 4) shows data from the event flight in colour, and from 74 other flights recorded on the FDR in grey. The data shows that during the event flight, several clusters of points have a markedly flatter slope indicating where the movement of the elevator was severely restricted. Whilst the elevator's movement was restricted, the control column was still able to move over a substantial range of travel, although high control forces (indicated by the orange/red shading) were experienced during these periods.

Elevator position vs column position data for the event flight

During this investigation the manufacturer reviewed flight data from a number of other PC-24 aircraft and confirmed that no other similar elevator restrictions were observed in the data, or have been reported by other PC-24 operators. However, data from the event flight clearly showed periods when an elevator control restriction was present on D-CMSL. The restrictions were most apparent in the data when it was plotted as a scatter plot against column position as the slope of neighbouring data points was markedly different when a restriction was present.

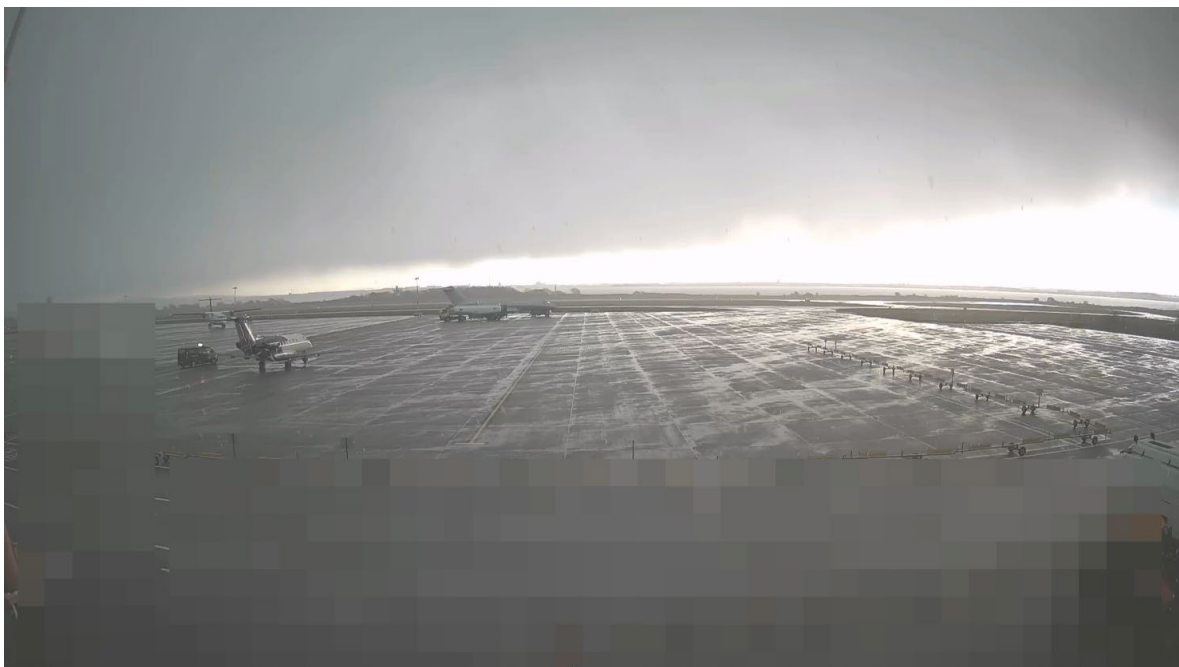
Figure 5

Closed-Circuit TV (CCTV) recordings from Liverpool showed the weather conditions, particularly the level of precipitation, in the hour prior to departure. It also showed how the pre-departure external checks were carried out by the crew. A screenshot from the recording (Figure 5) taken approximately one hour prior to departure shows rain and large areas of standing water on the apron.

Screenshot from the CCTV recording, an hour prior to departure of D-CMSL
