**Accident**

<b>Aircraft Type and Registration:</b>	Piper PA-28-180, G-AXSG	
<b>No &amp; Type of Engines:</b>	1 Lycoming O-360-A4A piston engine	
<b>Year of Manufacture:</b>	1970 (Serial no: 28-5605)	
<b>Date &amp; Time (UTC):</b>	7 April 2023 at 0827 hrs	
<b>Location:</b>	St Mary's Airport, Isles of Scilly	
<b>Type of Flight:</b>	Private	
<b>Persons on Board:</b>	Crew – 1	Passengers – 2
<b>Injuries:</b>	Crew – None	Passengers – None
<b>Nature of Damage:</b>	Left main landing gear cylinder and torque link lugs fractured, damage to underside of flap and wing	
<b>Commander's Licence:</b>	Private Pilot's Licence	
<b>Commander's Age:</b>	79 years	
<b>Commander's Flying Experience:</b>	1,400 hours (of which 500 were on type) Last 90 days – 31 hours Last 28 days – 7 hours	
<b>Information Source:</b>	AAIB Field Investigation

**Synopsis**

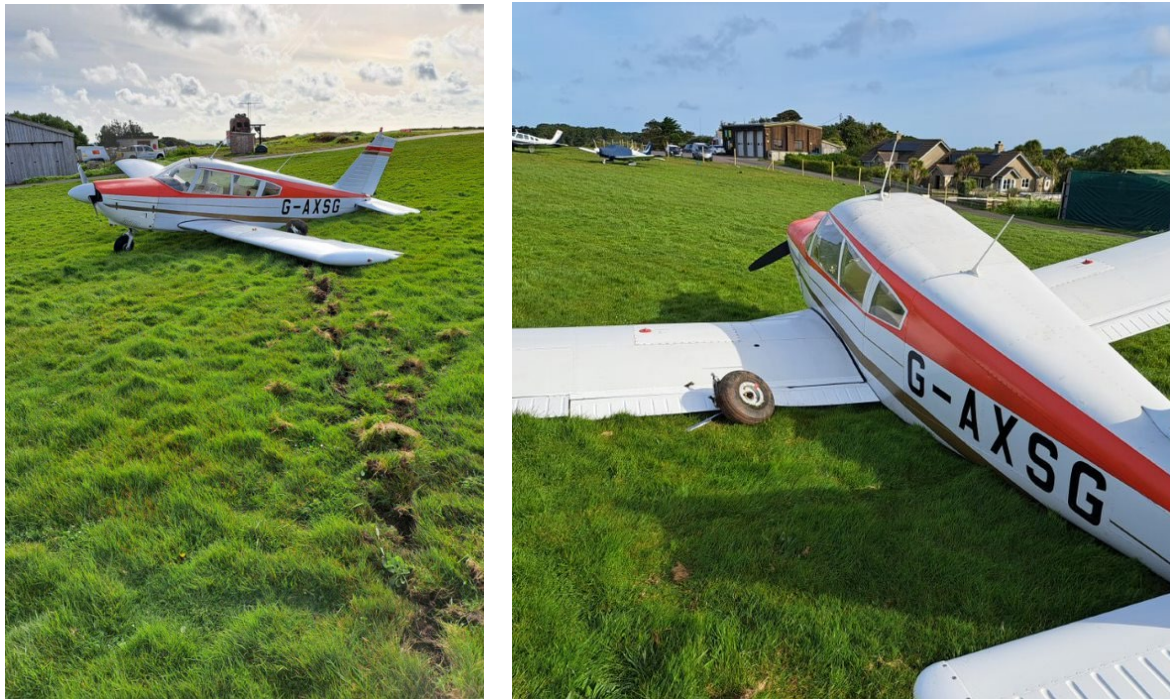
**Figure 1**

As the pilot applied the brakes after touching down, the aircraft veered to the left onto the grass where the left main landing gear leg collapsed. The remaining portion of the landing gear dug into the grass, turning the aircraft through 180° before it came to a stop (Figure 1). The pilot and passengers were uninjured.

G-AXSG following the landing

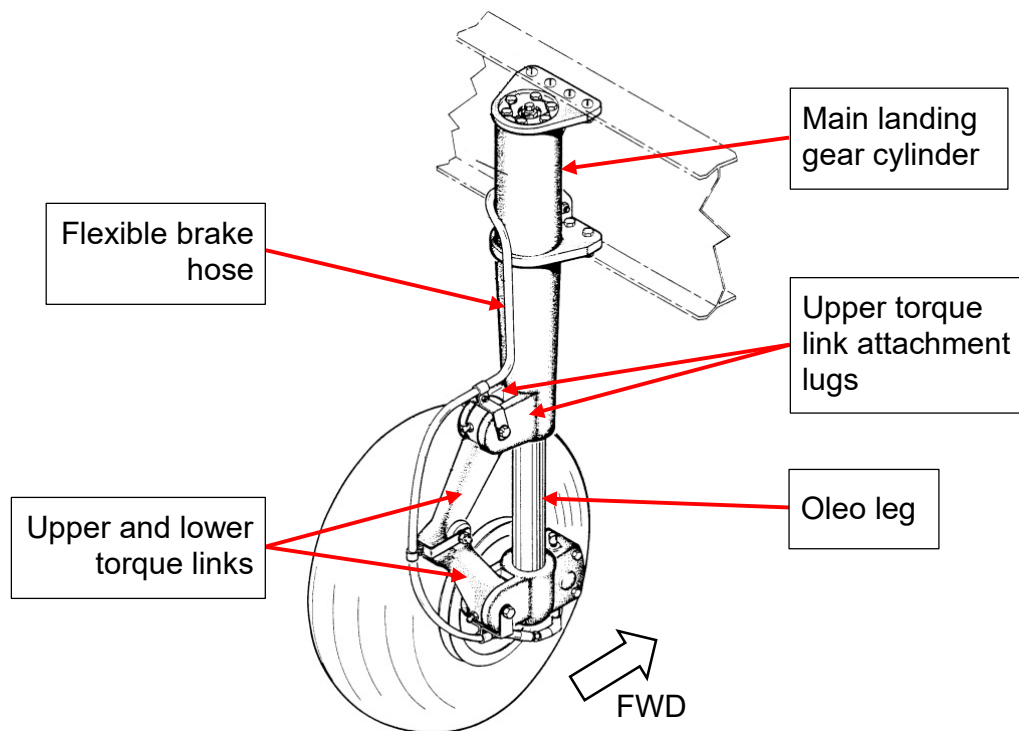
**Figure 2**  
Left main landing gear leg assembly

The Piper PA-28 has a fixed, tricycle landing gear. Each main landing gear leg comprises a cylinder attached to the main wing spar; an oleo leg with a wheel and brake assembly; and upper and lower torque links. The torque links retain the oleo leg within the cylinder and prevent it from rotating. The upper torque link is connected to the main landing gear cylinder via two torque link attachment lugs (Figure 2). The same cylinder is fitted to some models of the PA-32 aircraft.

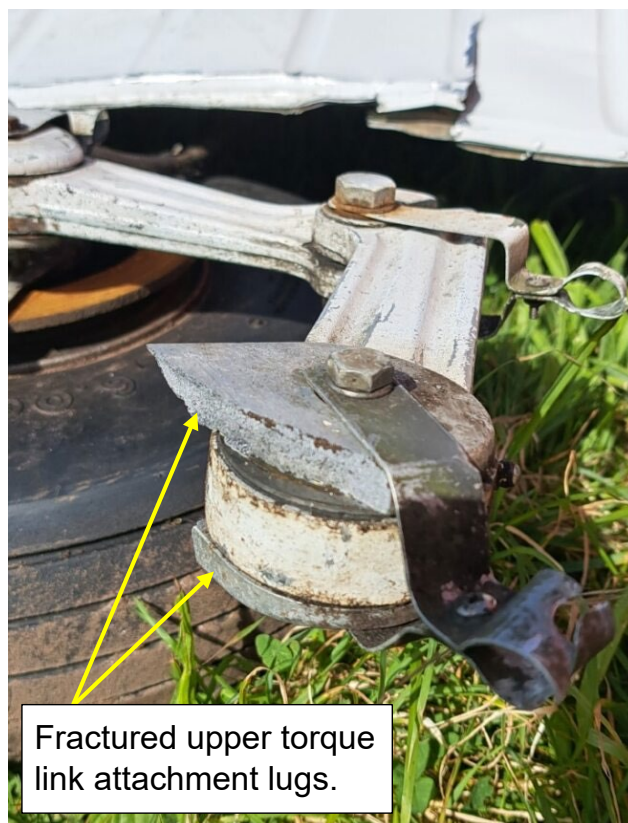
**Figure 3**

- The left landing gear wheel, torque link and oleo strut assembly had detached from the landing gear cylinder but remained attached to the aircraft by the brake hose.
- The torque link attachment lugs had broken from the main landing gear cylinder and remained attached to the upper torque link (Figure 3).
- The base of the main landing gear cylinder had fractured into several smaller pieces near to the upper torque link attachment lugs (Figure 4).
- There was damage to the left flap and wing surface sustained from the oleo leg and wheel assembly during the accident sequence.
- The left wheel brake disc surface was corroded and did not show witness marks from the brake pad rubbing against the disc.

Detached torque link lugs and wheel assembly

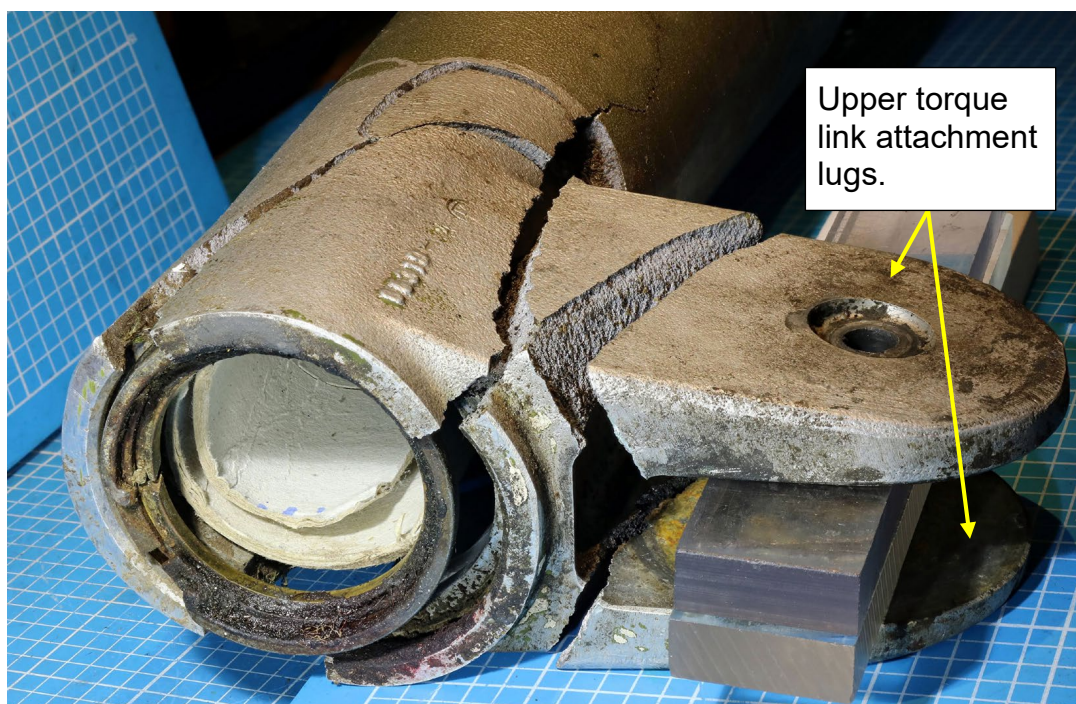
**Figure 4**

Fractured lower left main landing gear cylinder fragments

The landing gear cylinder fractures were assessed to have occurred due to overload. They happened after the failure of the torque link lugs and detachment of the oleo leg and wheel assembly.

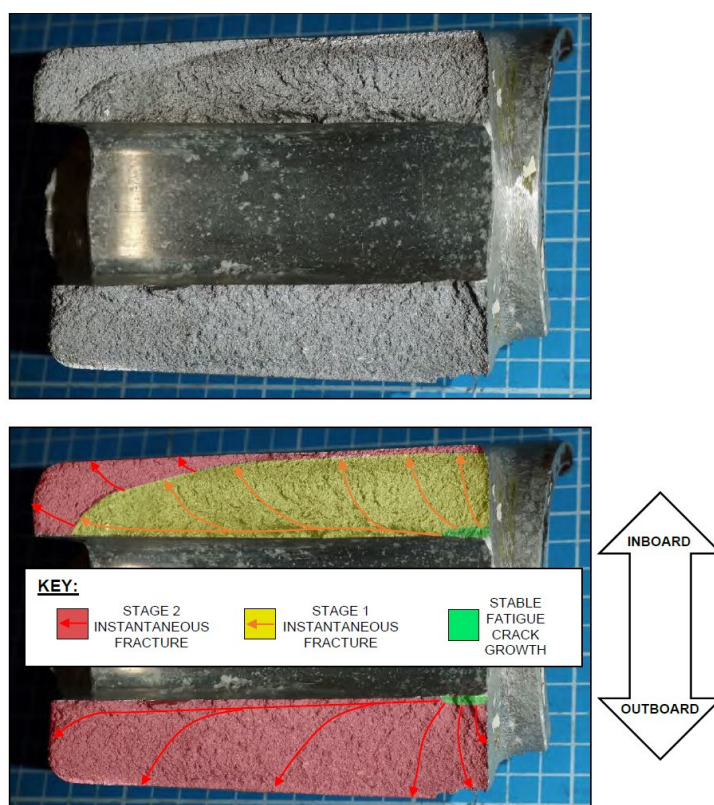
**Figure 5**

Both torque link attachment lug fracture surfaces showed an area of stable, progressive fatigue crack growth with faint striations<sup>2</sup> present. The fractures had initiated at the inner lower radii of each lug (Figure 5). The cracks reached a maximum depth of 2 mm on the inboard lug and 3 mm on the outboard lug before instantaneous fracture occurred. There was no evidence of pre-existing material or mechanical defects associated with the fatigue crack initiation.

Following the period of stable fatigue crack growth, the inboard lug showed evidence of having fractured in two stages. The first fracture (stage 1) extended to approximately three quarters of the lug's surface area, identified by slight oxidation of the fracture surface. Subsequent final separation of both the inboard and outboard lugs due to the secondary fracture (stage 2) are as assessed as having occurred at the same time.

Torque link attachment lug fracture surface analysis

The fatigue cracks formed and grew from the inner lower radii of each lug, followed by instantaneous failure. Fine fatigue striations were present in the areas of stable crack growth on both lugs, but it was not possible to correlate them with the numbers of landings. It was also not possible to determine how long the inboard lug's first fracture had been present, prior to final fracture occurring. It is possible that the fatigue cracks were present at the last inspection, which was carried out while the leg was fitted to the aircraft, but were not detected using the dye penetrant inspection technique.

It is recommended that the Civil Aviation Authority undertakes an unsafe condition assessment, in accordance with the requirements of UK Regulation (EU) No 748/2012 Annex I Part 21.A.3, for the cast main landing gear cylinder cracking affecting PA-28 and PA-32 aircraft, and take appropriate action based on the outcome of the assessment.
