Rail Accident Report

**Train striking debris at Yarnton near
Hanborough, Oxfordshire
10 February 2023**

Report 01/2024
February 2024

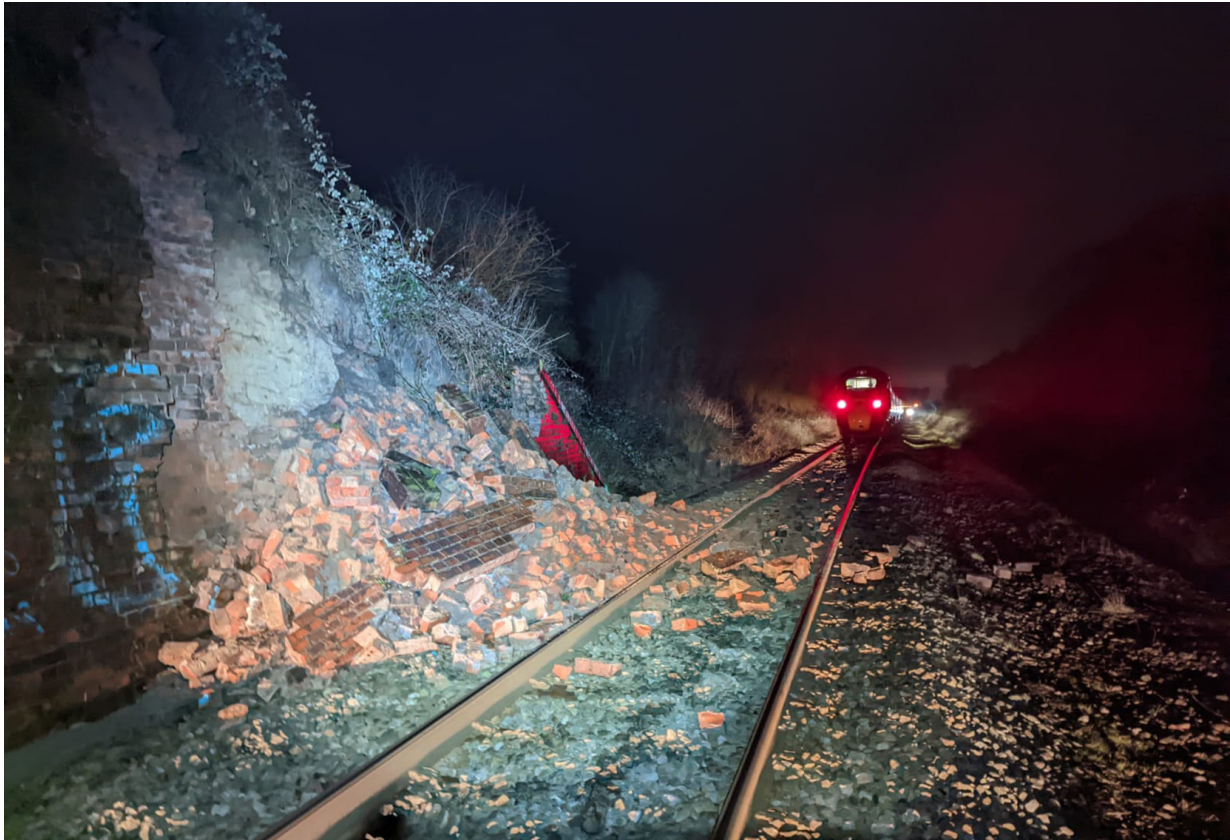
Figure 2: Debris and rear of stationary train soon after the accident (courtesy of Network Rail).

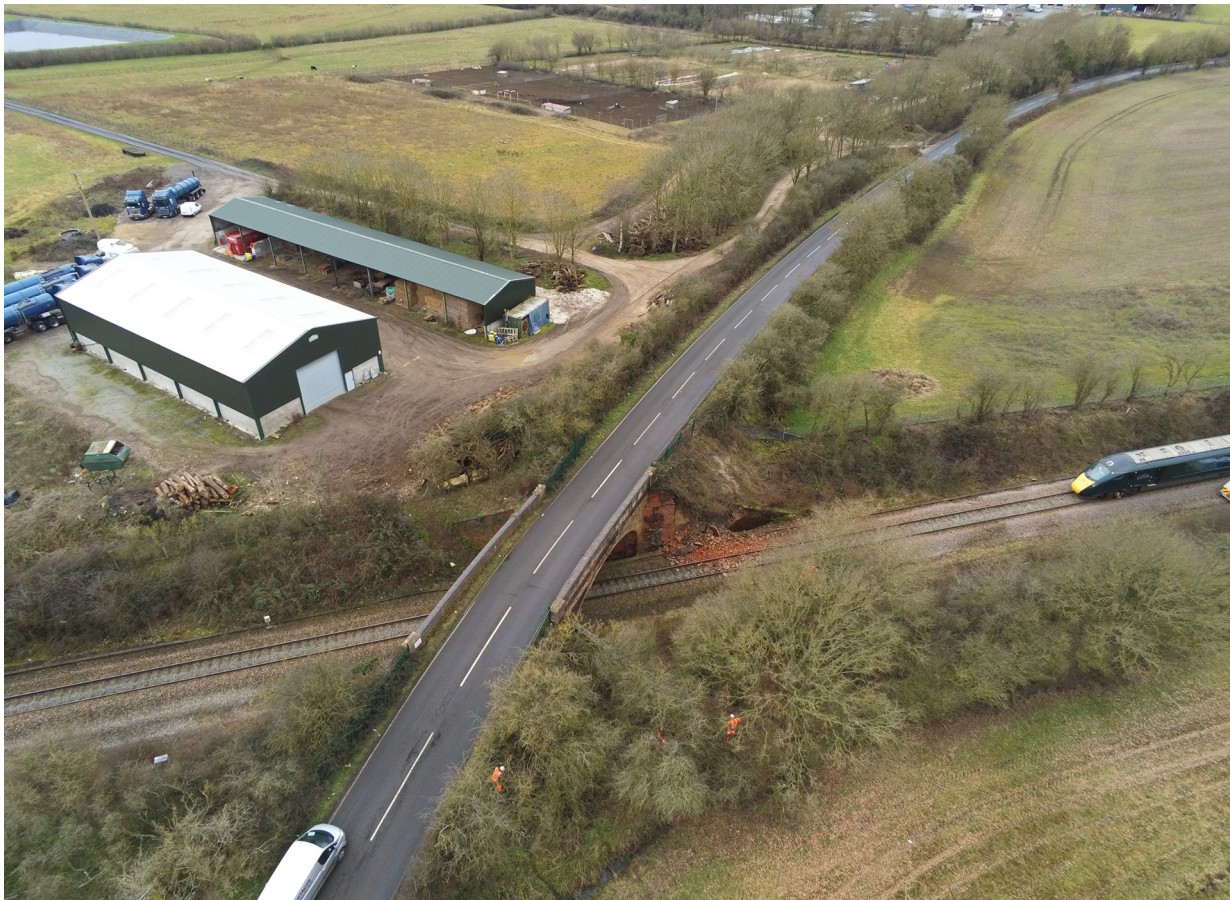
Figure 3: Overview on the morning after the accident showing the collapsed wing wall and rear vehicle of train 1W03 which stopped after passing under the bridge. The train was travelling from left to right.

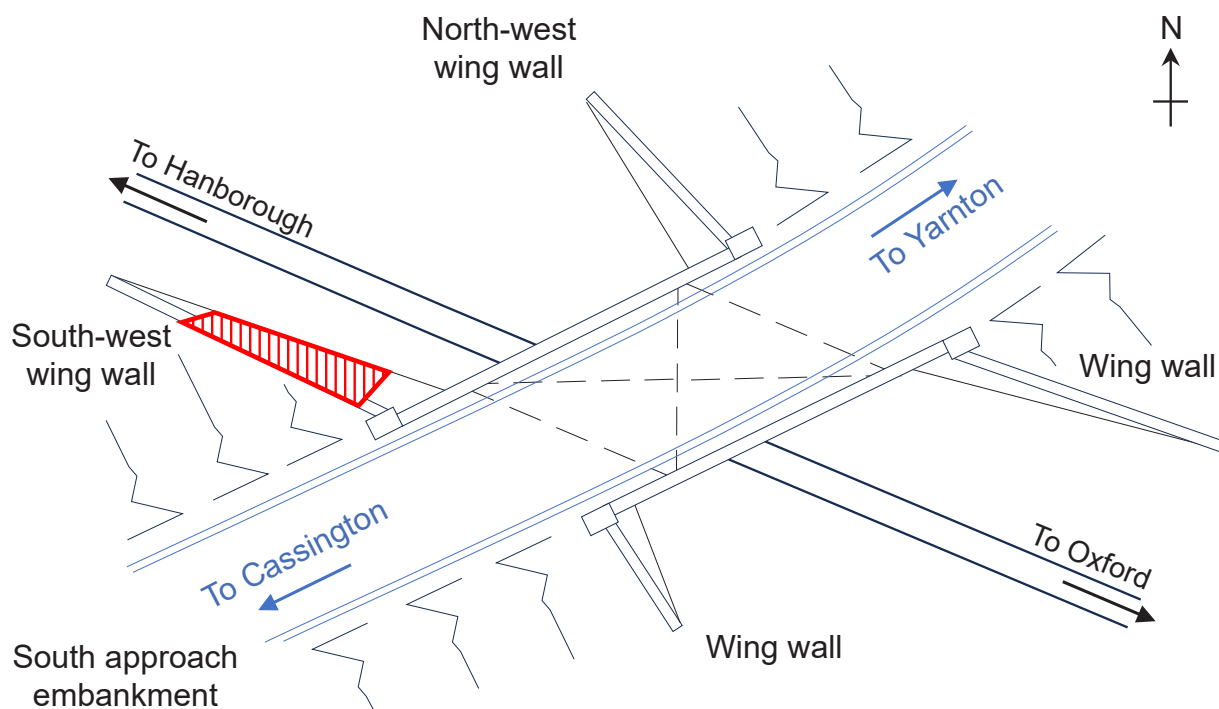
Figure 5: Bridge layout sketch showing the wing walls and south approach embankment. The section of the south-west wing wall that collapsed is highlighted in red.

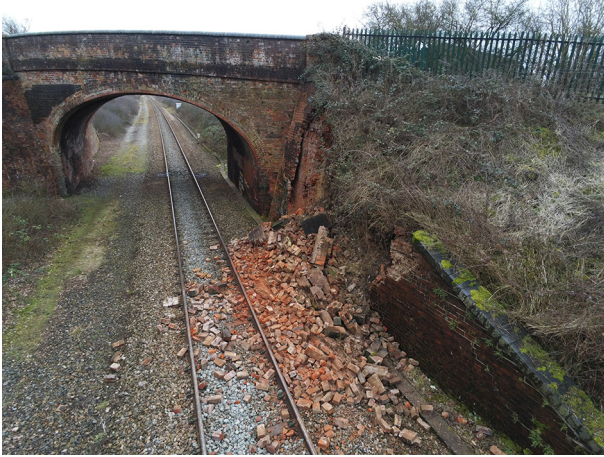
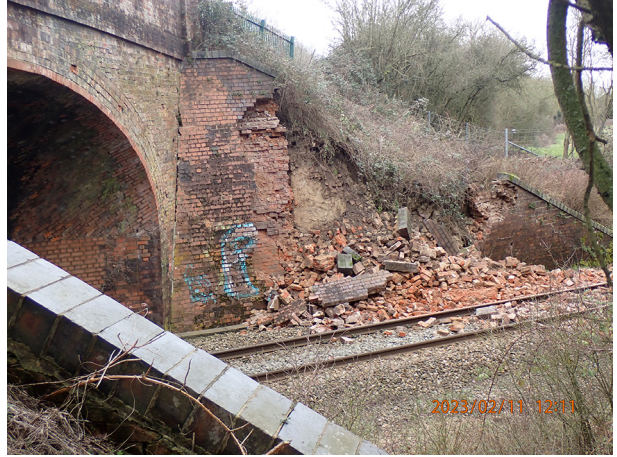
Figures 6a and 6b: Collapsed south-west wing wall on 11 February 2023.

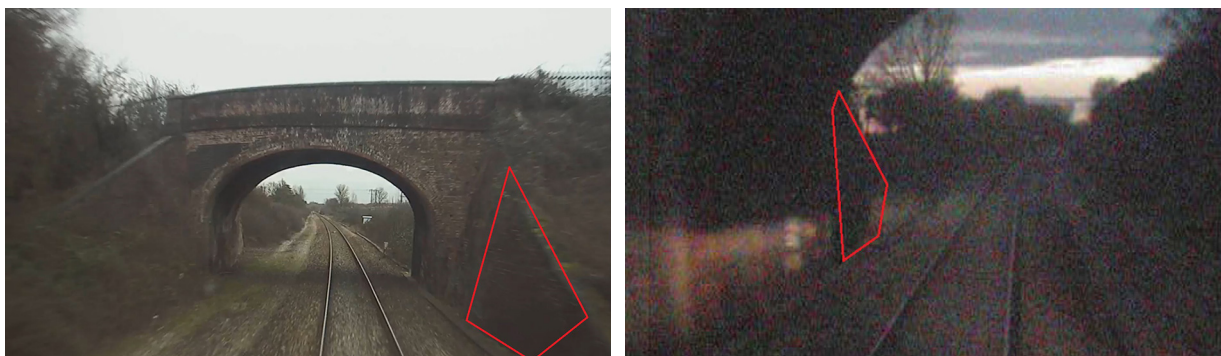
- 25 During the afternoon of 10 February, the line between Oxford and Hanborough was operating normally. Forward-facing CCTV recordings have been obtained from trains which passed under Yarnton Road bridge at around 16:29 hrs and 17:35 hrs. The images do not show any visible sign of an issue with the south-west wing wall at this point (figures 7a and 7b).

Figures 7a and 7b: Forward-facing CCTV images from passing trains at 16:29 hrs and 17:35 hrs. The section which later collapsed is outlined in red (courtesy of Great Western Railway).

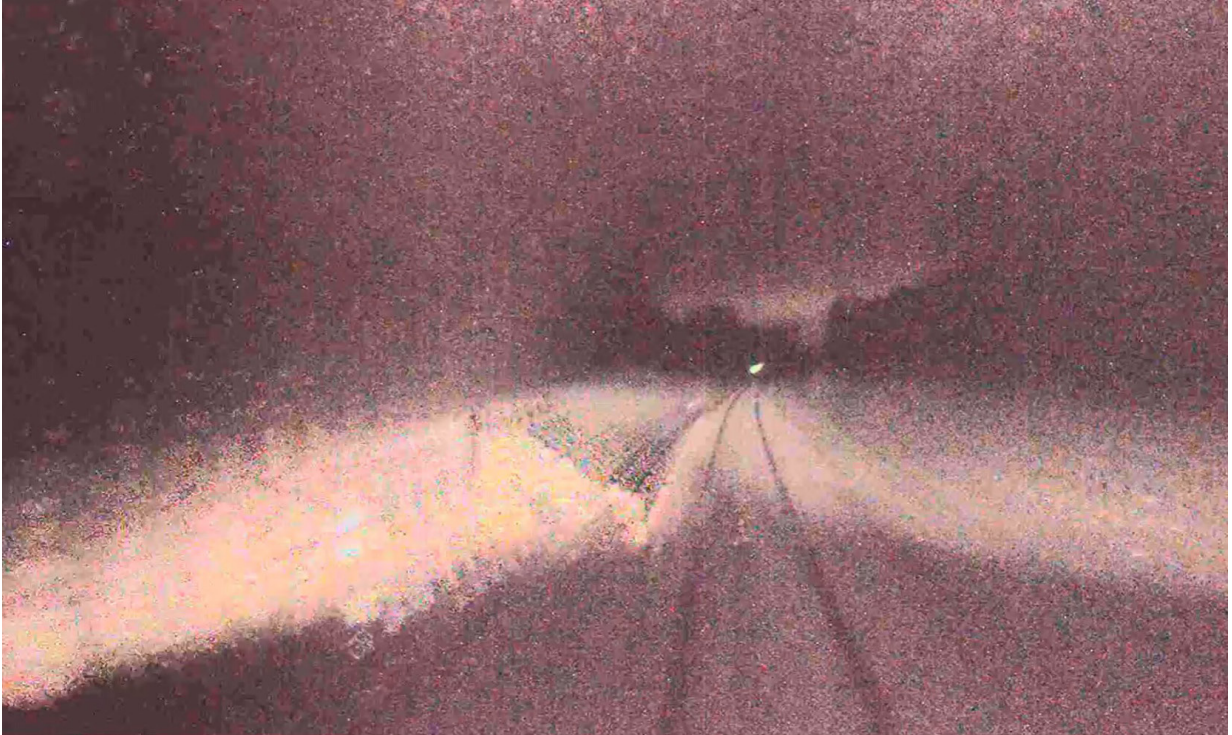
Figure 8: Forward-facing CCTV image from train 1W03 at 18:35 hrs, immediately before striking debris (courtesy of Great Western Railway).

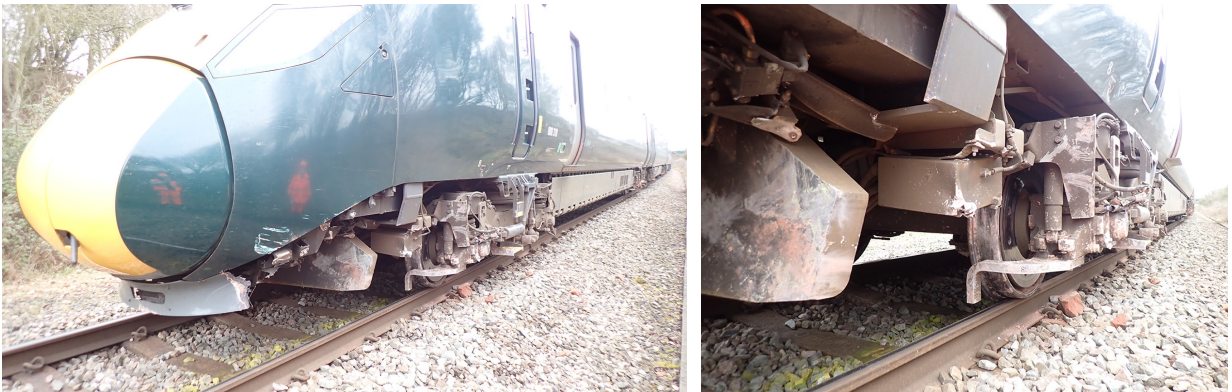
- 29 Damage to the train included a broken fibreglass panel located under the nose cone above the left-hand rail (in the direction of travel), displacement of safety equipment on the leading bogie and impact marks on the obstacle deflector, lifeguard, and leading wheelset (figure 9a and figure 9b). There were no injuries.

Figures 9a and 9b showing damage to the front of the train.

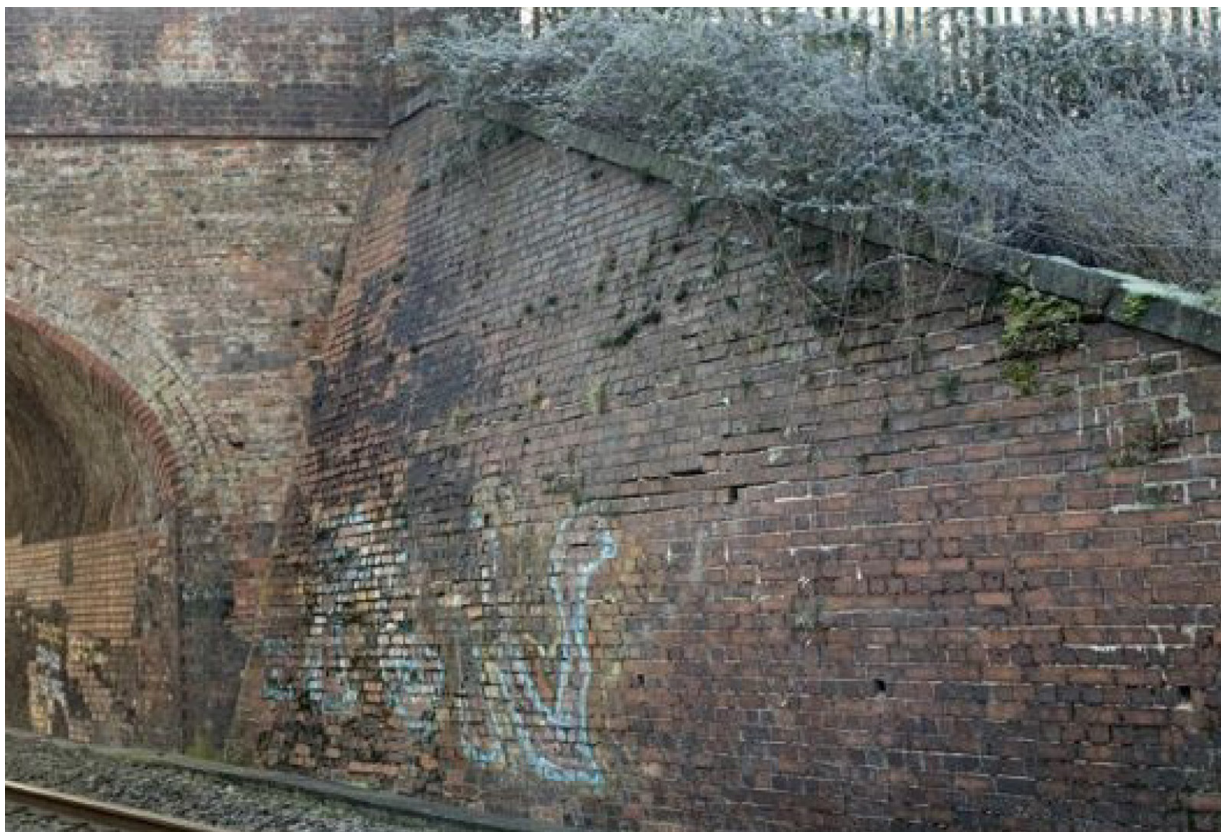
- 49 In January 2023, the examiner undertaking a planned visual examination noted that the bulging appeared to have increased and the fractures had opened up. They looked up the previous report electronically while on site to compare the photographs. Photographs in the 2023 visual report (figures 10 and 11) were captioned:

Figure 10: Image showing part of the south-west wing wall from the 2023 visual examination report captioned 'Appears to have increased bulging' (courtesy of XEIAD/Network Rail).

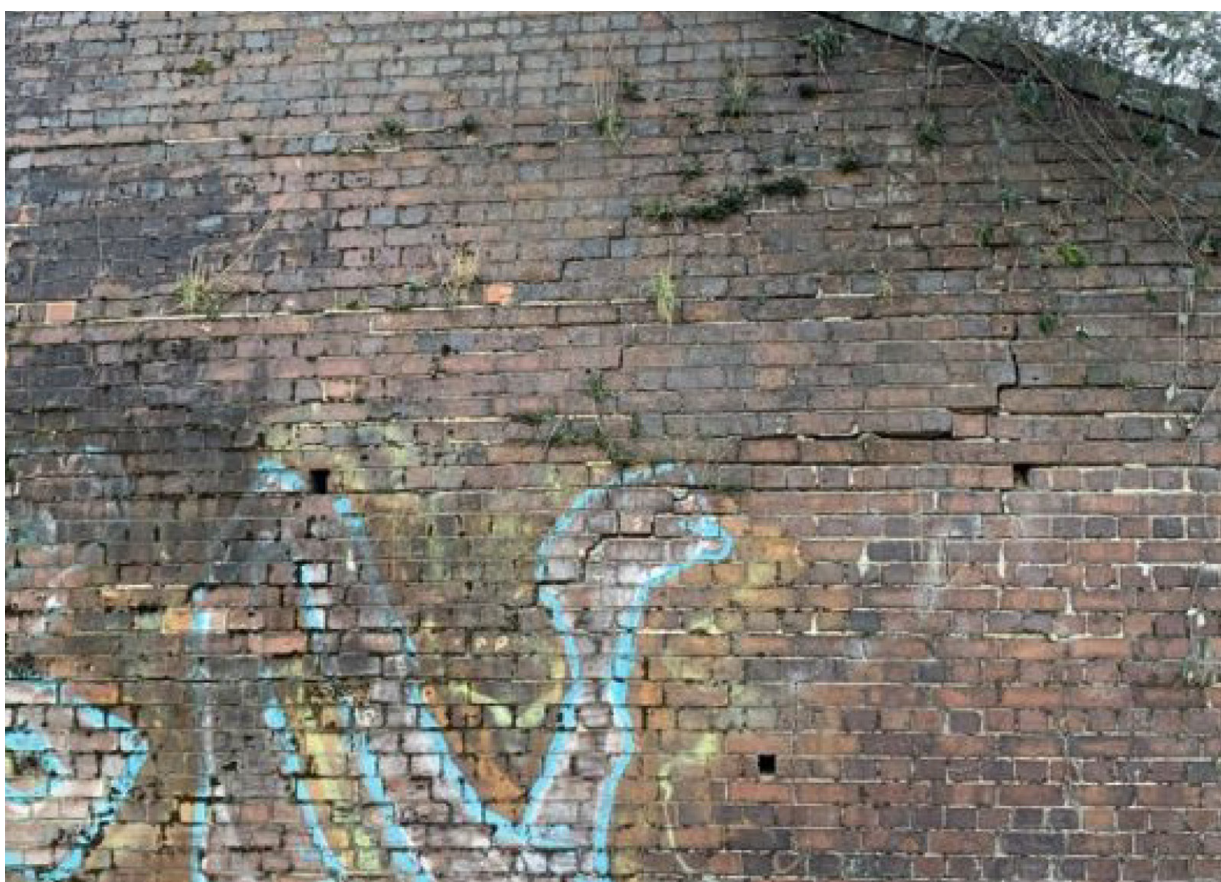
Figure 11: Image showing part of the south-west wing wall from the 2023 visual examination report captioned 'Deterioration throughout wall' (courtesy of XEIAD/Network Rail).

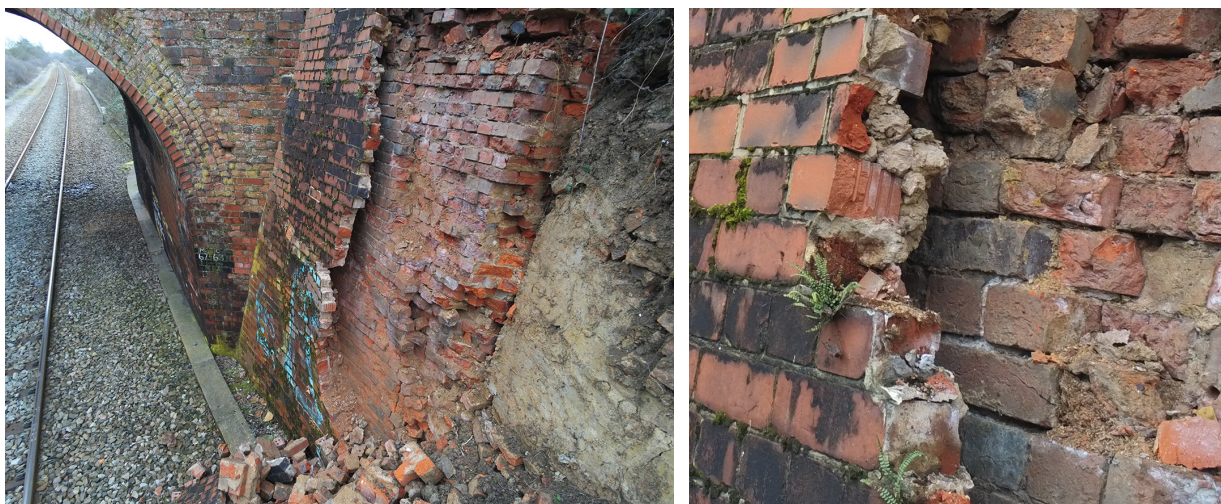
- 54 The repair should have created a stronger structure, interlocking new and older brickwork. However, a post-accident inspection of the partly collapsed wing wall showed that it comprised the original structural wall hidden behind a 'skin wall' just over 100 mm thick, leaving an internal cavity or void of a similar width. Bricks laid perpendicular to the face of the wall had been broken in half, and these half-bricks known as *snap headers* used in place of standard-length bricks (figures 12a and 12b). This would have saved on materials and disguised the fact that the new brickwork was not connected to the structural wall.

Figures 12a and 12b: View of partly collapsed wing wall and clay embankment core, and detailed view of skin wall showing short 'snap header' bricks and void around 100 mm wide.

- 55 As built, the construction of the outer skin wall was detrimental to the structural safety of the wing wall. This was because it concealed the inner structural wall, so its condition was unknown, and because it reduced the efficacy of the 2013 repair (see paragraph 58). It also added to the volume of debris which collapsed onto the track.

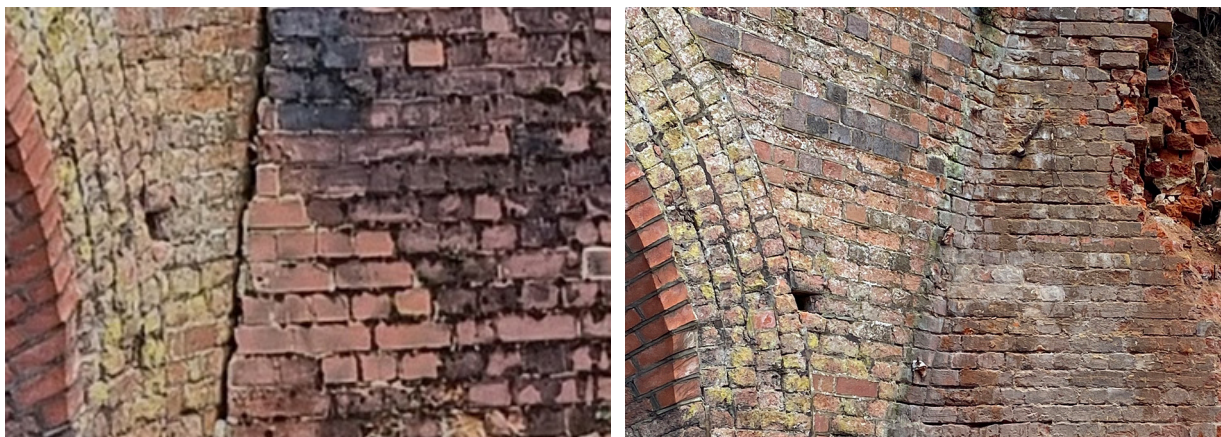
- 56 When the wing wall partially collapsed, a large part of the skin wall also failed. The remaining section of the skin wall was removed shortly afterwards, exposing this part of the structural wall for the first time in many years. This showed that the structural wall behind the skin wall was connected (that is, linked structurally) to the abutment (figure 4). However, the skin wall was not connected to the abutment leading to the development of a vertical fracture (figure 13a), a defect identified in examination reports from 2006 onwards and described as a 'mitre fracture' (see paragraph 71).

Figures 13a and 13b: Vertical fracture between skin wall and south abutment, and structural wall exposed after removal of skin wall (courtesy of Network Rail). Both images February 2023.

- 57 Exposure of the structural wall (figure 13b) revealed a bracket believed to be part of an early railway telegraph system. This suggests that the railway was already in operation before the skin wall was constructed.

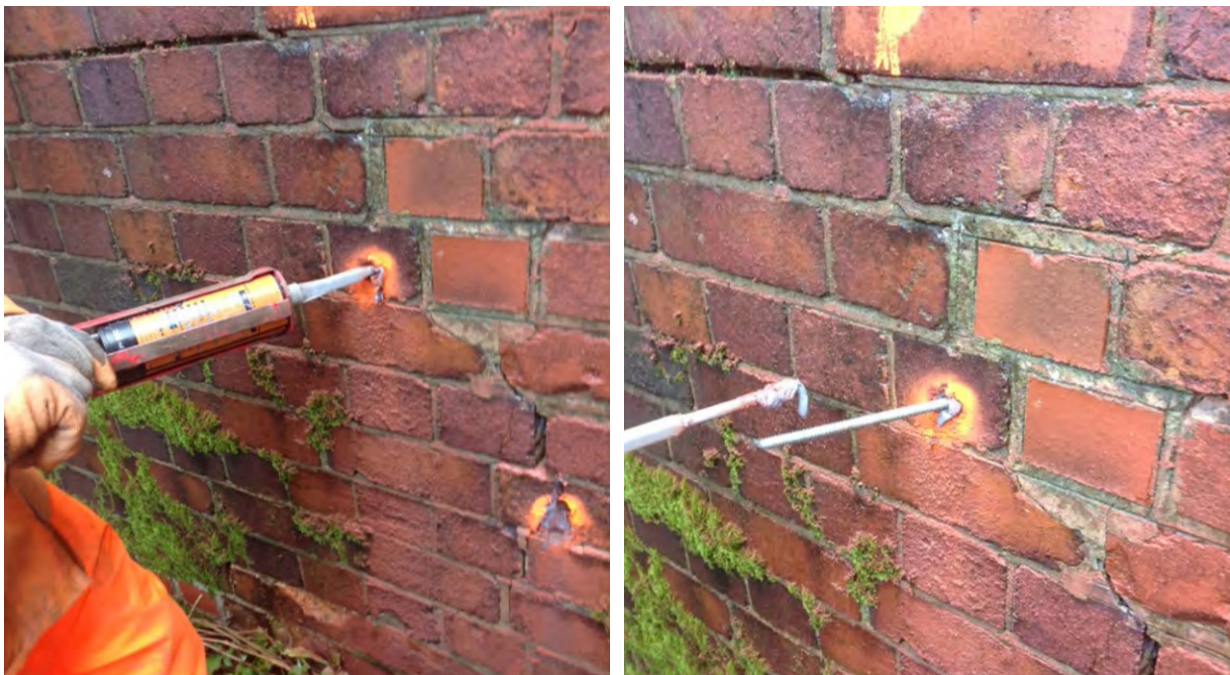
- 62 In early November 2013, QTS undertook pin and grout repairs to brickwork fractures affecting the two wing walls. This type of repair is detailed on Network Rail drawing NR/CIV/SD/109, ‘Stitching of shear cracks’, rev A dated 22 June 2006. It involved drilling a series of holes at an angle of 45 degrees on either side of a fracture and inserting, then grouting, a 6 mm diameter stainless steel bar into each hole. Pin and grout repairs of this nature can be used as a first intervention to try and stabilise a masonry fracture.

- 63 When the work was complete, QTS submitted a completion certificate valuing the work at £1,383.45, together with photographs of the work being undertaken (figures 14a and 14b). The completion certificate included text that had been prepopulated by Network Rail’s minor works management system ‘Monitor’ with the full text of the original recommendation (paragraph 58). This was not amended by either QTS or Network Rail to make it clear that only the final part, ‘*pin & grout brickwork fractures to hold rate of deterioration*’ had been done, although QTS stated that they felt that the photographs of the work would have made this clear. There is no report of a void being encountered while drilling into the wall or any other record of the work. The project did not meet the threshold for requiring a Health & Safety File, under the ‘The Construction (Design and Management) Regulations 2007’, to be submitted, so QTS was not required to provide as-built information.

Figures 14a and 14b: Drill and grout repair in November 2013 (courtesy of QTS).

- 64 Successful pin and grout repairs rely on stronger masonry being present behind the fracture to tie the damaged area in to. If there had been no void present behind the outer skin of the south-west wing wall, then this type of repair would have worked more effectively to stabilise it.

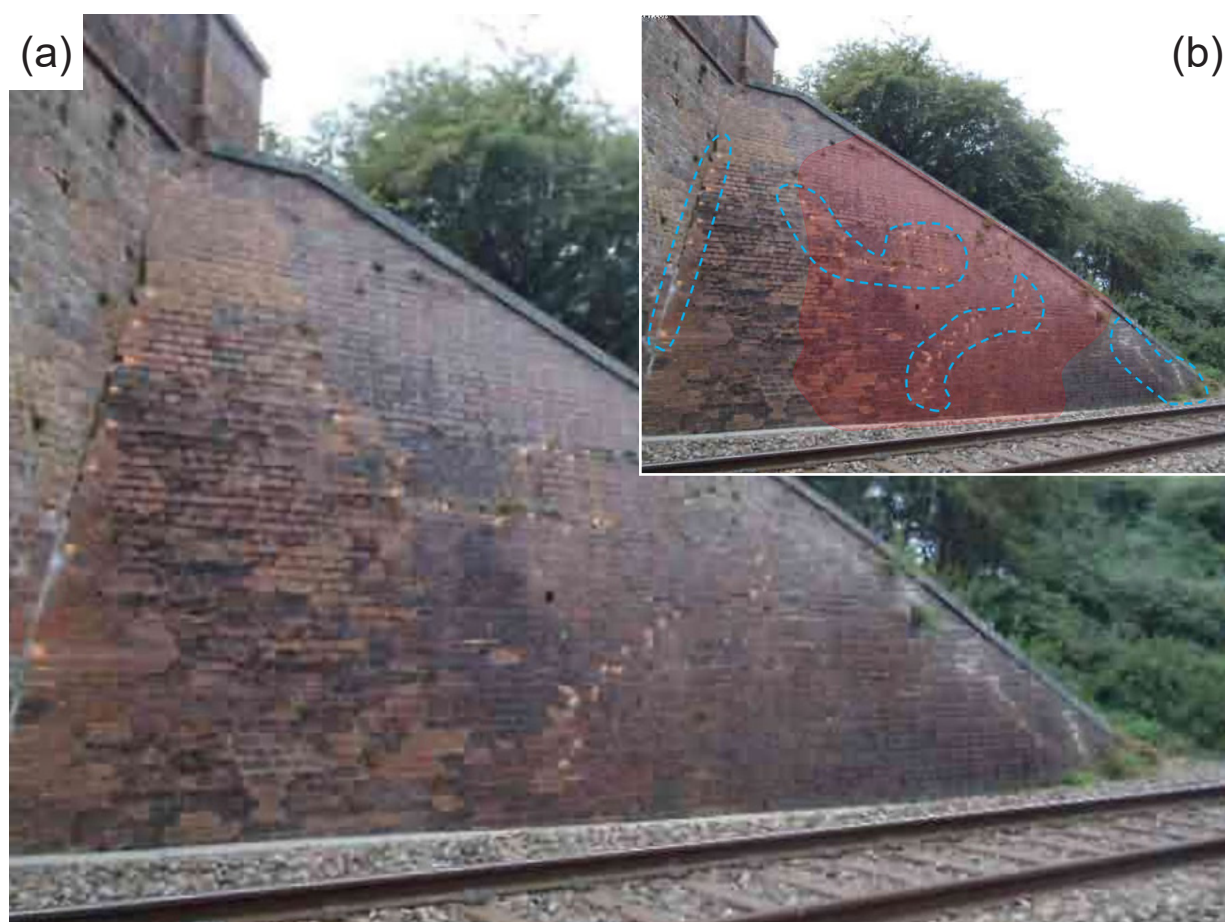
- 65 The detailed examination report in 2014, which followed this repair, included a photograph indicating the extent of the pin and grout work to the south-west wing wall (figure 15). Although the precise extent of the void is not known, it is likely that some or all of the holes drilled in November 2013 passed through it. Pins installed through the void would not have been effectively anchored into the structural wall as some of the grout pumped into the hole from the exterior face of the wall would have been lost into the internal void or loose fill material, and likely to have left most of the pin's length ungrouted. There are no records, or other evidence, to indicate whether the presence of the void was apparent to staff on site.

Figure 15: Image from the 2014 detailed examination report showing south-west wing wall and location of pin and grout repairs indicated by yellow paint marks (a), and with areas of repair outlined and area of collapse indicated by shading (b) (courtesy of Amey/Network Rail)

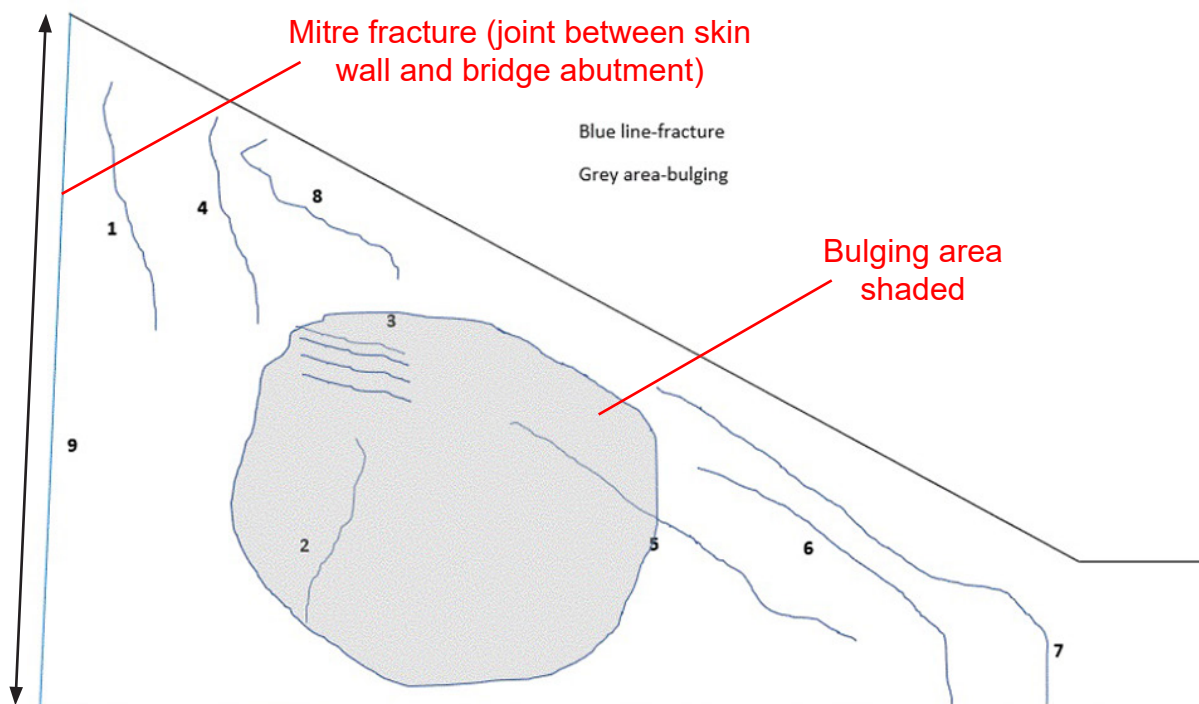
71 Subsequent examination reports contain similar observations and sketches of defects (figure 16). Those issued between 2011 and 2023 describe the significant defects affecting the south-west wing wall as:

'Bulging up to 70mm, 8m². Full height mitre fracture up to 12mm wide.'

72 This indicates that the shape (protuberance) of the bulge had apparently increased by 10 mm over a period of about 20 years. However, the difference between a 60 mm and 70 mm outstand over a large area cannot be seen or reliably quantified without using electronic distance measuring equipment. The examiners did not have access to this type of equipment and, in the absence of an established or practical alternative method, used a string line or a spirit level for this purpose. In the absence of any identified change, they reported the previous value. The 2011 report made the only reference to the measurement issue. It stated:

Figure 16: Sketch from 2021 detailed examination report showing defects affecting the south-west wing wall, with RAIB annotations (courtesy of Amey/Network Rail).

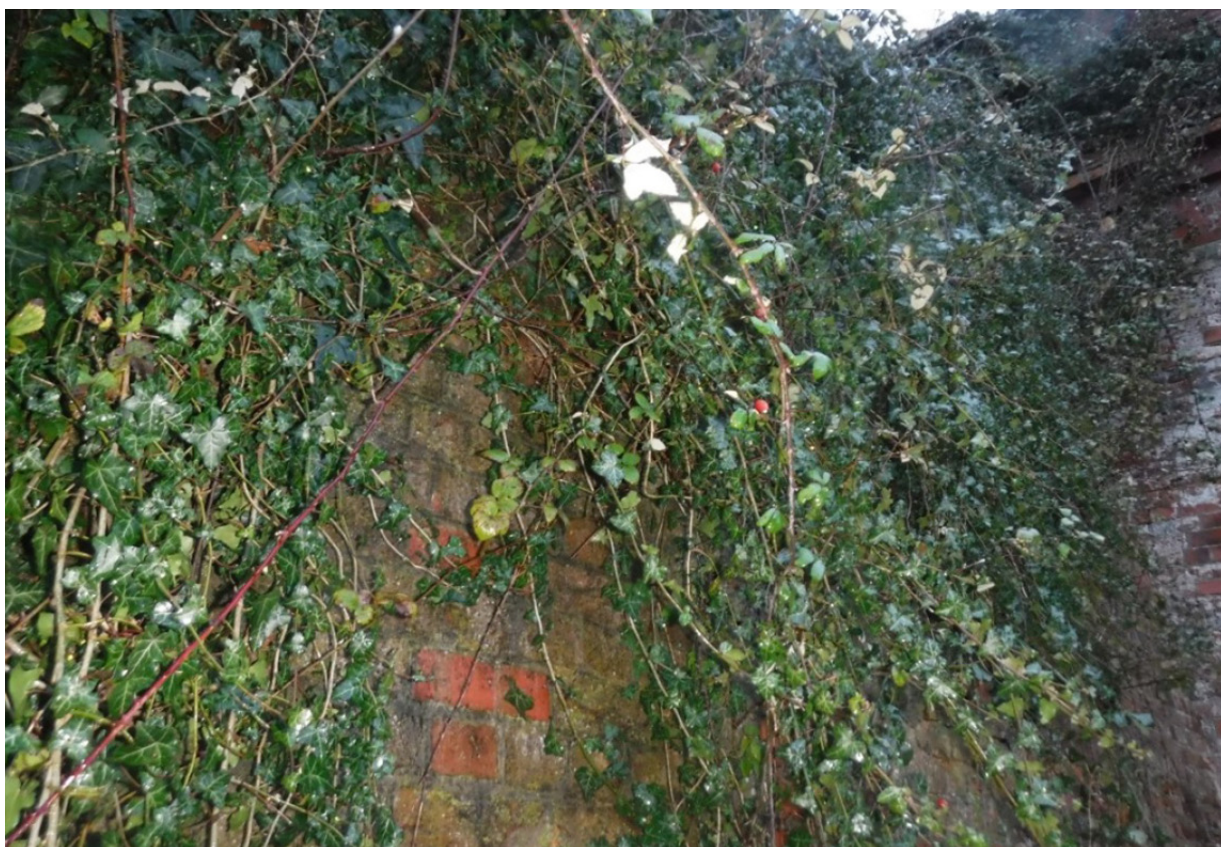
111 The 2021 detailed examination was recorded as incomplete. A different wing wall could not be fully examined due to extensive vegetation growth (figure 17). The examining engineer recommended:

Figure 17: Image from 2021 detailed examination report showing vegetation growth obscuring the north-west wing wall (courtesy of Amey/Network Rail).

'Remove vegetation from face of wingwall, make good stonework as required, treat to prevent re-growth and clear from site, to complete a compliant detailed examination.'
