SB1/2024

Fatal injury to a deckhand following a chain failure

Honeybourne III (PD905)

MAIB SAFETY BULLETIN 1/2024

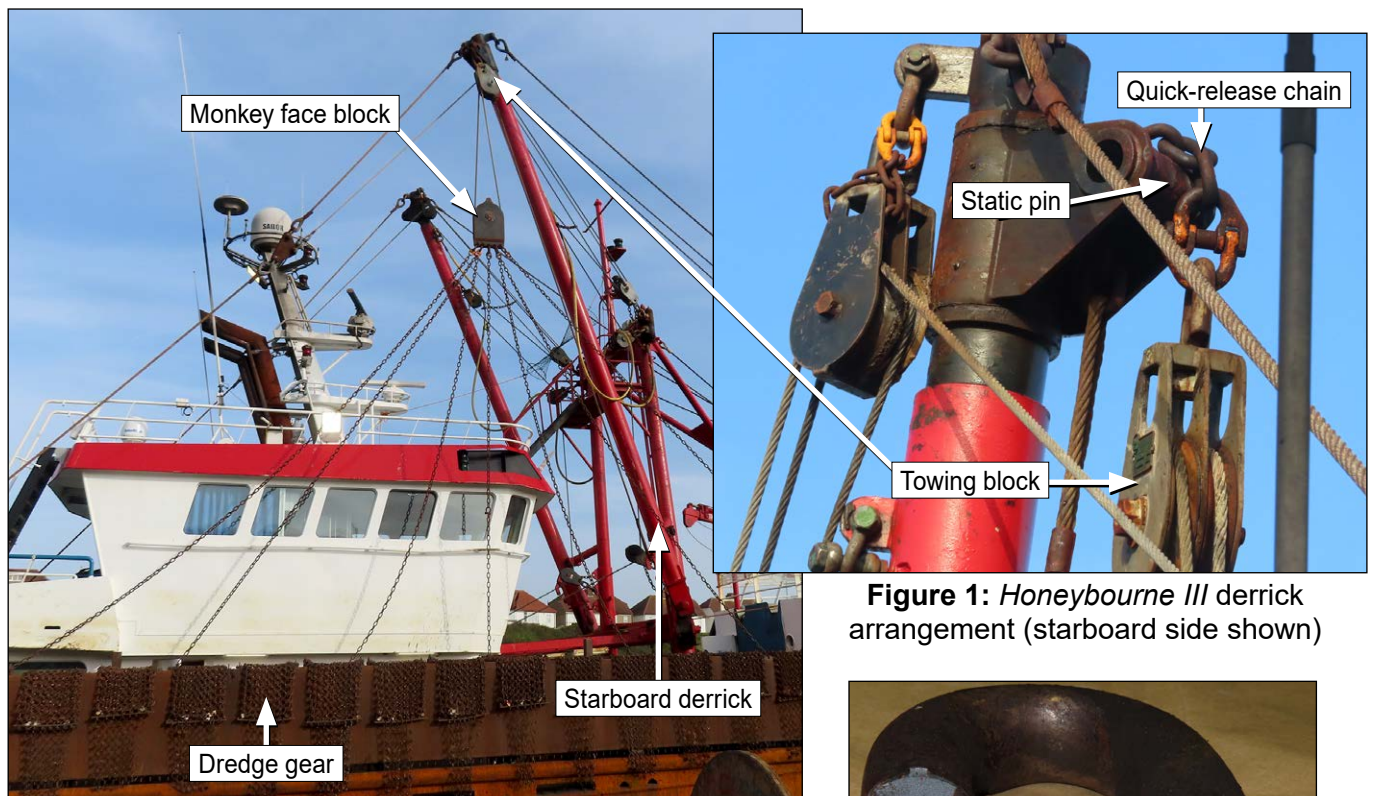
Figure 1: *Honeybourne III* derrick arrangement (starboard side shown)

The ongoing MAIB investigation has found that a section of chain in the port dredging gear quick-release assembly failed as the gear was being retrieved. A 32mm chain link, which was led over a static steel pin at the derrick head (**Figure 1**), parted (**Figure 2**) and allowed the towing block, monkey face block and associated gear to fall to the deck below.

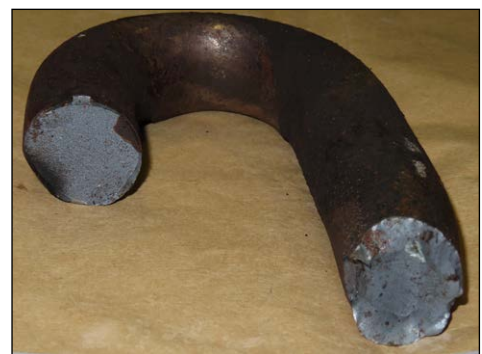
Figure 2: Failed chain link on *Honeybourne III*

- The recent recorded accidents and failures of chain links leading over a static pin as part of a quick-release mechanism indicate the significant risk of such arrangements failing when loads are applied to the chains. These arrangements can induce complex loading forces in the chain links, leading to excessive wear on the chain links and significantly reducing the chain strength.

S2024/102M Urgently ensure that a suitable and sufficient assessment of the risk of a failure of the derrick quick-release mechanism chain has been undertaken and documented, noting the safety issues identified in this safety bulletin, and that:

- mitigations are identified and immediately implemented to reduce the risk to the crew associated with a failure of the derrick quick-release mechanism to a level that is as low as reasonably practicable; and
- the crew are informed of the findings of the risk assessment and the measures taken for their protection.

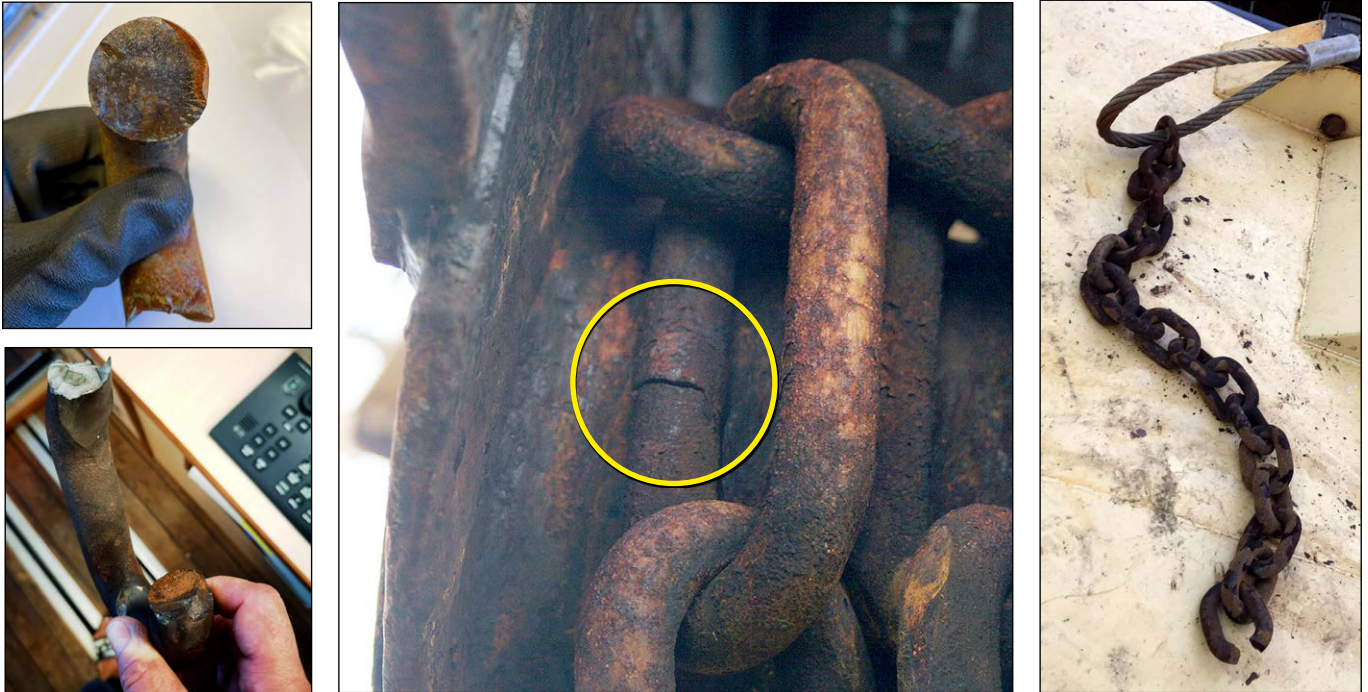
Figure 3: Identified chain defects in static pin arrangements

The configuration of a chain led over a static pin as part of a quick-release gear is commonly used on board scallop dredgers and beam trawlers. Such arrangements are known to have failed previously and chain fractures have been identified during routine inspections of quick-release gear (**Figure 3**).
