Fatal fall overboard from the fishing vessel *Eder Sands* (UL 257) approximately 150 nautical miles west of Ireland on 7 October 2022

SUMMARY

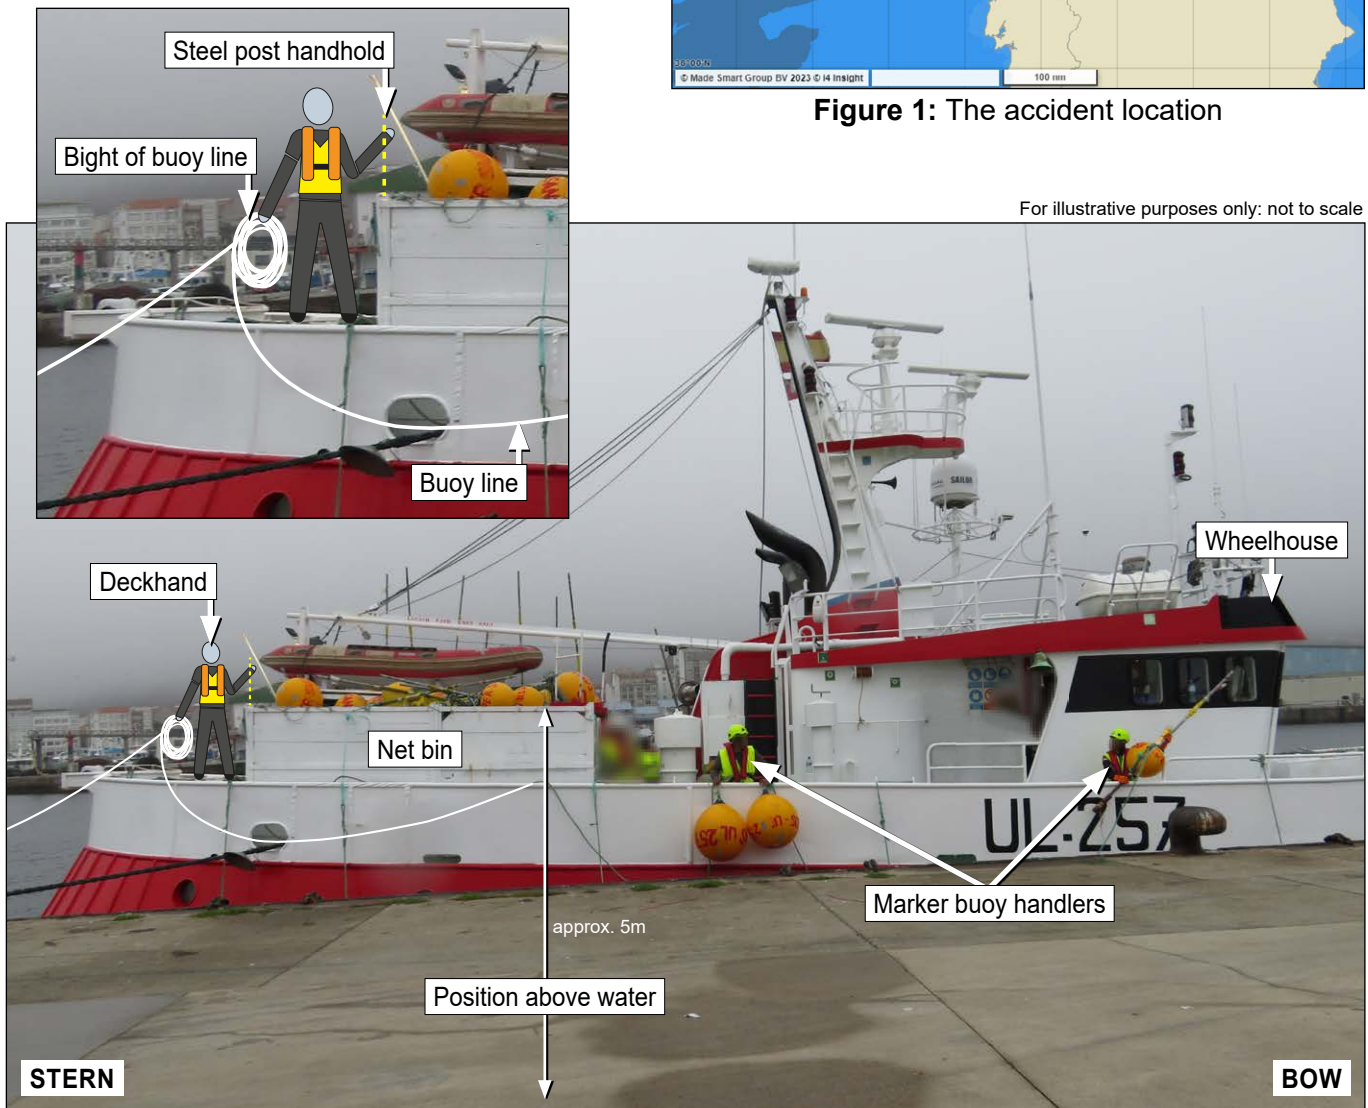
At about 1900, as the last of the net was about to be laid, the skipper called the on-watch crew to the upper deck. On arrival, the three deckhands took up their usual positions, one close to the vessel's stern and the other two tending the net marker buoys next to the starboard wheelhouse door. The upper deck was lit by deck lights and all three deckhands were each wearing foul weather dungarees, boots and an auto-inflate lifejacket. The deckhand at the stern was standing on the lid of a storage locker above the vessel's main deck, in line with the top of the bulwarks (**Figures 2 and 3**); he was holding on to a bight of buoy line (**Figure 4**).

Figure 2: Reconstruction, showing the positions of the deckhands during the final phase of shooting the net

The crew of *Eder Sands* had developed their own local, undocumented procedure for shooting nets and the final stage of this process required three deckhands to be on deck. The practice was that the more experienced deckhand would stand on the lid of the storage locker beside the bulwark at the stern of the vessel (**Figures 2 and 3**), which allowed them to simultaneously observe the laying of the fishing gear (net, anchor weight and buoy line) and communicate by voice with the two deckhands holding the marker buoys and the skipper or mate in the wheelhouse. The lid of the storage locker, which was about 4m above the waterline, had no guard rails but a steel post had been welded into the net bin next to the storage locker to provide a handhold. Post-accident, the steel post was found to have sheared off.

In the absence of any guidance in the vessel's safety folder the crew of *Eder Sands* had developed their own local, unwritten procedure for shooting nets. This was unsafe because it required a deckhand to stand on the locker lid, which had no means of preventing them falling overboard, such as guard rails or a safety harness and tether. The procedure also required this crew member to handle the fishing gear when throwing the bight of buoy line over the side to finish shooting the net.

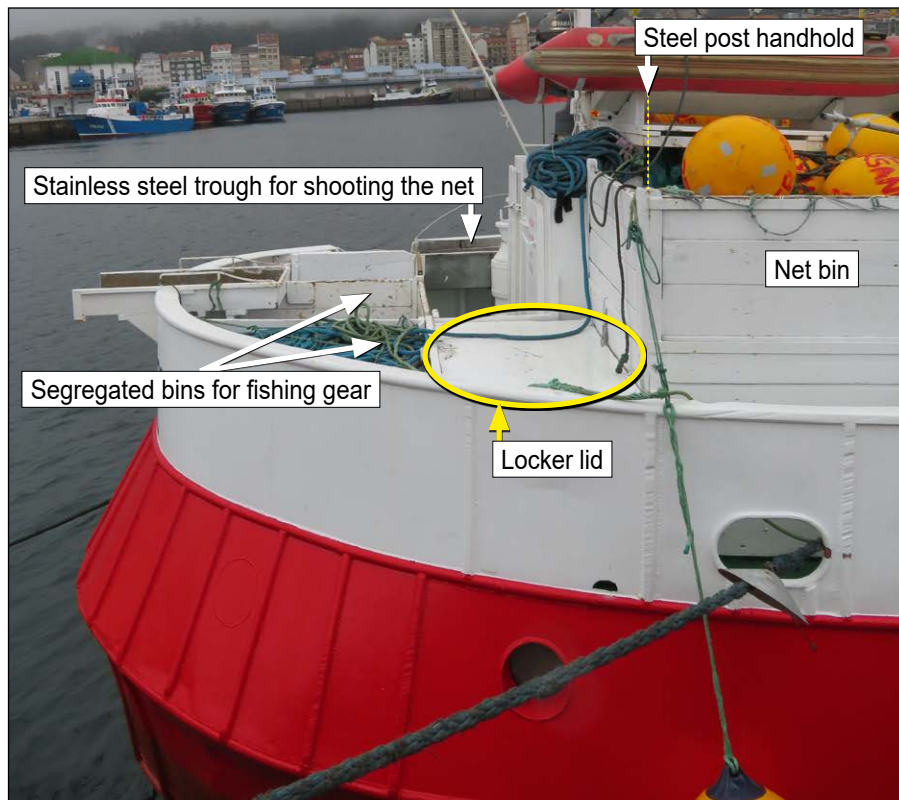
Figure 3: The fishing gear stowage arrangement at the stern

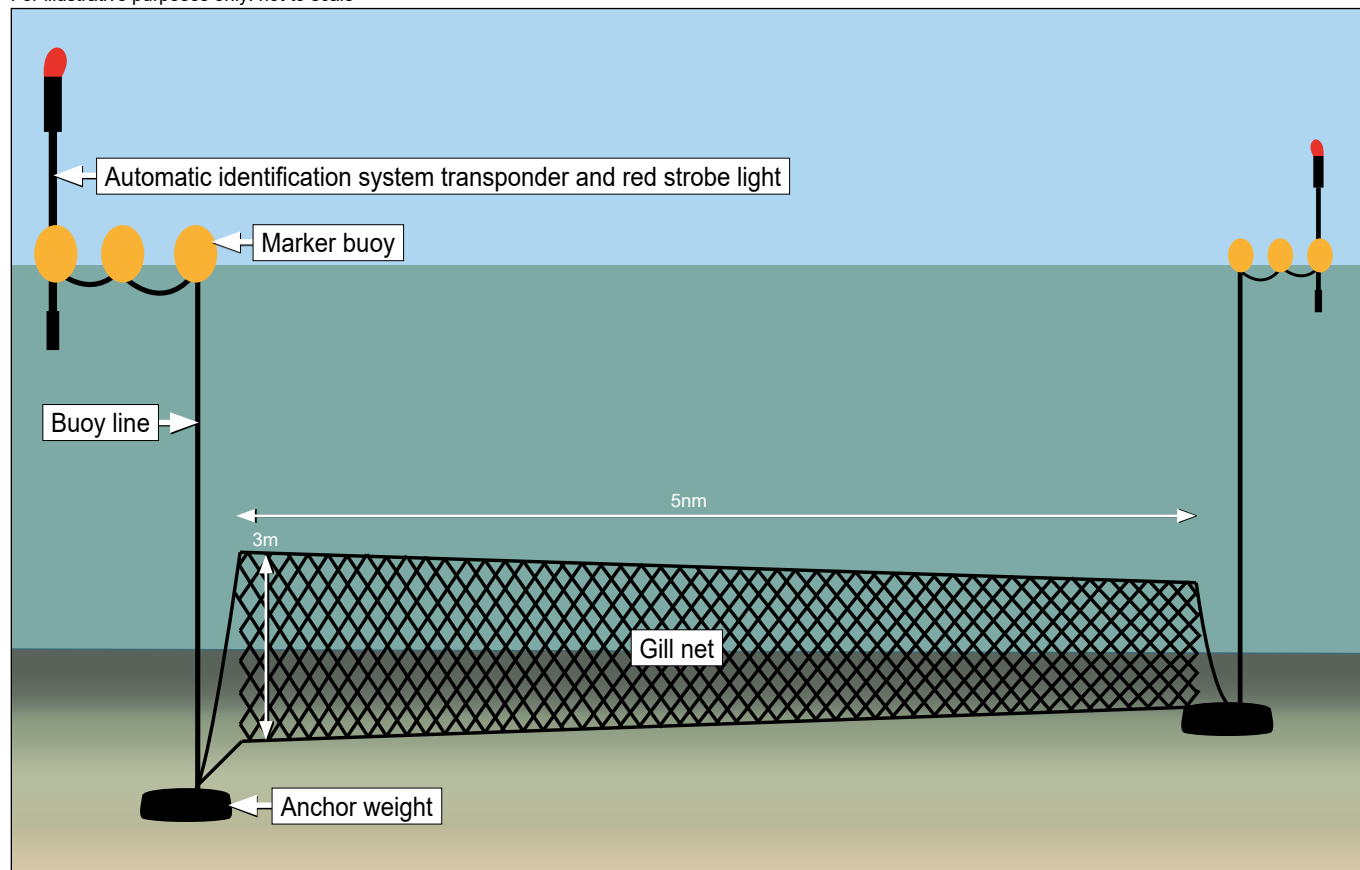
Figure 4: The fishing gear arrangement

The deckhand positioned at the stern of the vessel usually held a bight of buoy line in their free hand, throwing it over the side when they shouted to their two colleagues to release the marker buoys.

It is impossible to determine what caused the deckhand to fall overboard; however, the lack of a guard rail/bulwark or safety harness and tether combined with the dangerous practice of holding on to a bight of fishing gear meant that there was nothing to prevent him falling from the vessel and entering the water. Post-accident, the steel post sometimes used as a handhold by deckhands standing on the lid of the storage locker at the rear of the vessel was found to have sheared off; the use of this handhold was unsafe and it did not adequately mitigate this risk.

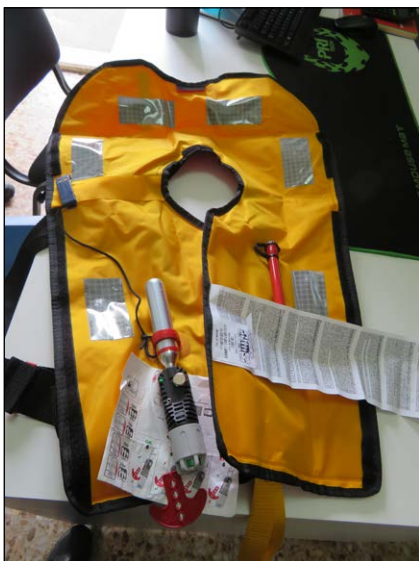
The owner of *Eder Sands* provided the crew with 170N auto-inflate lifejackets to wear while working on deck (**Figure 5**). These were compliant with the International Organization for Standardization (ISO) performance standard prescribed in the regulations¹⁸ and were equipped with the mandatory accessories of whistle, lifting loop and retroreflective strips. The lifejackets were not fitted with spray hoods, lights, crotch straps or PLBs.

Figure 5: The auto-inflate lifejackets carried on *Eder Sands*

- *Eder Sands* routinely operated 24 hours a day while hundreds of miles from shore. Although compliant, the lifejackets on board the vessel were not fitted with lights, spray hoods, crotch straps or PLBs. Without these additions the chances of location and survival of a man overboard were reduced.
- The delay in alerting maritime search and rescue authorities did not impact the effectiveness of the 21-hour search for the missing deckhand or the outcome of the accident.
- The MCA guidance did not advise fishing vessel owners of the MSN 1870 (M+F) requirement to review the suitability of PFDs to ensure they are appropriate for the risks, nor did it reflect fishing industry advice on the choice of appropriate lifejackets.

2024/105 In light of the risk assessments conducted in accordance with recommendation 2024/104, review the suitability of the personal flotation devices on board *Eder Sands* to ensure this equipment supports the survival and swift location and recovery of any crew that have fallen overboard; this process should consider the provision of a light, spray hood and personal locator beacon.

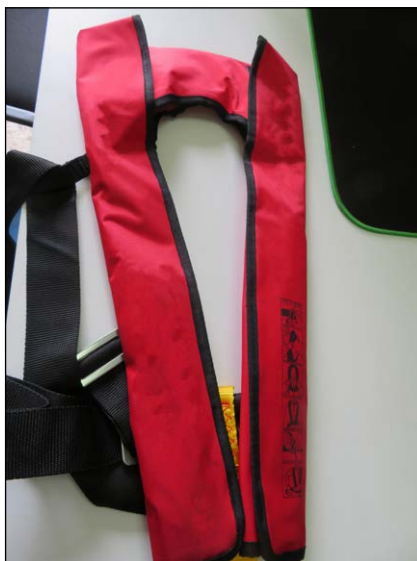
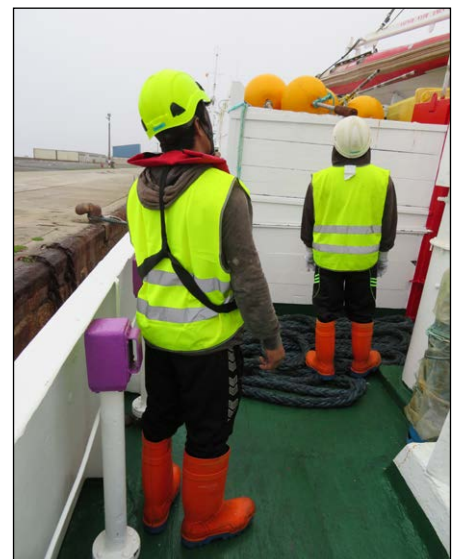
The investigation found no maintenance or inspection records for *Eder Sands*' auto-inflate lifejackets, but they had been replaced annually and appeared in good condition. The investigation noted that the crew shared the auto-inflate lifejackets and had adopted the practice of leaving the waist strap buckled and loose so that they could quickly put on or remove the lifejacket by slipping it over their head (**Figure 6**). *Eder Sands* did not carry PLBs for its crew.

Figure 6: Deckhand wearing an auto-inflate lifejacket with loose waist strap

The crew had not been instructed in how to wear their lifejackets correctly during training, copies of the manufacturer's instructions were not displayed within the vessel and the practice of wearing the lifejackets with loose straps went unchallenged by the officers on board. Without appropriate training and oversight there was no mechanism to ensure that the crew wore their lifejackets in accordance with the manufacturer's instructions to make sure that they functioned as intended if a crew member fell into the water.

2024/106 Take action to ensure that its crew follow the guidance in MGN 588 (F) and wear their working personal flotation devices in accordance with the manufacturer's instructions.

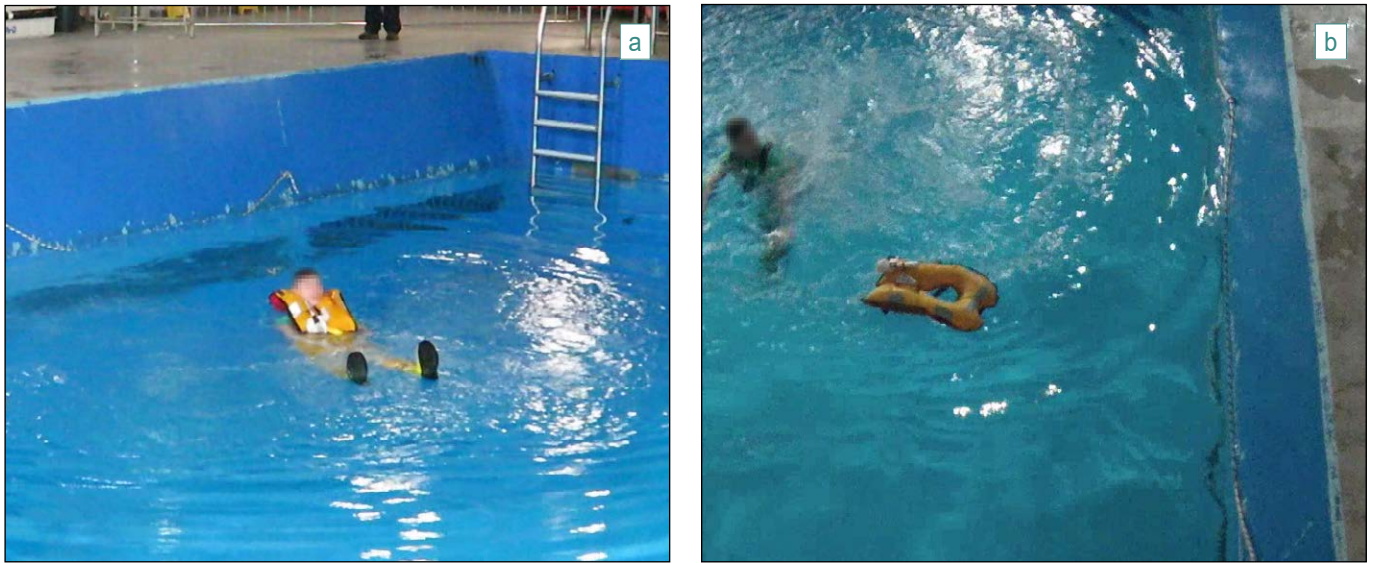
The MAIB conducted lifejacket trials (**Figure 7**) using the same make and model of auto-inflate lifejackets as those worn by the crew of *Eder Sands*. The trials established that:

- if the waist strap was correctly adjusted, the lifejacket operated as designed and remained in place on the user when entering the water from a height of up to 4m; and

- when the waist strap was loose, the wearer consistently slipped out of the lifejacket harness when the lifejacket automatically inflated after the person entered the water from a height of 1.5m.

The results of the trials also demonstrated that an inflated, but unoccupied, lifejacket was quickly blown away across the surface of the water in simulated winds and that an unlit lifejacket was almost impossible to see in the dark unless one of its retroreflective strips was directly illuminated by a light.

Figure 7: MAIB trial showing the effects of a person entering the water from 1.5m wearing a personal flotation device with a correctly adjusted waist strap (a) and with loose waist strap (b)

was seen but not his lifejacket. Therefore, it is likely that either his lifejacket failed to inflate or that, with the waist strap loose, he slipped out of its harness as it inflated and the unoccupied, unlit lifejacket then blew away from the scene without anyone noticing.
