SAFETY FLYER TO THE FISHING INDUSTRY

Fatal fall overboard from the fishing vessel *Eder Sands* (UL 257) approximately 150 nautical miles west of Ireland on 7 October 2022

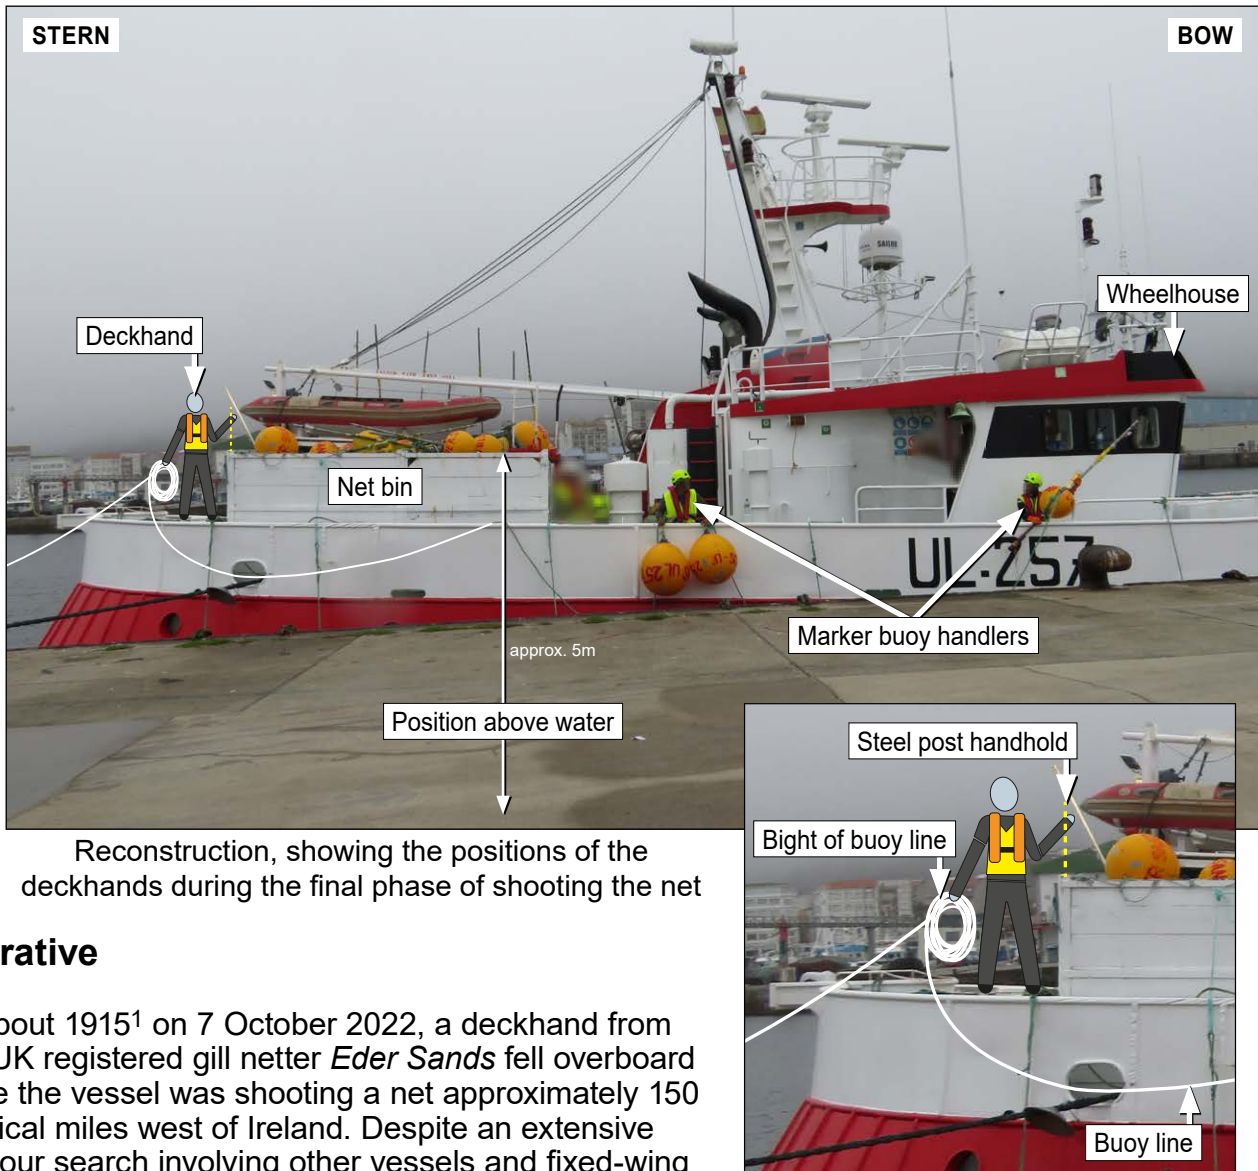
Reconstruction, showing the positions of the deckhands during the final phase of shooting the net

The onboard procedure for shooting the final part of the fishing gear required three deckhands, one standing close to the vessel's stern and the other two tending the net marker buoys next to the starboard wheelhouse door. All three deckhands were wearing foul weather dungarees, boots and an auto-inflate lifejacket. The deckhand at the stern was standing on the lid of a storage locker that aligned with the top of the bulwarks; he was holding on to a bight of the buoy line and might have been holding on to a steel post, which was subsequently found to have sheared off.

As the last of the net was about to be laid, the deckhand at the stern shouted to stop the vessel and call the bosun. The deckhand at the stern was seen to fall overboard 30 seconds later.

1. The procedure for shooting nets must be included in a fishing vessel's safety management system and properly risk assessed. *Eder Sands*' crew had developed an informal routine that required one of them to stand on the lid of a storage locker close to the stern while holding a bight of buoy line. This process had not been appropriately risk assessed, resulting in no guard rails or safety harness to prevent the crew member falling overboard. Additionally, the crew were routinely handling the fishing gear when shooting the nets, putting themselves at risk of becoming entangled and dragged overboard by the gear.
