Accident

Aircraft Type and Registration:	Slingsby Swallow T45, BYJ
No & Type of Engines:	None
Year of Manufacture:	1967 (Serial no:1568)
Date & Time (UTC):	7 November 2023 at 1330 hrs
Location:	Bishop Hill, near Portmoak Airfield, Kinross
Type of Flight:	Private
Persons on Board:	Crew – 1 Passengers – None
Injuries:	Crew – 1 (Serious) Passengers – N/A
Nature of Damage:	Substantial
Commander's Licence:	Other
Commander's Age:	68 years
Commander's Flying Experience:	114 hours (of which 2 were on type) Last 90 days – 1 hour Last 28 days – 0 hours
Information Source:	Aircraft Accident Report Form submitted by the pilot

Synopsis

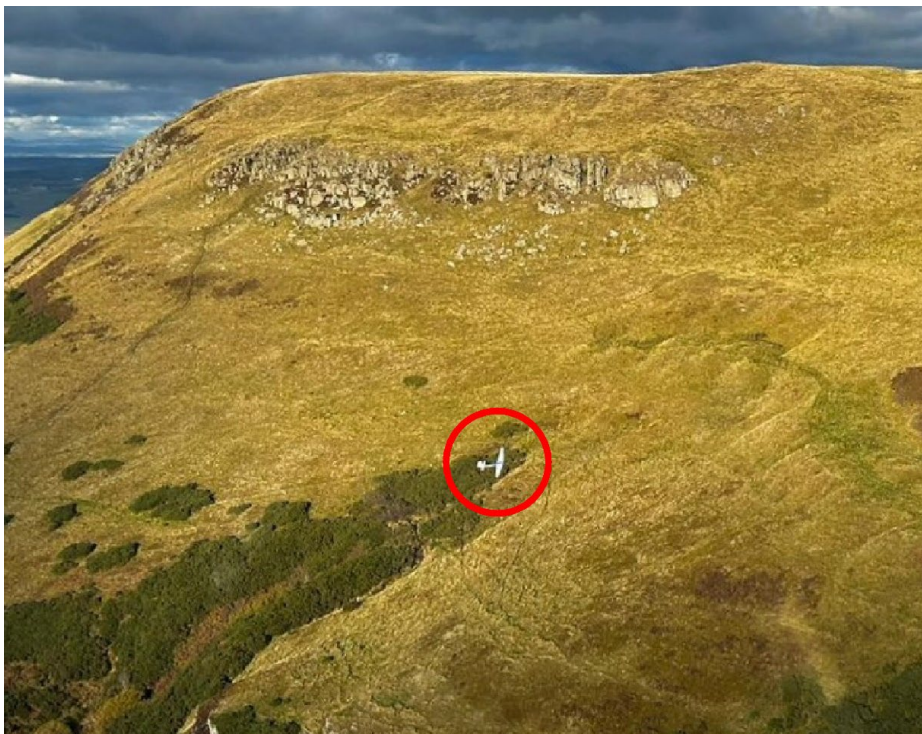
parallel to the windward ridge line. The glider momentarily started to climb, but then experienced turbulence with the vario indicating “severe sink”. The glider was now below the summit of the hill, at a visually estimated height of 800 ft, and the pilot stated that he had intended to make a left turn, away from the hill. However, his next recollection was of the glider striking the side of the hill and travelling through gorse shrubs before coming to a stop on a south-easterly heading (Figure 1).

The glider’s wings and cockpit were damaged. The pilot suffered injuries to his spine and was attended to at the accident site by emergency services and mountain rescue, prior to being airlifted to hospital.

Figure 1
Accident site (the glider is circled)

Based on the pilot's recollection, the glider's airspeed as it approached the hill was just less than the $1.45 V_s$ recommended by the FFVP. However, it is likely that the glider's airspeed was lower than this when it encountered turbulent sinking air, resulting in insufficient energy to safely manoeuvre away from the hill.
