AAIB Bulletin

2/2024

Aircraft Type and Registration:	Bombardier CL-600-2B16 (604 Variant), D-AAAY	
No & Type of Engines:	2 General Electric CF34-3B turbofan engines	
Year of Manufacture:	2004 (Serial no: 5602)	
Date & Time (UTC):	10 August 2022 at 1640 hrs	
Location:	In the climb after departing Farnborough Airport, Hampshire	
Type of Flight:	Commercial Air Transport (Passenger)	
Persons on Board:	Crew – 3	Passengers – 7
Injuries:	Crew – None	Passengers – None
Nature of Damage:	Damage to the No 1 flap retract relay	
Commander's Licence:	Airline Transport Pilot's Licence	
Commander's Age:	56 years	
Commander's Flying Experience:	13,091 hours (of which 5,655 were on type) Last 90 days – 102 hours Last 28 days – 41 hours	
Information Source:	AAIB Field Investigation

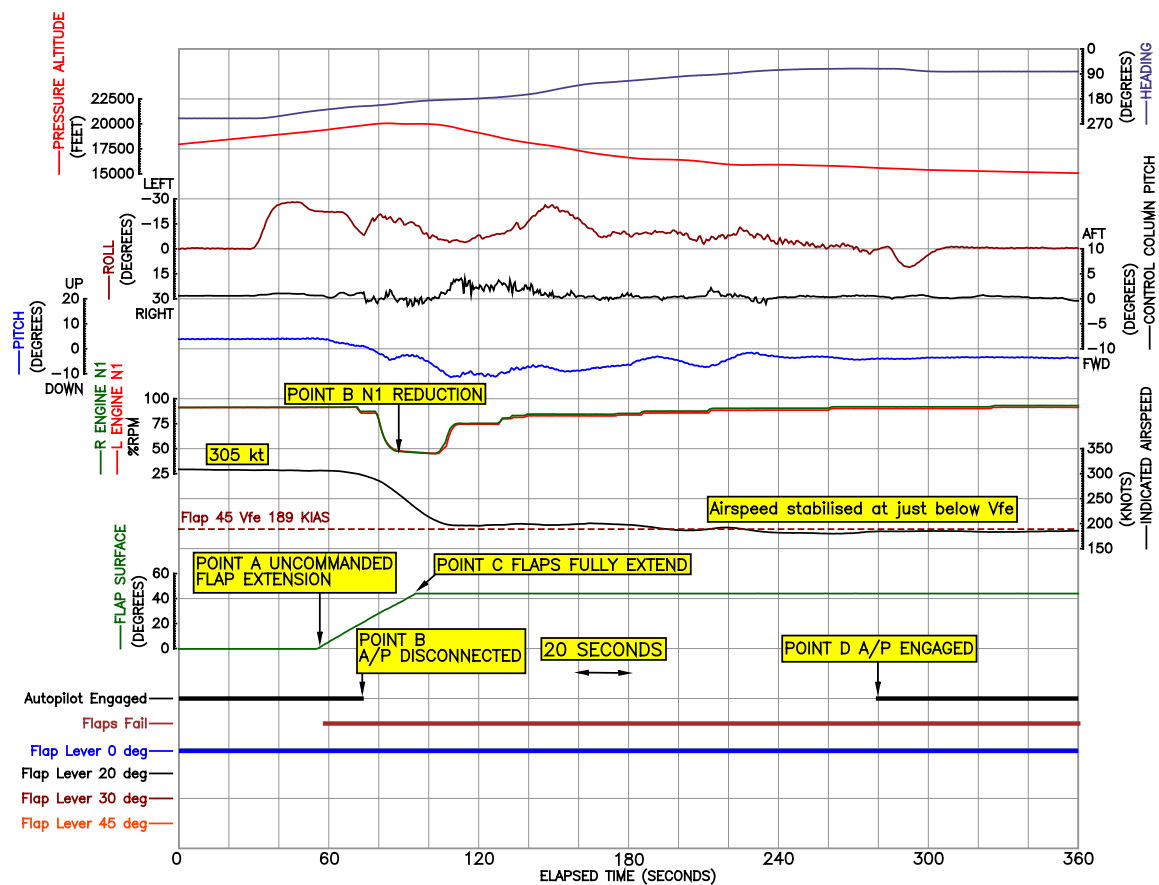
Figure 5

As the aircraft climbed through FL190, at a recorded airspeed of 305 KIAS, the flaps started to extend while the flap control lever remained in the flap 0 position (Figure 5, Point A). The rate at which the flaps extended was about 1.1°/sec. The flaps extended at a near linear rate from the flap 0 position, with no evidence of prior flap creep⁹. The autopilot remained engaged, and the aircraft's speed started to progressively reduce while the aircraft pitched down from 4° nose-up. Shortly after, a FLAPS FAIL caution was recorded which occurred when the flaps had extended by about 3°.

91% to 47% N1 (Figure 5, Point B). The flaps continued to extend over the next 21 seconds until reaching 45° where they stopped, at which point the airspeed was 234 KIAS, 45 kt above flap 45 V_{FE} (Figure 5, Point C).

FDR data of uncommanded flap extension

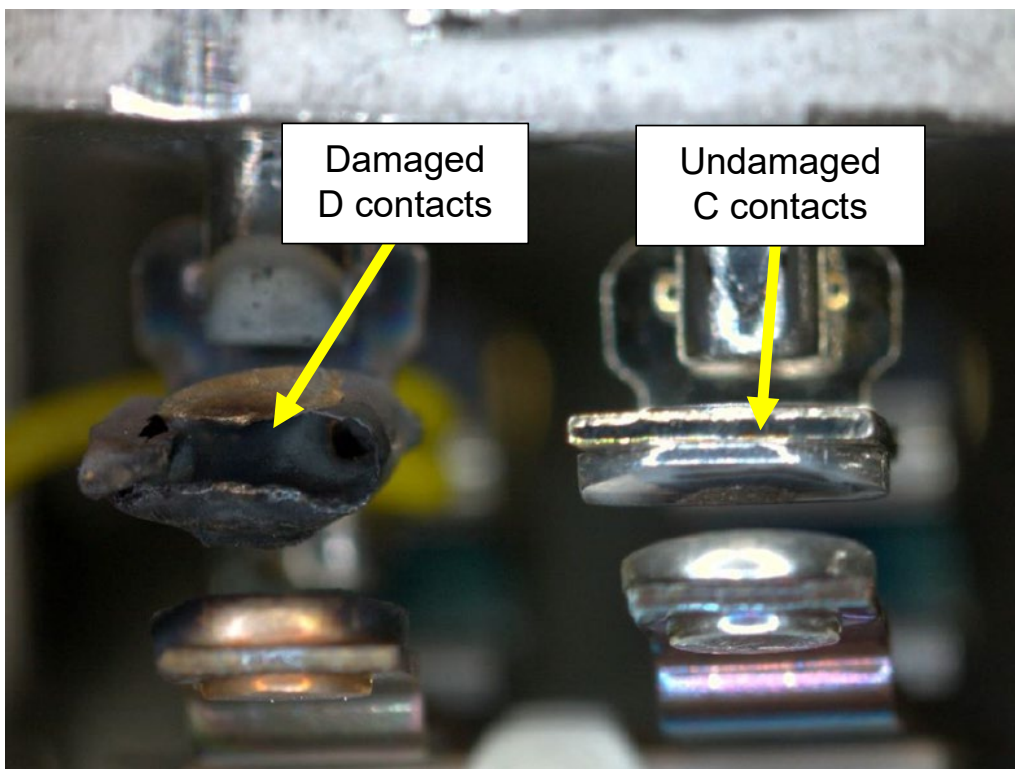
from damage to the D contacts which provide electrical power to the flap Brake Detector Units. This damage was caused by electrical arcing resulting from an unsuppressed back-EMF generated when the Brake Detector Units were de-energised to apply the flap brakes when the flaps reached their selected position.

When the relays were disassembled, the D contacts were found to exhibit varying amounts of damage that was typical of electrical arcing:

- On the No 1 extend relay, material had transferred from the moving contact to the stationary contact which reduced the airgap between the contacts.
- On the No 2 extend relay, the contact was significantly discoloured (blueing) indicating that it had been subject to localised heating. There was no significant material transfer between the moving and stationary contacts.
- On the No 1 retract relay, the material forming the stationary contact had melted and reformed and there was distortion of the moving contact which reduced the airgap. Figure 6 shows the damaged D contact alongside the undamaged C contact.

Damaged D contact (left) and undamaged C contact (right)

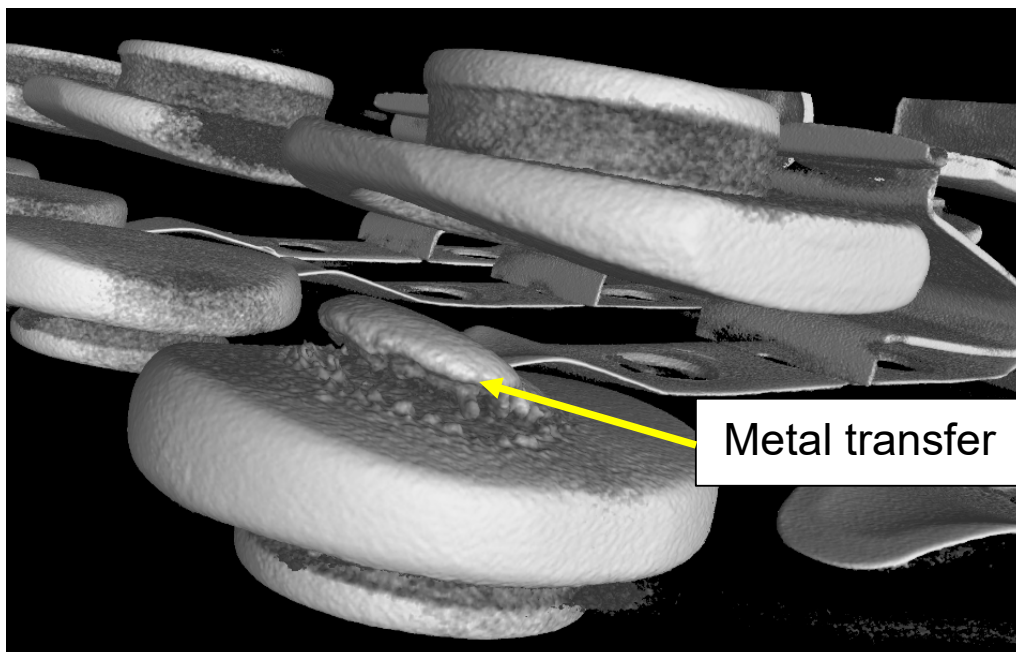
Figure 7

There was evidence of erosion and material transfer between the D contacts on the No 1 extend relay (Figure 7). It is possible that the contacts were initially welded together, which would explain why the flaps extended at half-speed during the on aircraft testing. Failure of the weld after the flaps had been cycled a number of times would allow the contacts in the relay to move, and the flaps operate at their normal speed.

Erosion and metal transfer on the D contacts

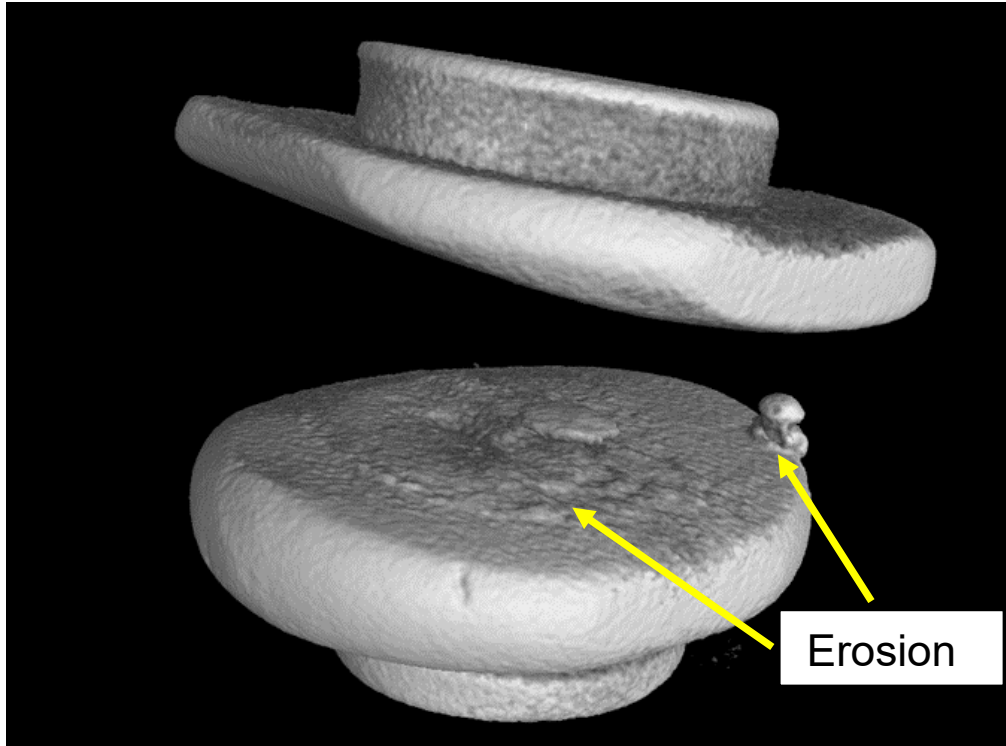
Figure 8

The No 2 extend relay, which had been in-service for approximately 2,700 flight hours and 1,372 flight cycles, showed evidence of material erosion and transfer between the D contacts (Figure 8). The aircraft maintenance records showed that this relay was fitted in April 2018 following a defect that generated a FLAPS FAIL EICAS caution; it was found that the BDU brake solenoids were permanently energised.

Material erosion on D contact

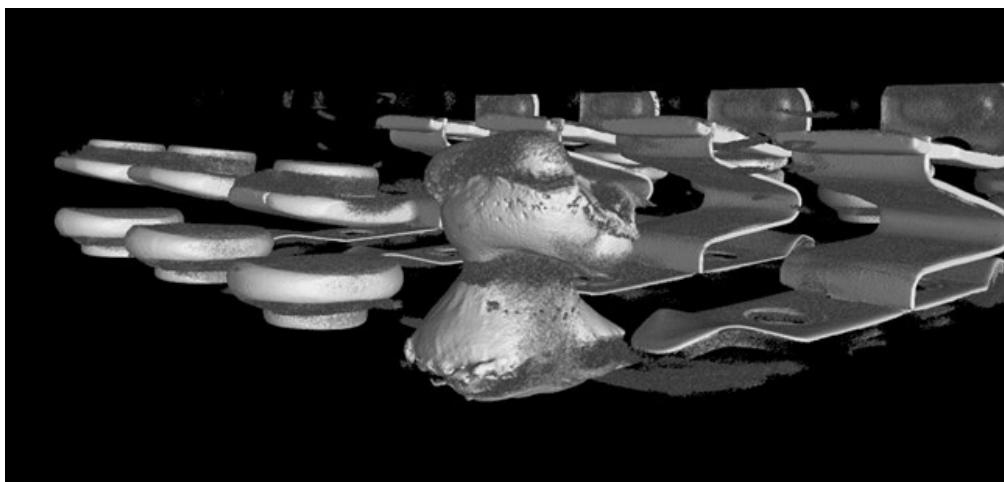
Figure 9

The D contacts on the No 2 extend relay were welded closed (Figure 9). In normal operation, when the relay is in a de-energised condition, these contacts would be open. In the welded condition, if the uncommanded flap movement arrest system was activated, the flaps would retract instead of their movement being arrested. This was observed during the testing of Aircraft 3.

D contacts welded closed

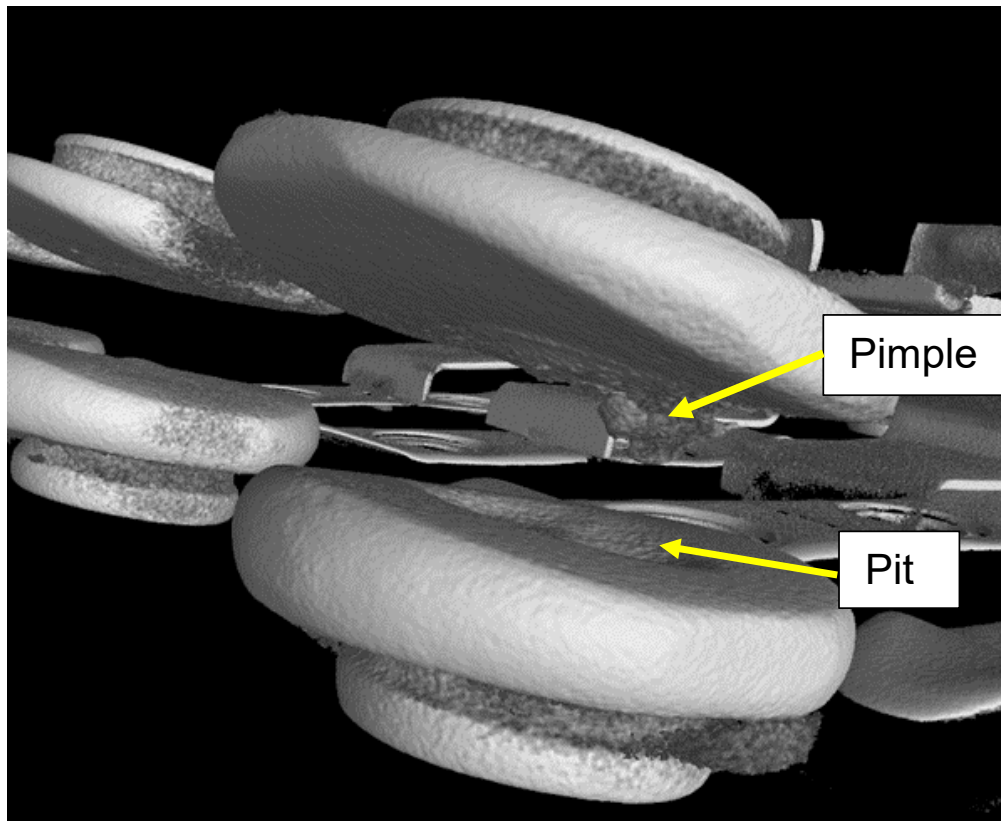
Figure 10

While the flaps operated normally during testing, on the No 1 retract relay, material had transferred across the D contacts. This damage was typical of electrical arcing, which leaves a 'pit' where material is eroded and a 'pimple' where it accumulates (Figure 10).

Metal transfer between the D contacts as seen by the pit and pimple effect

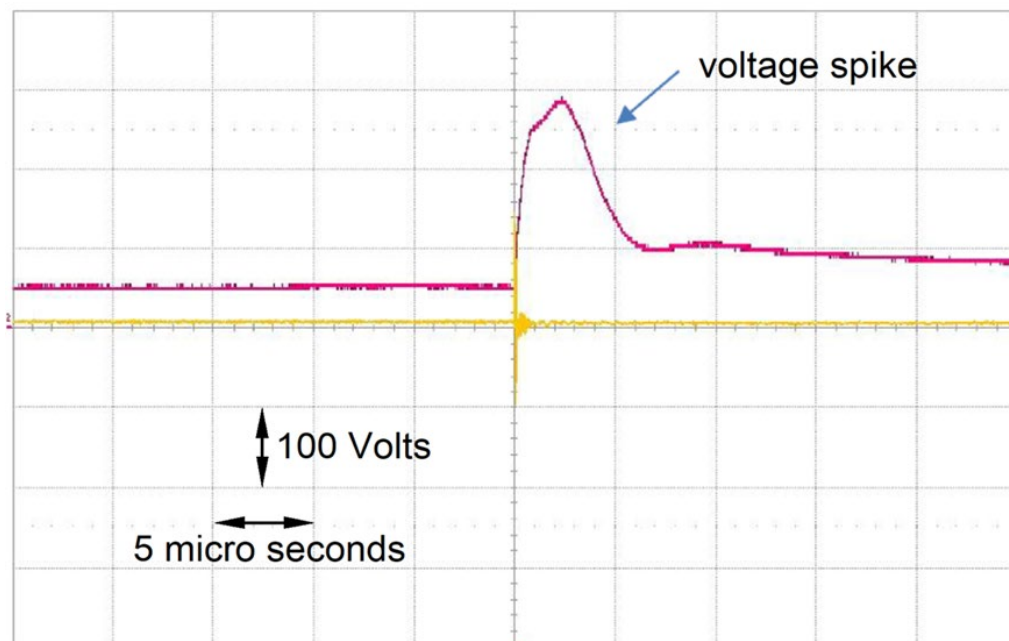
Figure 11

The current and voltage during solenoid switching was measured using an oscilloscope (Figure 11). When the solenoid was de-energised a maximum transient voltage spike of 300V was seen; this spike regularly exceeded 150V during repeated switching of the BDU. The voltage spike is caused by a back electro motive force (EMF), which occurs when removing electrical power from inductive loads such as the solenoid coils. There was no protection or suppression provided within the flap operating system to prevent or reduce this back-EMF, which could cause arcing across the D contacts.

Oscilloscope output showing voltage spike after de-energising coil

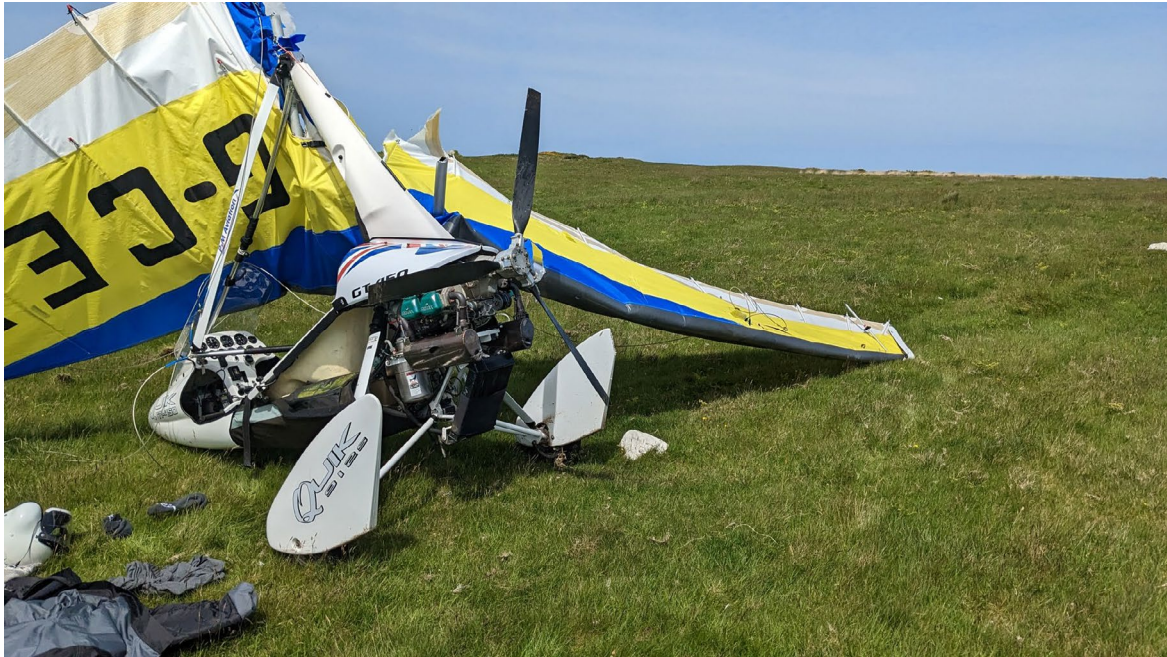
Figure 3

The AAIB did not attend the accident site but was provided with images of the aircraft taken shortly after the accident. The aircraft had come to rest upright, north of the landing strip, but the wing had been destroyed. The nose landing gear had also collapsed.

G-CEVW after the accident (reproduced with permission)

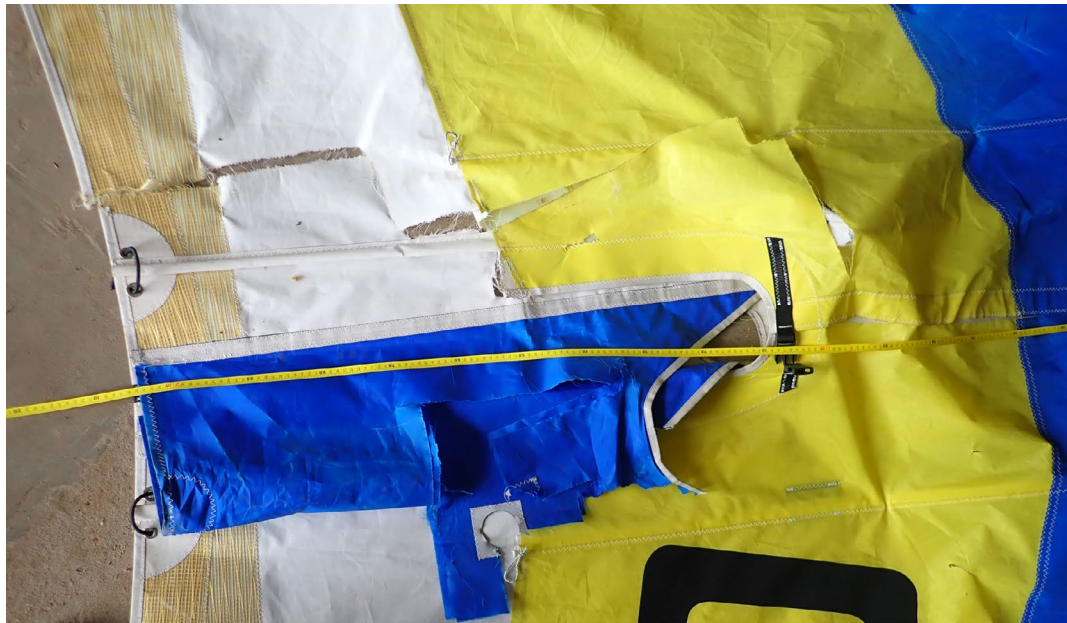
Figure 7

A series of rips and bunched fabric was noted on the keel pocket (Figure 7), indicating that the hang bracket had moved rearward along the wing keel.

Underside of G-CEVW wing material showing rips around the keel beam pocket

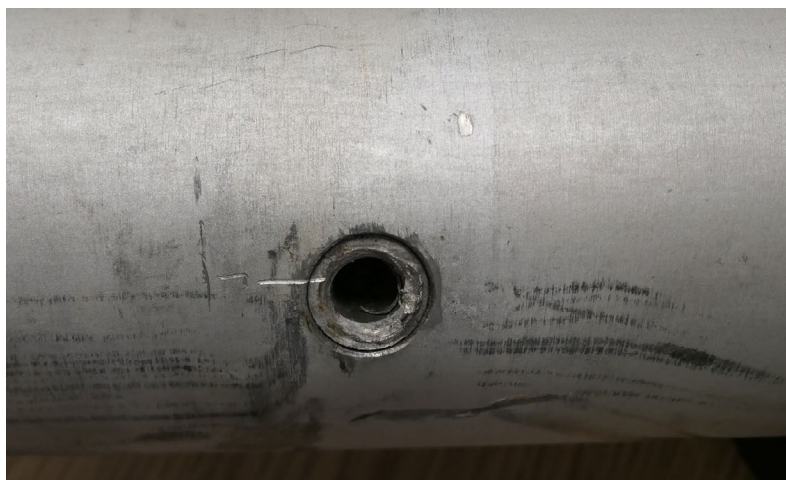
Figure 8

Examination of the wing keel confirmed that the roll bearing had migrated rearwards. The M6 cap head bolt, which retained the roll bearing in position, and its associated Nylok nut were missing and were not recovered. Fretting was observed on the bolt head side of the bushing through which the bolt would have passed through the wing keel (Figure 8). The trim cable attachment bracket was deformed and the inner diameter of the roll bearing had worn, indicating that the roll bearing had moved rearwards down the wing keel and struck the trim attachment bracket during flight (Figure 9).

Wing keel bushing showing fretting around bolt hole

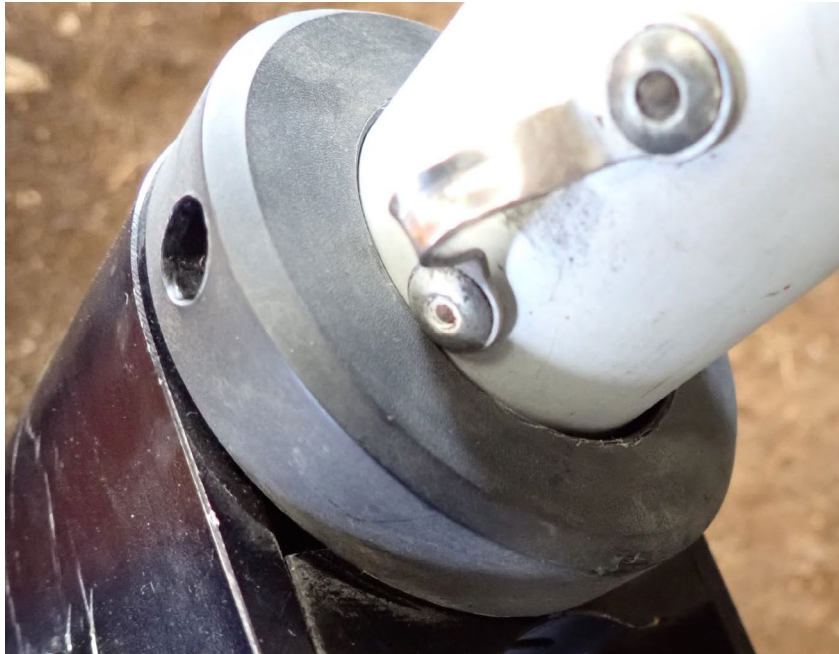
Figure 9

Roll bracket bearing showing witness marking from contact with trim bracket
