ACCIDENT

Aircraft Type and Registration:	Boeing 777-336ER, G-STBL
No & Type of Engines:	2 General Electric Co GE90-115B turbofan engines
Year of Manufacture:	2014 (Serial no: 42124)
Date & Time (UTC):	15 June 2023 at 1740 hrs
Location:	Entering Bay of Bengal
Type of Flight:	Commercial Air Transport (Passenger)
Persons on Board:	Crew - 17 Passengers - 244
Injuries:	Crew - 2 (Serious) Passengers - None 3 (Minor)
Nature of Damage:	None reported
Commander's Licence:	Airline Transport Pilot's Licence
Commander's Age:	49 years
Commander's Flying Experience:	17,678 hours (of which 1,662 were on type) Last 90 days - 156 hours Last 28 days - 47 hours
Aircraft Type and Registration:	Boeing 777-236, G-YMML
No & Type of Engines:	2 Rolls-Royce RB211 Trent 895-17 turbofan engines
Year of Manufacture:	2001 (Serial no: 30313)
Date & Time (UTC):	28 June 2023 at 1240 hrs
Location:	Beijing Daxing International Airport
Type of Flight:	Commercial Air Transport (Passenger)

Synopsis

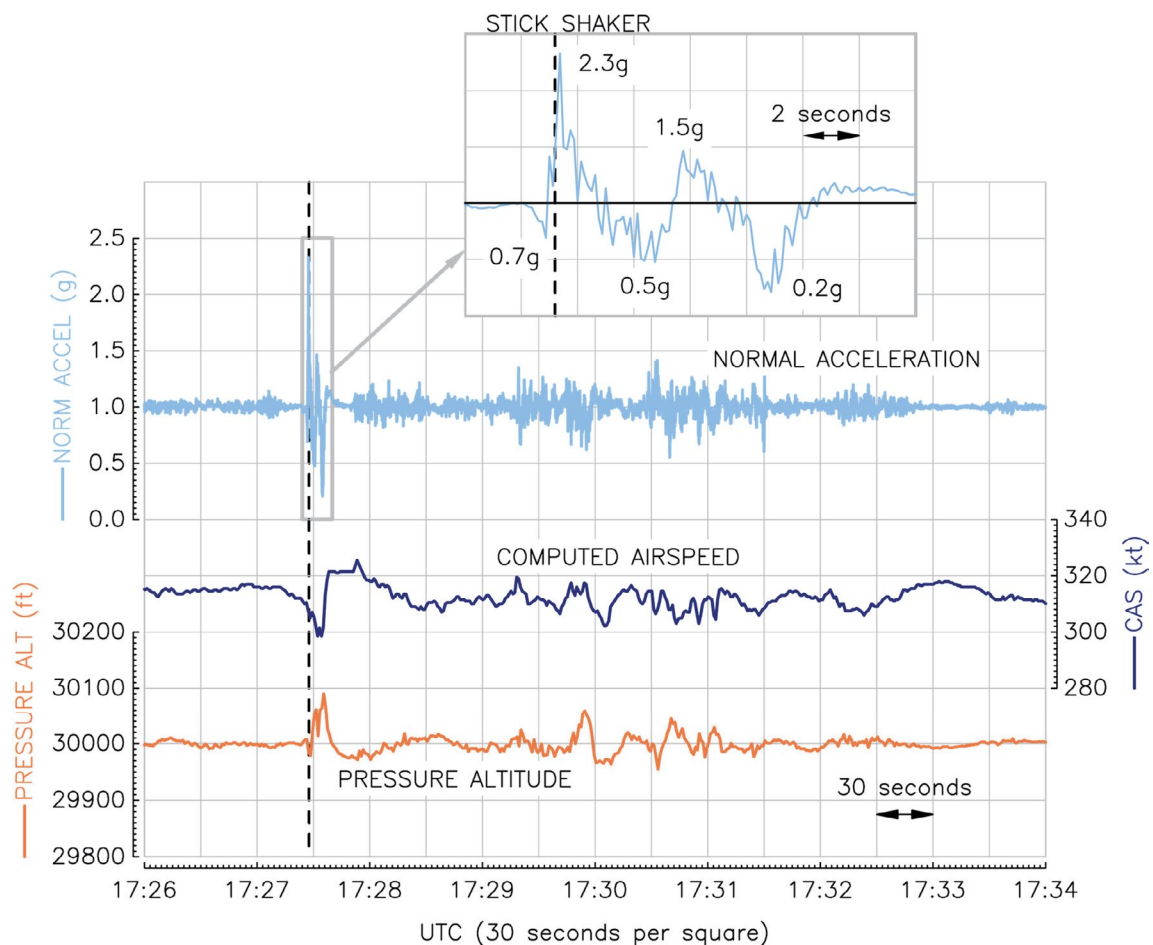
For G-STBL (Figure 1), the aircraft was cruising at FL300 and 315 kt CAS at the start of the event. The minimum and maximum recorded normal acceleration for the duration of the event (about five minutes) was 0.2 g and 2.3 g. These occurred within the first 10 seconds where the normal acceleration initially dipped to 0.7g and then spiked at 2.3 g in less than one second. A stick shaker activation was recorded during the 2.3 g spike. The recorded normal acceleration was between 0.5 g and 1.5 g for the remaining time during the event.

Figure 1
G-STBL flight data for turbulence event

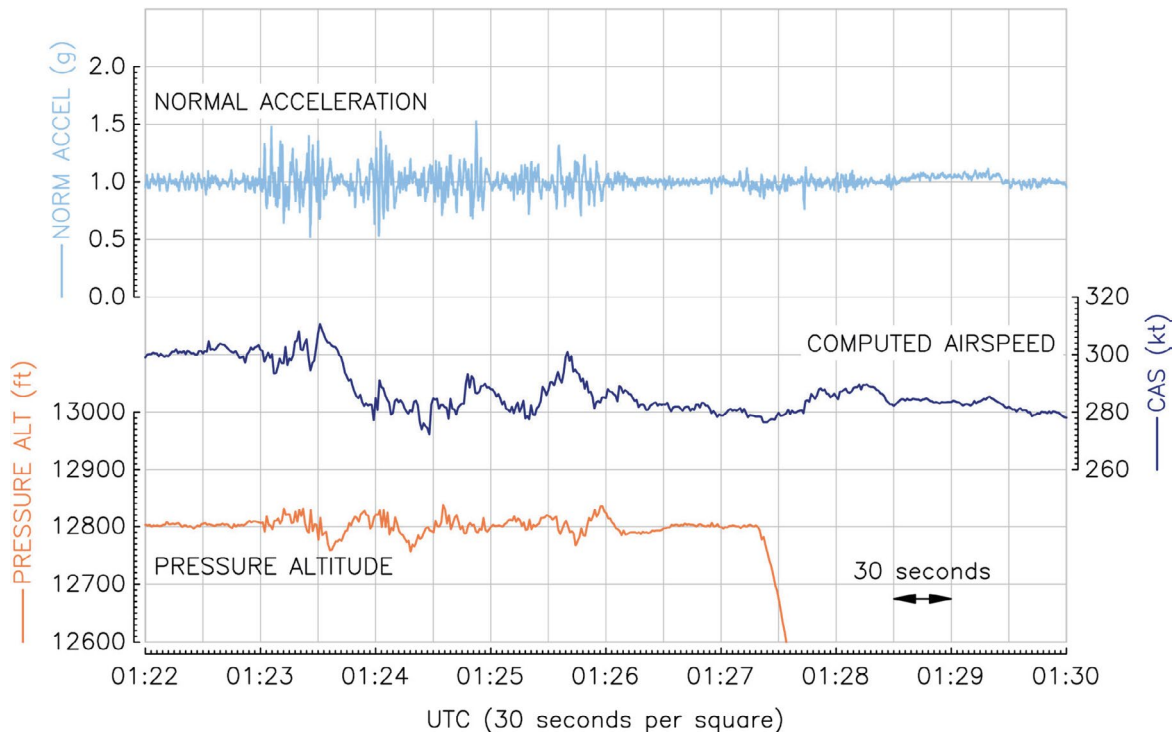
For G-YMML (Figure 2), the aircraft was level at FL128 and at about 300 kt CAS at the start of the event. The minimum and maximum recorded normal acceleration for the duration of the event (about three minutes) was 0.5 g and 1.5g.

Figure 2
G-YMML flight data for turbulence event

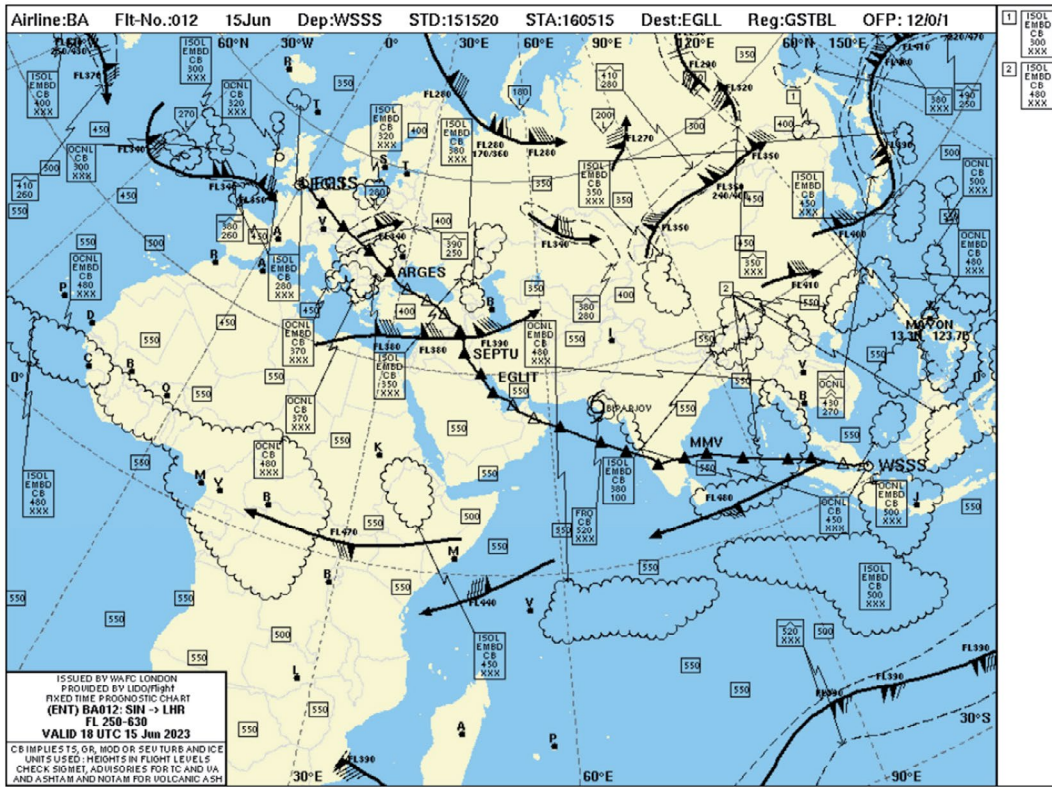
A SIGMET had been issued and was valid until 1745 hrs on 15 June 2023. It, along with the significant weather chart (Figure 3), forecast isolated embedded thunderstorms on the aircraft's route. The chart indicated CB tops reaching FL480 and the SIGMET indicated CB tops to FL520. The explanatory note on the significant weather chart stated that the forecast of CB implies the presence of thunderstorms, hail, ice and moderate to severe turbulence.

Figure 3
 Significant weather chart from the crew briefing pack

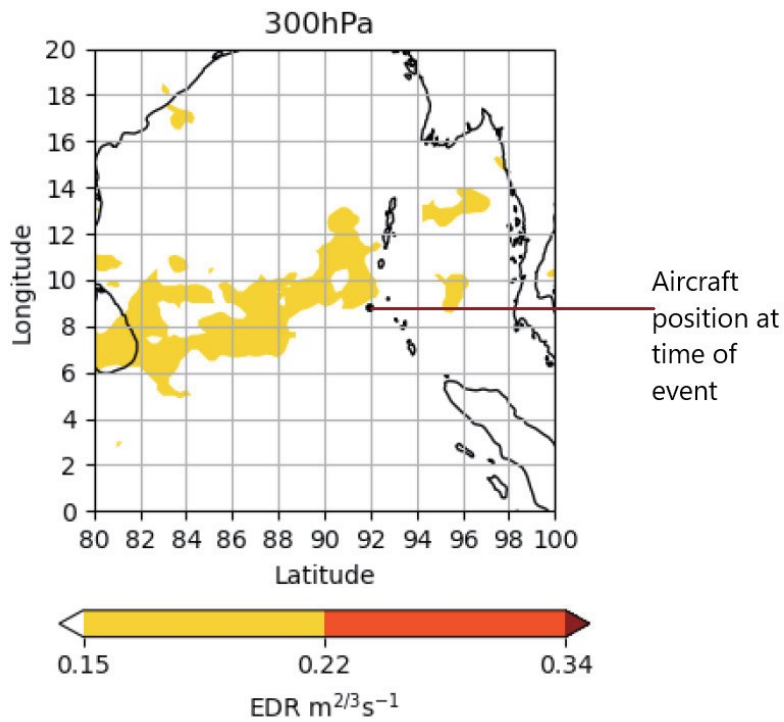
The Met Office provided additional turbulence information to the AAIB which, while used to construct the forecast, was not available to the pilots on the flight. The additional information was based on Eddy Dissipation Rate, which is the ICAO standard for turbulence forecasting and is based on Graphical Turbulence Guidance developed by the National Centre for Atmospheric Research in the USA. The Eddy Dissipation Rate forecast for FL300, valid at 1800 hrs on 15 June 2023, (Figure 4), indicated that there would be light to moderate turbulence in the vicinity of the incident. The black dot shows the position of the incident and is near the eastern edge of any turbulence.

Figure 4
 Eddy Dissipation Rate for 300 hPa (approximately FL300) valid at 1800 hrs on 15 June 2023

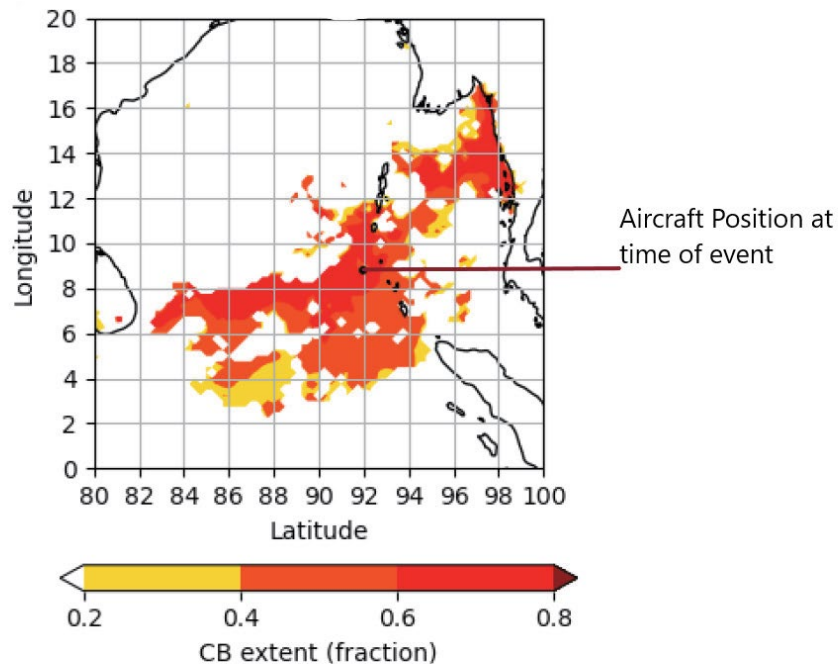
The forecast of the extent of CB is shown on the image in Figure 5. This indicated a large area of CB across the Bay of Bengal with over 60% of the sky affected by CB. The information supplied to the crew was based on a forecast model run at 1800 hrs on 14 June 2023. The CB extent shown in Figure 5 was drawn from a model run at 1200 hrs on 15 June 2023. Later forecast charts than those supplied to the crew showed greater amounts of CB over the Bay of Bengal.

Forecast extent of cumulonimbus clouds

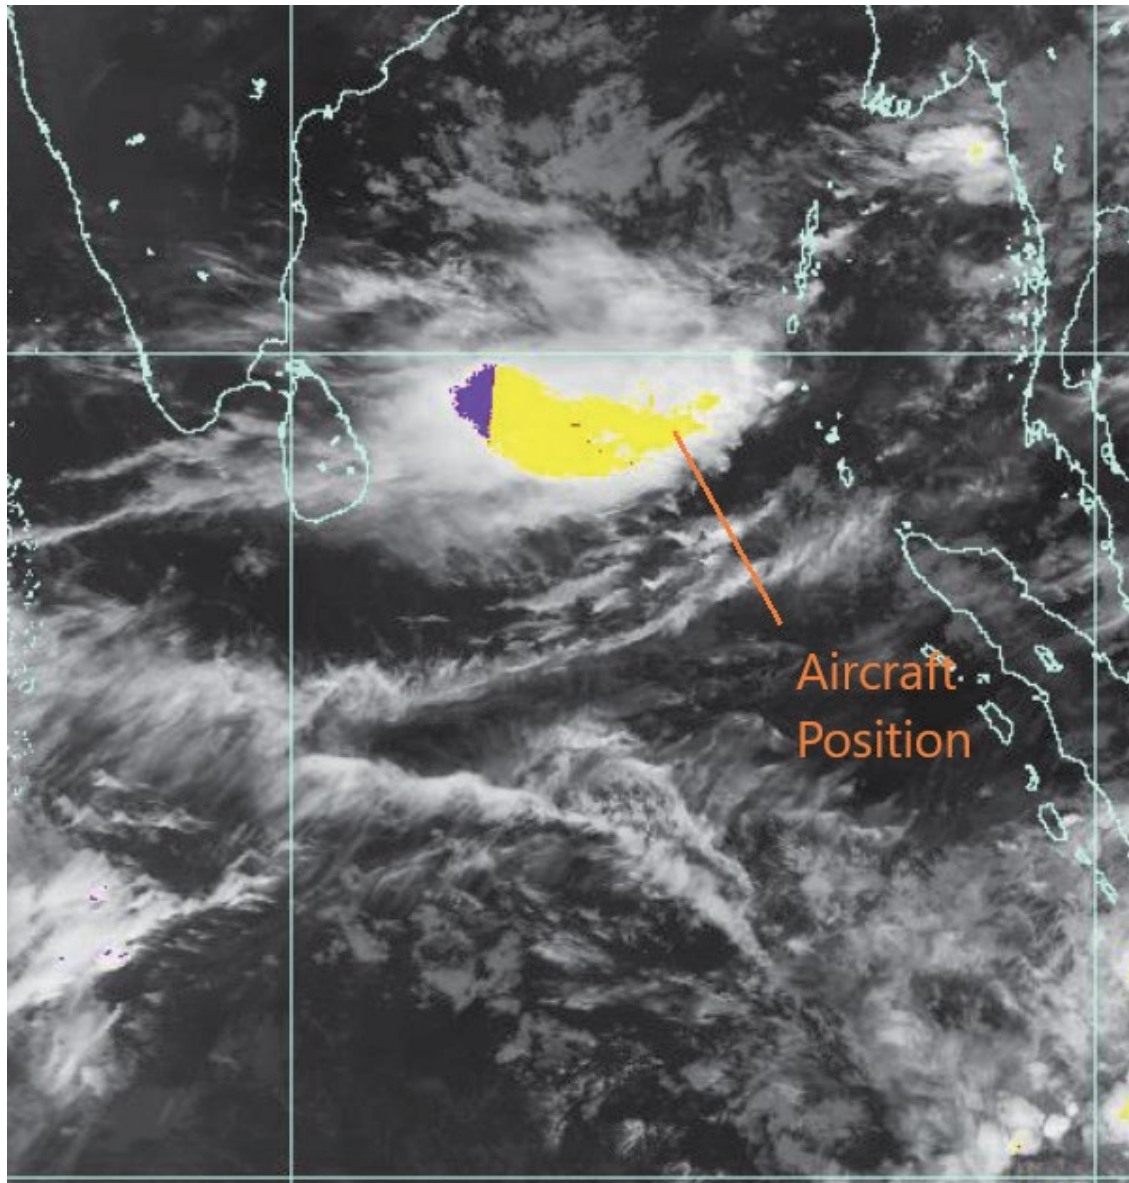
Overshooting tops are areas of a CB where the cloud top is higher than would normally be expected through thermal equilibrium. Normally, the rising warm air within a CB will stop rising when its temperature equals the temperature of the surrounding air. However, rapidly rising air will have built up a momentum that allows it to rise further above the normal anvil top of the cloud. The evidence of an overshooting top is indicative of strong updraughts within the cloud structure. The satellite imagery in Figure 6 is indicating in yellow, areas where there is evidence of overshooting tops. This area is in the vicinity of the incident.

'There was an extremely active system in the vicinity of the incident location. Evidence from Figure 6 suggests that there were significant updraughts within the cloud, with cloud tops extending up to FL480. In addition, there would also be significant downdraughts in the region immediately ahead of the system. There was no Clear Air Turbulence forecast in the area.'

Satellite imagery indicating areas of overshooting cloud tops

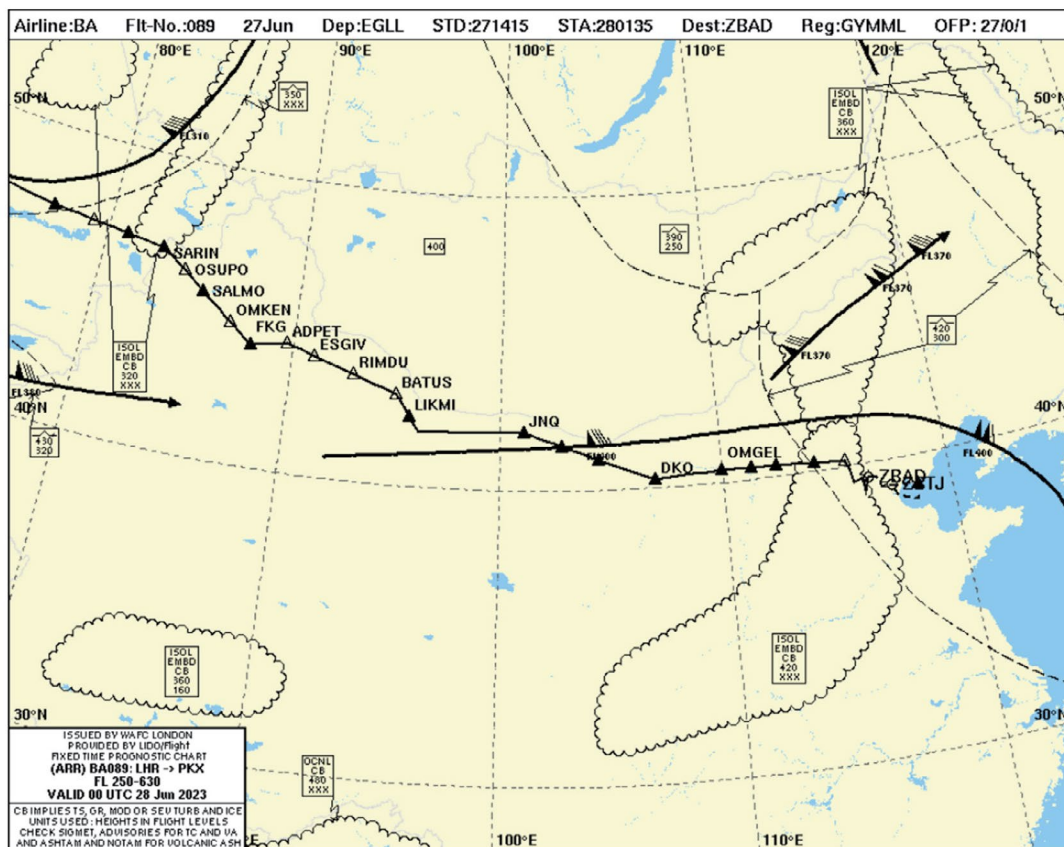
G-YMML was approximately 20 minutes from landing at Beijing Daxing Airport when it encountered turbulence. The crew's forecast weather chart for the arrival section of the route is at Figure 7. The route crossed a forecast area of CB with tops up to FL420 just before Beijing. The crew recalled weather consistent with the forecast being visible on weather radar during the aircraft's descent toward Beijing. After discussion with ATC, they changed course to avoid the weather shown on radar.

Figure 7
Beijing Daxing Airport arrival weather chart
