Defence
Safety Authority

Service inquiry

Death of a RAF Service
person and serious injuries
during British Services
Mountaineering Expedition,
Pakistan July 2022

Service inquiry into the death of a Service person and the seriously injured casualties whilst participating in the British services mountaineering expedition in Pakistan in July 2022

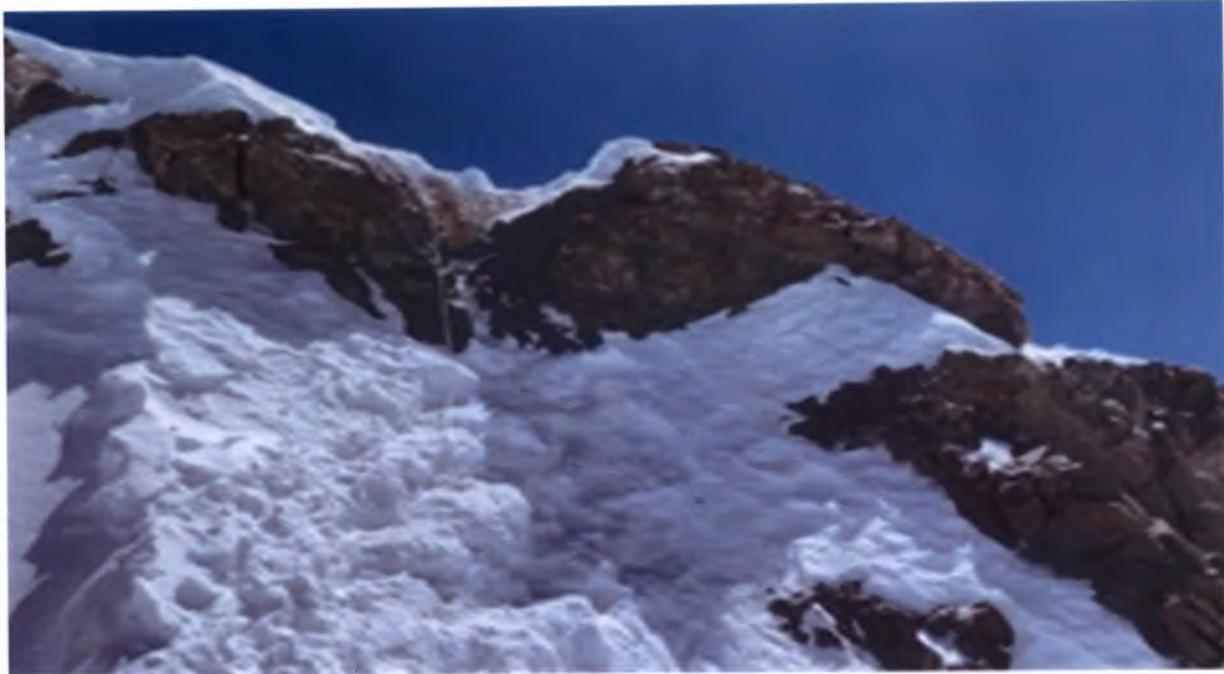
1.3.15. Fall from height event of Wg Cdr Henderson. At approximately 14:00, a climber from a separate expedition, civilian mountaineer 1 (CM-1), whilst ascending, observed, from a distance of approximately 20m, Wg Cdr Henderson descending from Rocky Summit towards the col. Wg Cdr Henderson was slightly below the Rocky Summit, at a section that only permitted one person at a time to pass (Figure 1.3.6). The pair exchanged gestures to determine who would move first. Wg Cdr Henderson signalled that he would move first, and CM-1 acknowledged this with a thumbs up. Wg Cdr Henderson began his descent and was observed by CM-1 to fall down the south face of the mountain. After losing sight of Wg Cdr Henderson, CM-1 called out and attempted to search areas of the south face for approximately 1 hour.

Figure 1.3.6 – High ground from where Wg Cdr Henderson fell (just below Rocky Summit).¹⁴

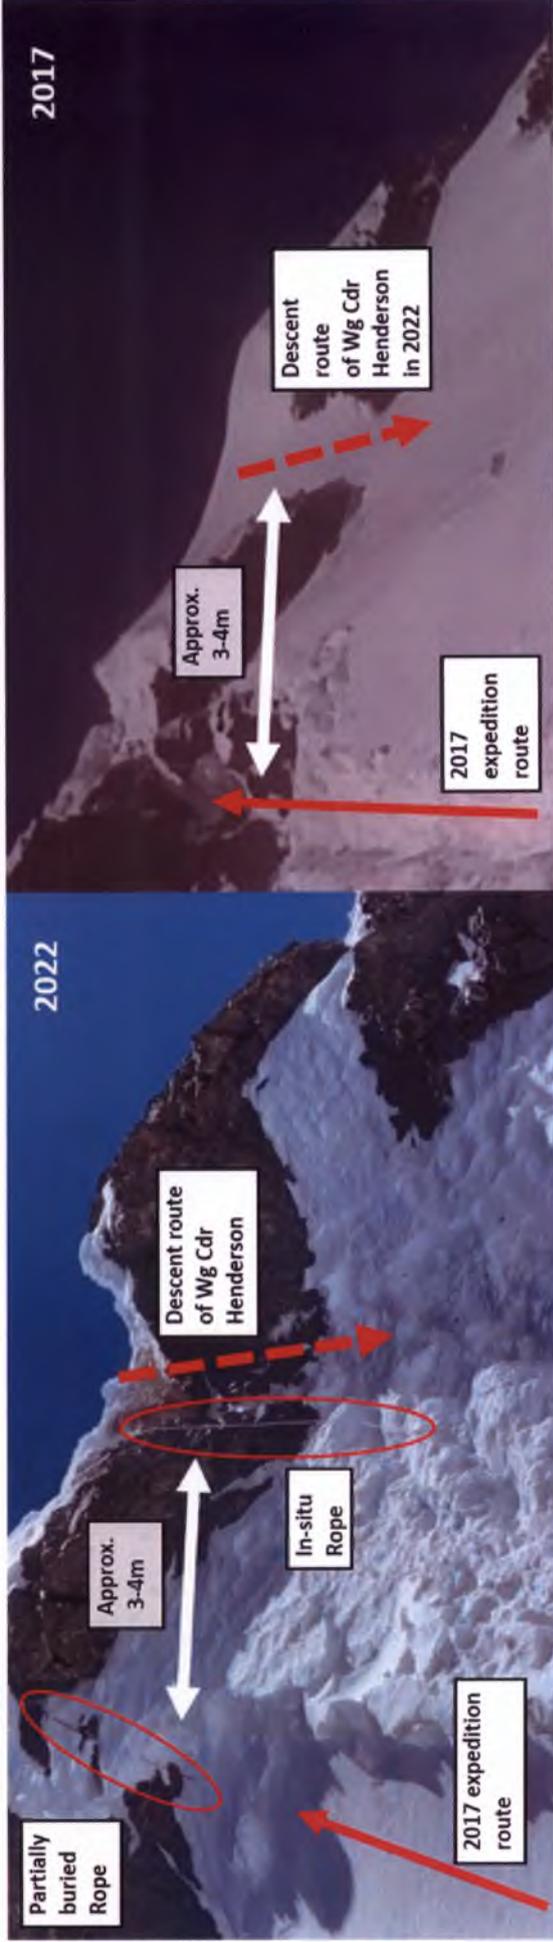
1.4.75. The panel compared a still image from the video taken by CM-1 with an image taken at the same location in 2017 (Figure 1.4.6). The panel was able to determine that the descent route taken by Wg Cdr Henderson, compared to the route taken by another expedition in 2017, was steep, directly above, and therefore exposed to, the steep mountain face (Figure 1.4.7).

Figure 1.4.6 – Comparison of 2022 route (left) and 2017 route (right).²⁰

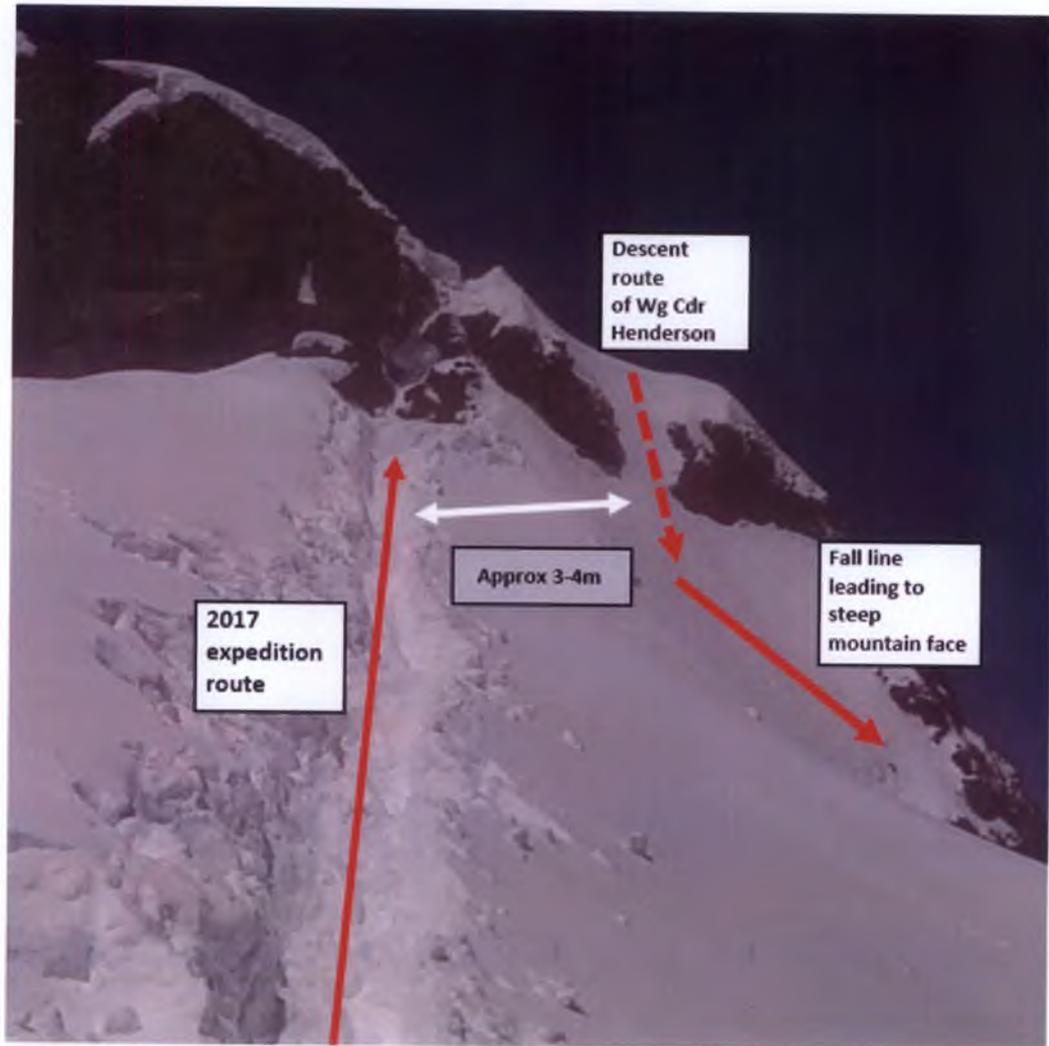
Figure 1.4.7 – 2017 Expedition route.²¹

1.4.76. The 2017 expedition route appeared to lead directly from the ridge, and did not deviate towards the exposed area in the same way as the route that Wg Cdr Henderson took (Figure 1.4.7). It was highly likely that the descent route taken by Wg Cdr Henderson was based on the route that other mountaineers had taken on that day.

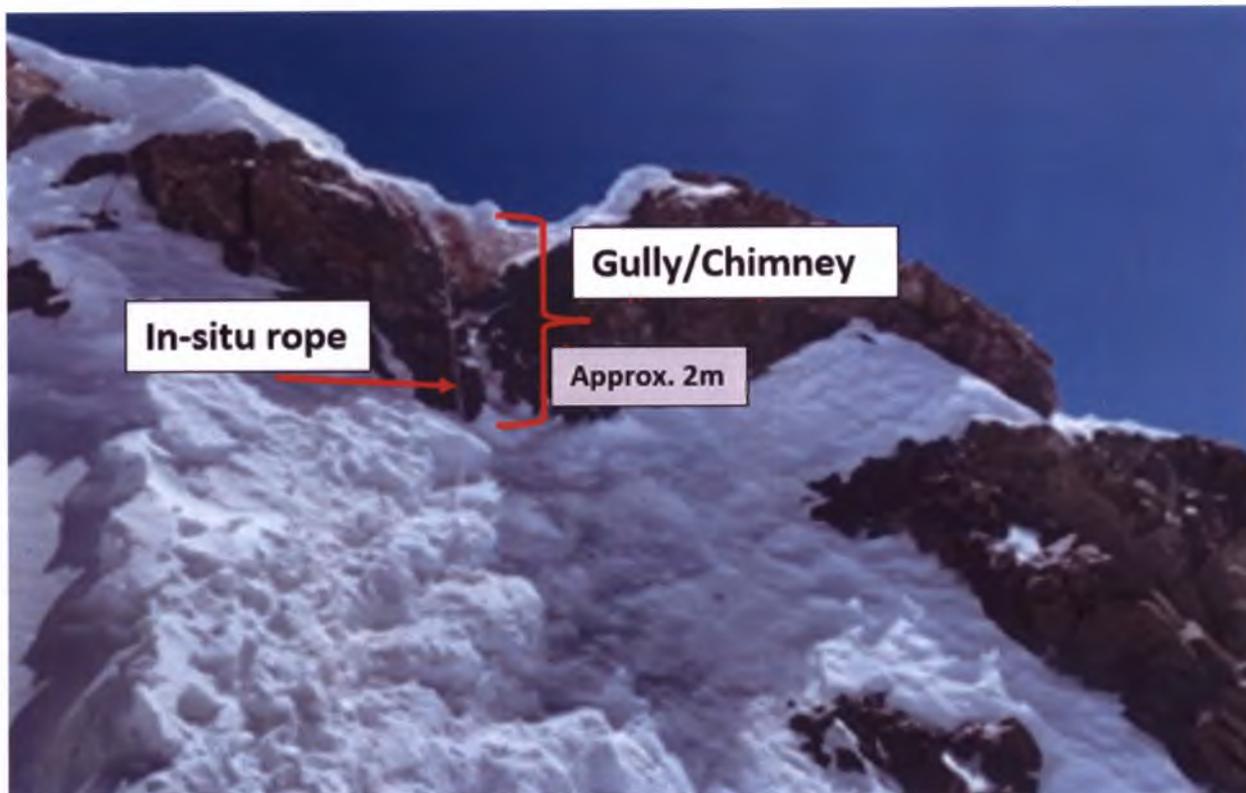
1.4.79. The descent from the Rocky Summit area where Wg Cdr Henderson fell, was described as a short, almost vertical gully, or ‘chimney,’ approximately 2m in vertical height (Figure 1.4.8). The terrain directly beneath this section was exposed and led steeply down the face.

Figure 1.4.8 – High ground from where Wg Cdr Henderson fell (just below Rocky Summit).²²

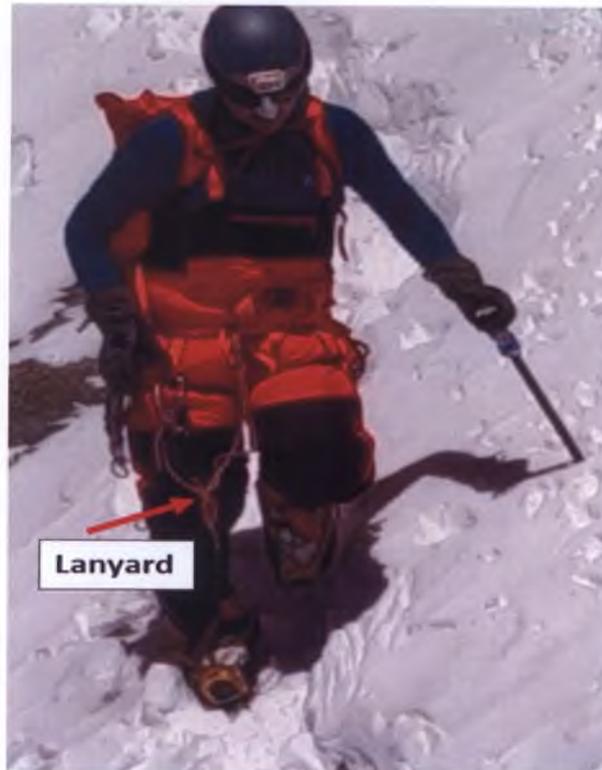
Figure 1.4.9 – Still from last video footage of Wg Cdr Henderson taken at 12:26 on 19 July 2022.

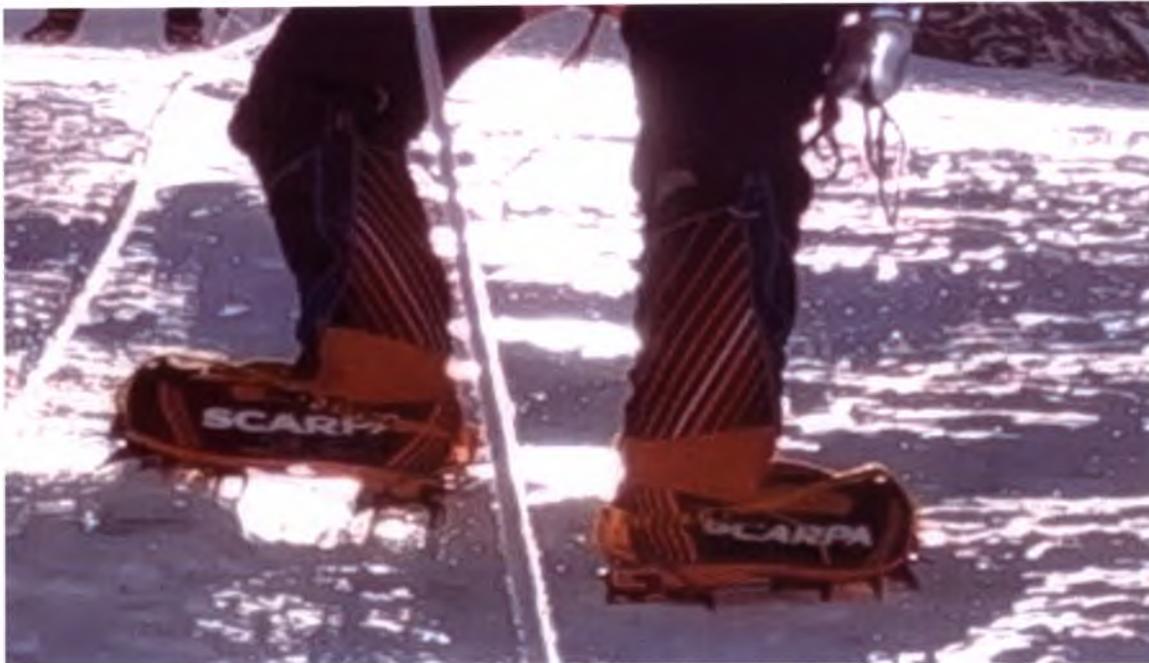
1.4.146. **Crampons.** Wg Cdr Henderson wore Grivel G12 crampons (Figure 1.4.10) during his ascent of Broad Peak.³⁰ He was observed to be wearing them at various stages throughout his summit attempt, including at the time he fell.

Figure 1.4.10 – Wg Cdr Henderson's Grivel G12 crampons.

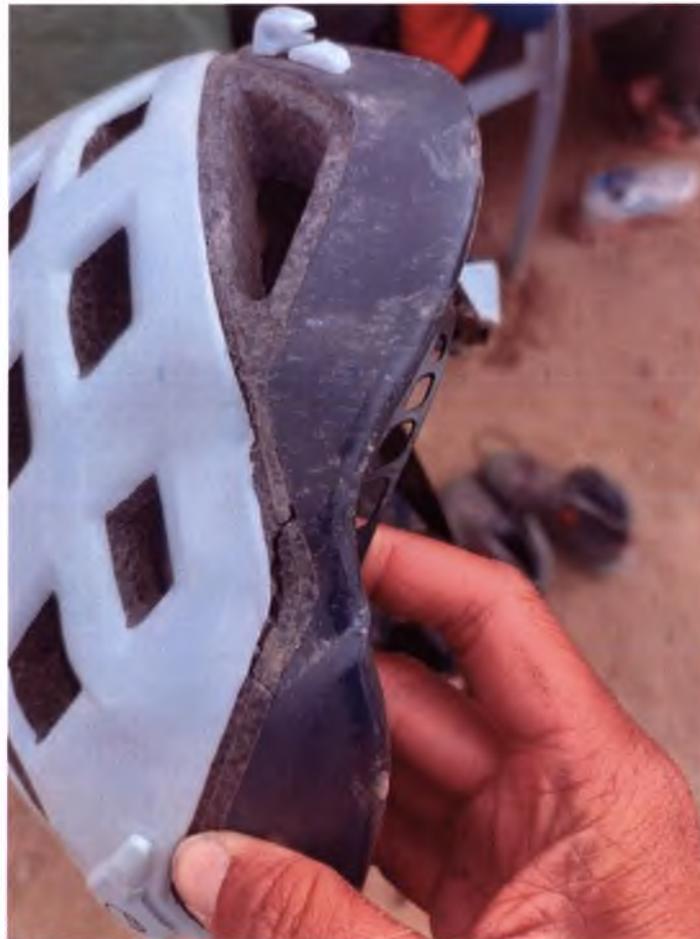
1.4.203. **Utilisation of PPE.** The panel determined that the rockfall risk control of personnel wearing helmets was undertaken as required and that the leaders managed this effectively. The wearing of this PPE was instrumental in ensuring that the injuries to DT-4 were not more serious. The damaged helmet of DT-4 (Figure 1.4.15) detailed the rock impact area and the protection that it provided, and strongly supported the requirement to wear a helmet as a rockfall risk control.

Figure 1.4.15 – Photograph of DT-4’s damaged helmet after being struck by rockfall.⁴⁰
