**Siemens Gamesa Renewable Energy - Siemens 3 MW SWP 3.0 Wind Turbine Generator fitted with Avanti SWP L service lift**

<p><b>PSD Number</b></p>	<p>2202-0389</p>
<p><b>Product Type</b></p>	<p>Machinery - Wind Turbine Generator</p>
<p><b>Product Identifiers</b></p>	<p>Model: SWT-3.0-113 DD            Full product name: Siemens SWT-3.0-113 DD wind turbine generator fitted with Avanti Wind Systems A/S service lift model SWP L, including swinging door (landing gates) and trapped-key fence interlock system.            Affected serial numbers: 3001073, 3001074, 3001075, 3001076, 3001077, 3001078, 3001079, 3001082, 3001083, 3001084, 3001085, 3001086, 3001087, 3001089, 3001090,3001091.</p>
<p><b>Product Description</b></p>	<p>An Onshore wind turbine generator with rated power 3000 kW and rotor diameter 113.0 m, fitted with Avanti Wind Systems A/S Model SWP L.</p>
<p><b>Country of Origin</b></p>	<p>Denmark</p>

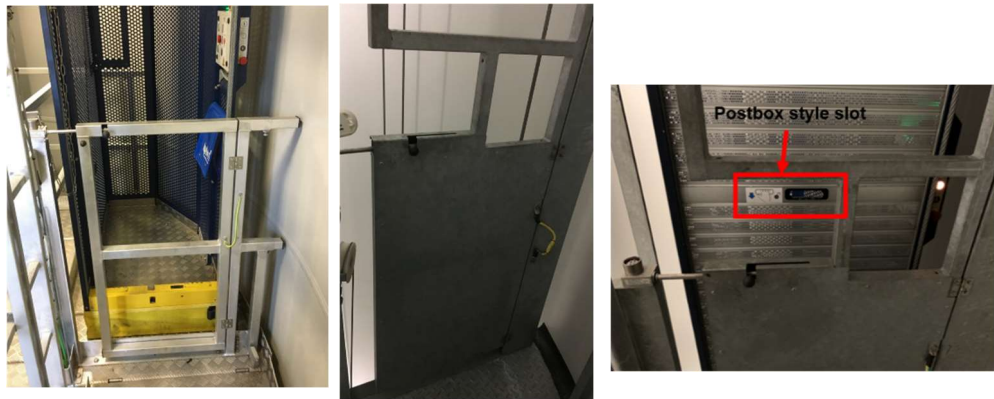
Aspect	Details
<p><b>Images</b></p>	<p>Images of some of the relevant parts of the wind turbine generator</p>

<p><b>Counterfeit</b></p>	<p>No</p>
<p><b>Risk Level</b></p>	<p>Serious</p>
<p><b>Risk Type</b></p>	<p>Injuries</p>
<p><b>Risk Description</b></p>	<p>The Siemens SWT-3.0-113 DD wind turbine generator fitted with the Avanti Wind Systems A/S SWP L service lift and landing gates, presents a serious risk of injury due to entrapment and shearing/crushing with the moving lift car.</p> <p>The service lift installed in the wind turbine can be operated from inside the lift car, and from outside using the control box mounted on the outside of the lift car. The design of the landing gates is inadequate, as when the service lift is operated using either the internal or external controls, the gates do not prevent persons outside the lift car from coming into contact with the moving lift. It is possible for parts of a person to become caught in the post-box style slots and drawn in or trapped between the moving lift and the landing gate or platform edges, resulting in risk of serious injury.</p>

<p>The design of the landing gates and their integration with the service lift did not result in a safe installation. It did not include appropriate protective measures to eliminate identified hazards or to reduce risks related to being caught in the slots of the moving lift or between the landing gate or platform edges and the moving lift.</p> <p>The wind turbine generator fitted with the SWP L service lift and landing gates does not meet the requirements of the Supply of Machinery (Safety) Regulations 2008.</p>
<b>Corrective Measures</b>	<p>The manufacturer in Denmark and the supplier in Great Britain have been informed of the non-compliance with the Supply of Machinery (Safety) Regulations 2008.</p> <p>The supplier has agreed to engage with all previously supplied customers, recommending that they initiate a risk review of the service lift and wind turbine generator interface as a matter of priority.</p> <p>Operators of the wind turbines should ensure that contact with moving parts of the service lift is not possible, and that the landing gates do not create crushing/shearing hazards to persons on the landings during lift operation.</p> <p>The Health and Safety Executive issued Safety Notice ED 4 – 2023 (15.08.2023) on wind turbine generator service lifts and the risk of serious injury or death to operators using, or working near, them. This safety notice provides information on actions that operators should take to ensure dangerous moving parts cannot be reached over or through landing gates. The HSE Safety Notices can be found at the following link: <a href="https://www.hse.gov.uk/safetybulletins/">https://www.hse.gov.uk/safetybulletins/</a>.</p>
