Our ref: EJM/CH/19553~01

22nd February 2019

RE: LAND TO WEST OF MILL LANE, HATFIELD HEATH, ESSEX

Further to your request I was able to visit the above site on 21st February 2019. The purpose was to inspect seven existing structures dating from WWII which are part of a former Prisoner of War Camp (No 116), and situated to the east of the access road, as well as the Water Tower. We have numbered the huts on the attached plan for ease of reference.

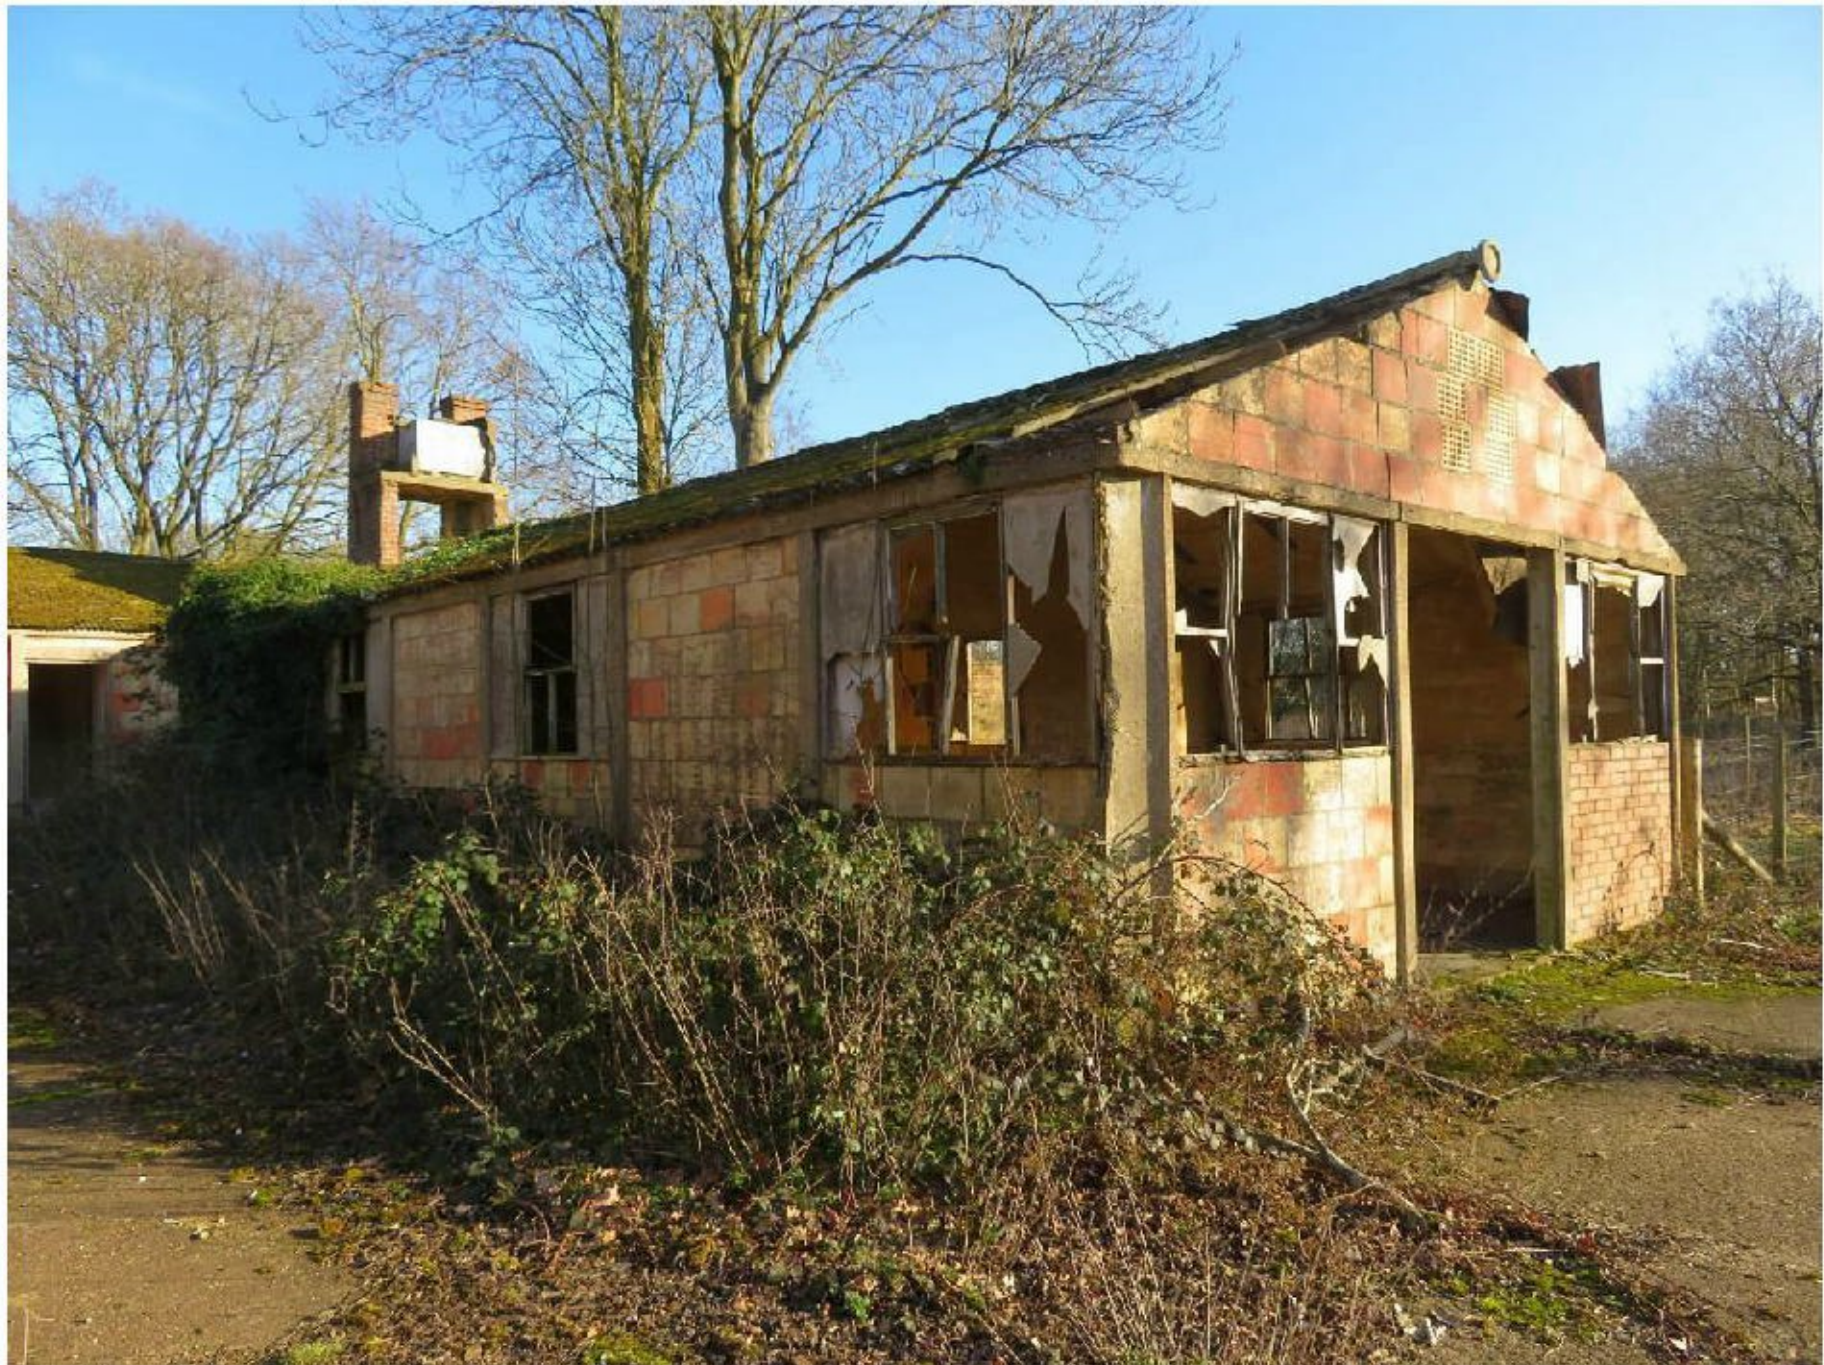
Photograph 1: Typical Ministry of War Production Standard Hut

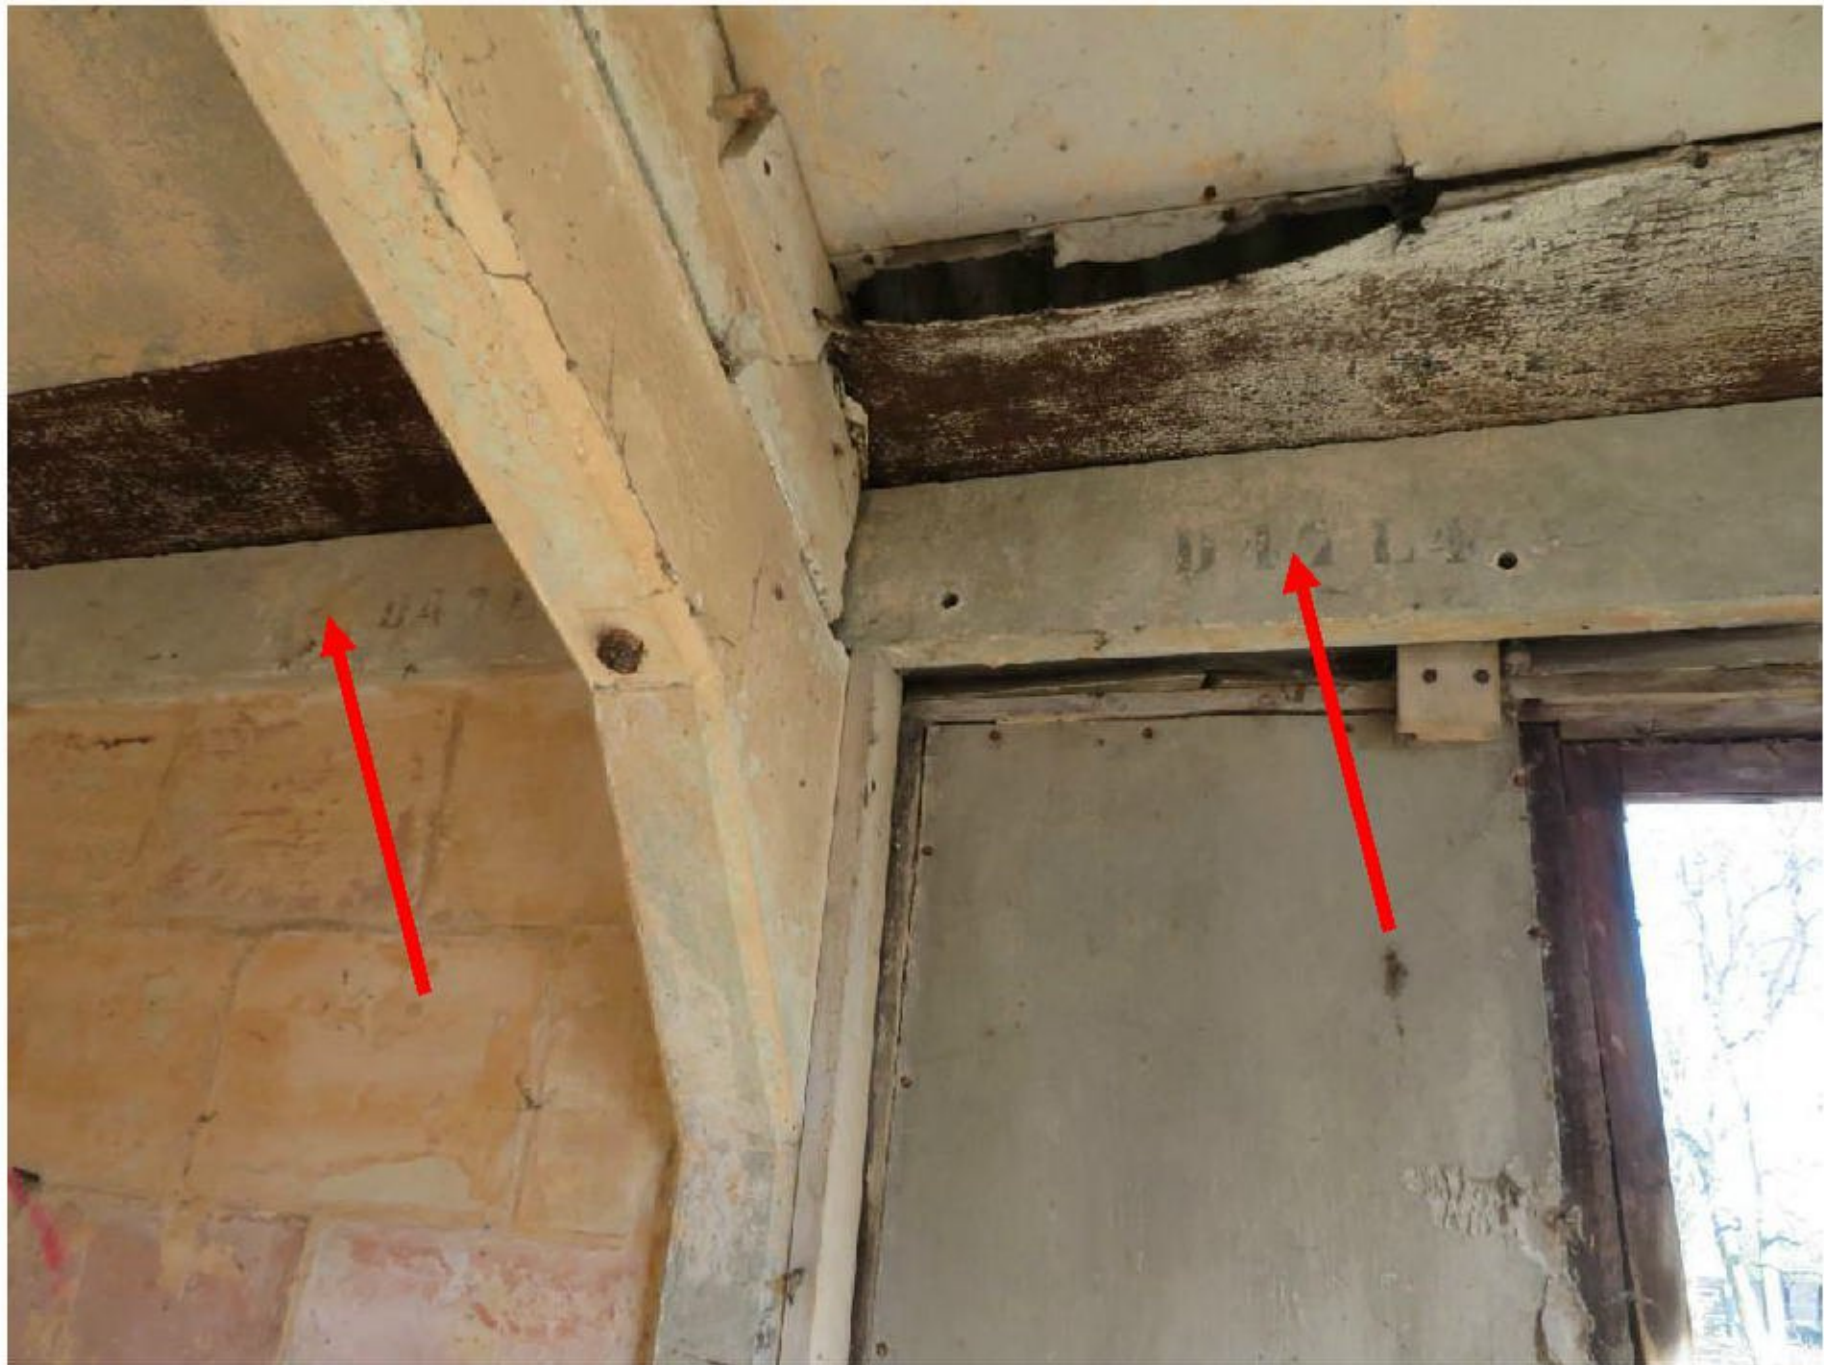
The fact that it is a modular system is confirmed by unique numbers stamped on some of the members and still visible in places (see photograph 3). In between the concrete frames is predominantly a clay hollow block (see photograph 7), although in the case of building five, this has been replaced with brickwork (see photograph 8).

Photograph 3: Pre-cast concrete eaves plates

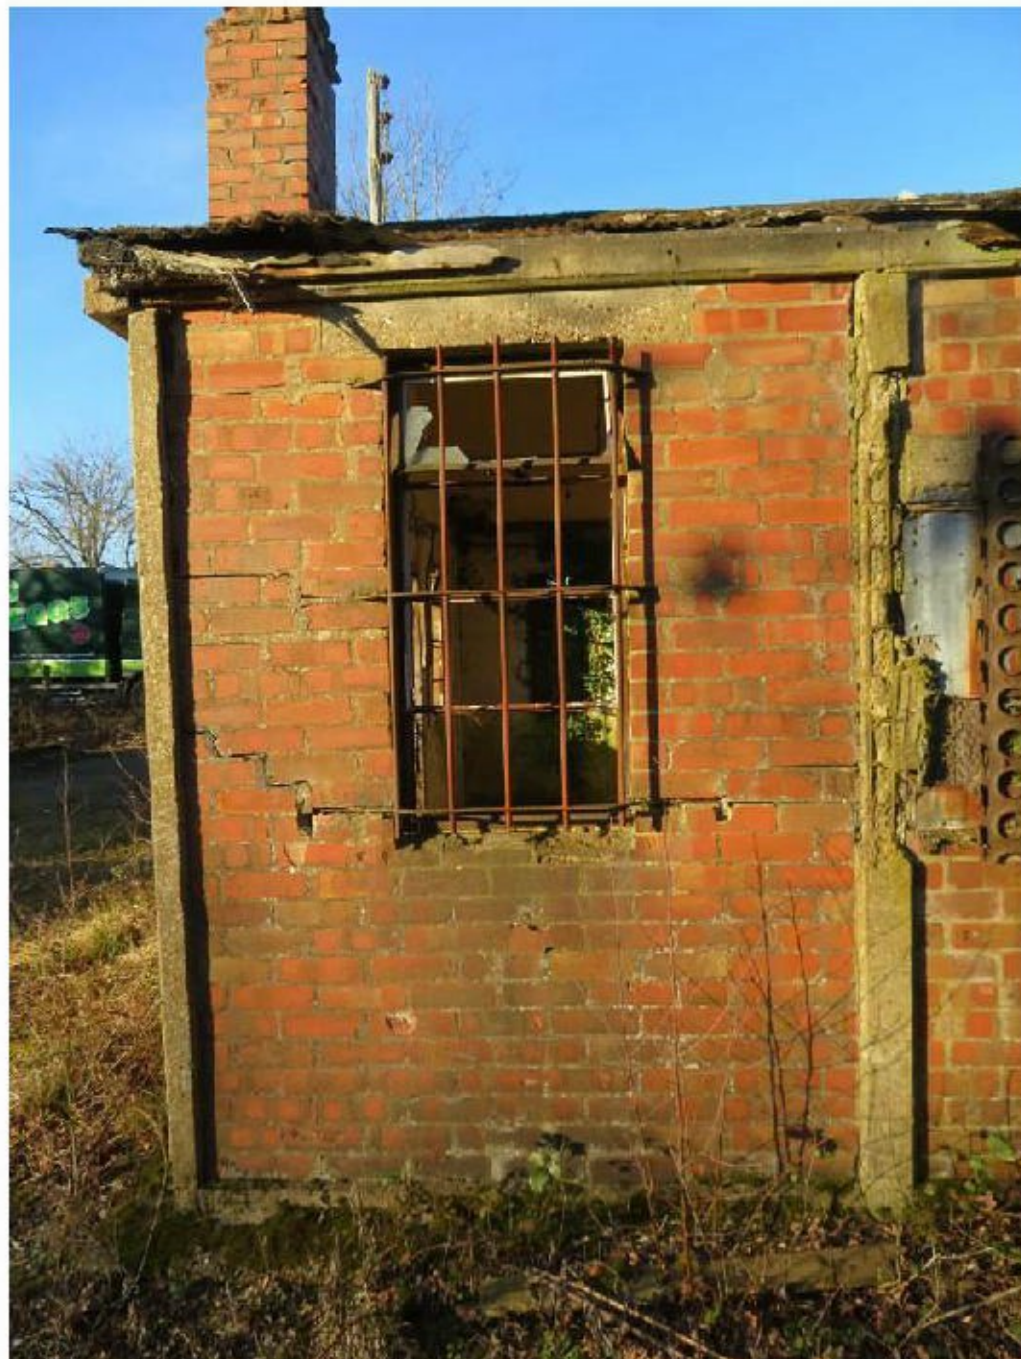
To Building 5 the windows are of iron with iron grilles externally (see photograph 8). Corrosion of the inbuilt sections has caused brickwork to fracture and it will be necessary to remove the grilles and ensure any new elements are appropriately treated to resist this action in the future.

Photograph 8: Building 5 with brick infill

The infill clay hollow blocks or brick generally survive well although the hollow blocks, where ground levels have risen, have in cases shattered through frost or damp action and some local replacement will be needed. Windows will need to be replaced and where iron frames and/or grilles are built in, these will need to be removed to resist the cracking which can occur through corrosion jacking.

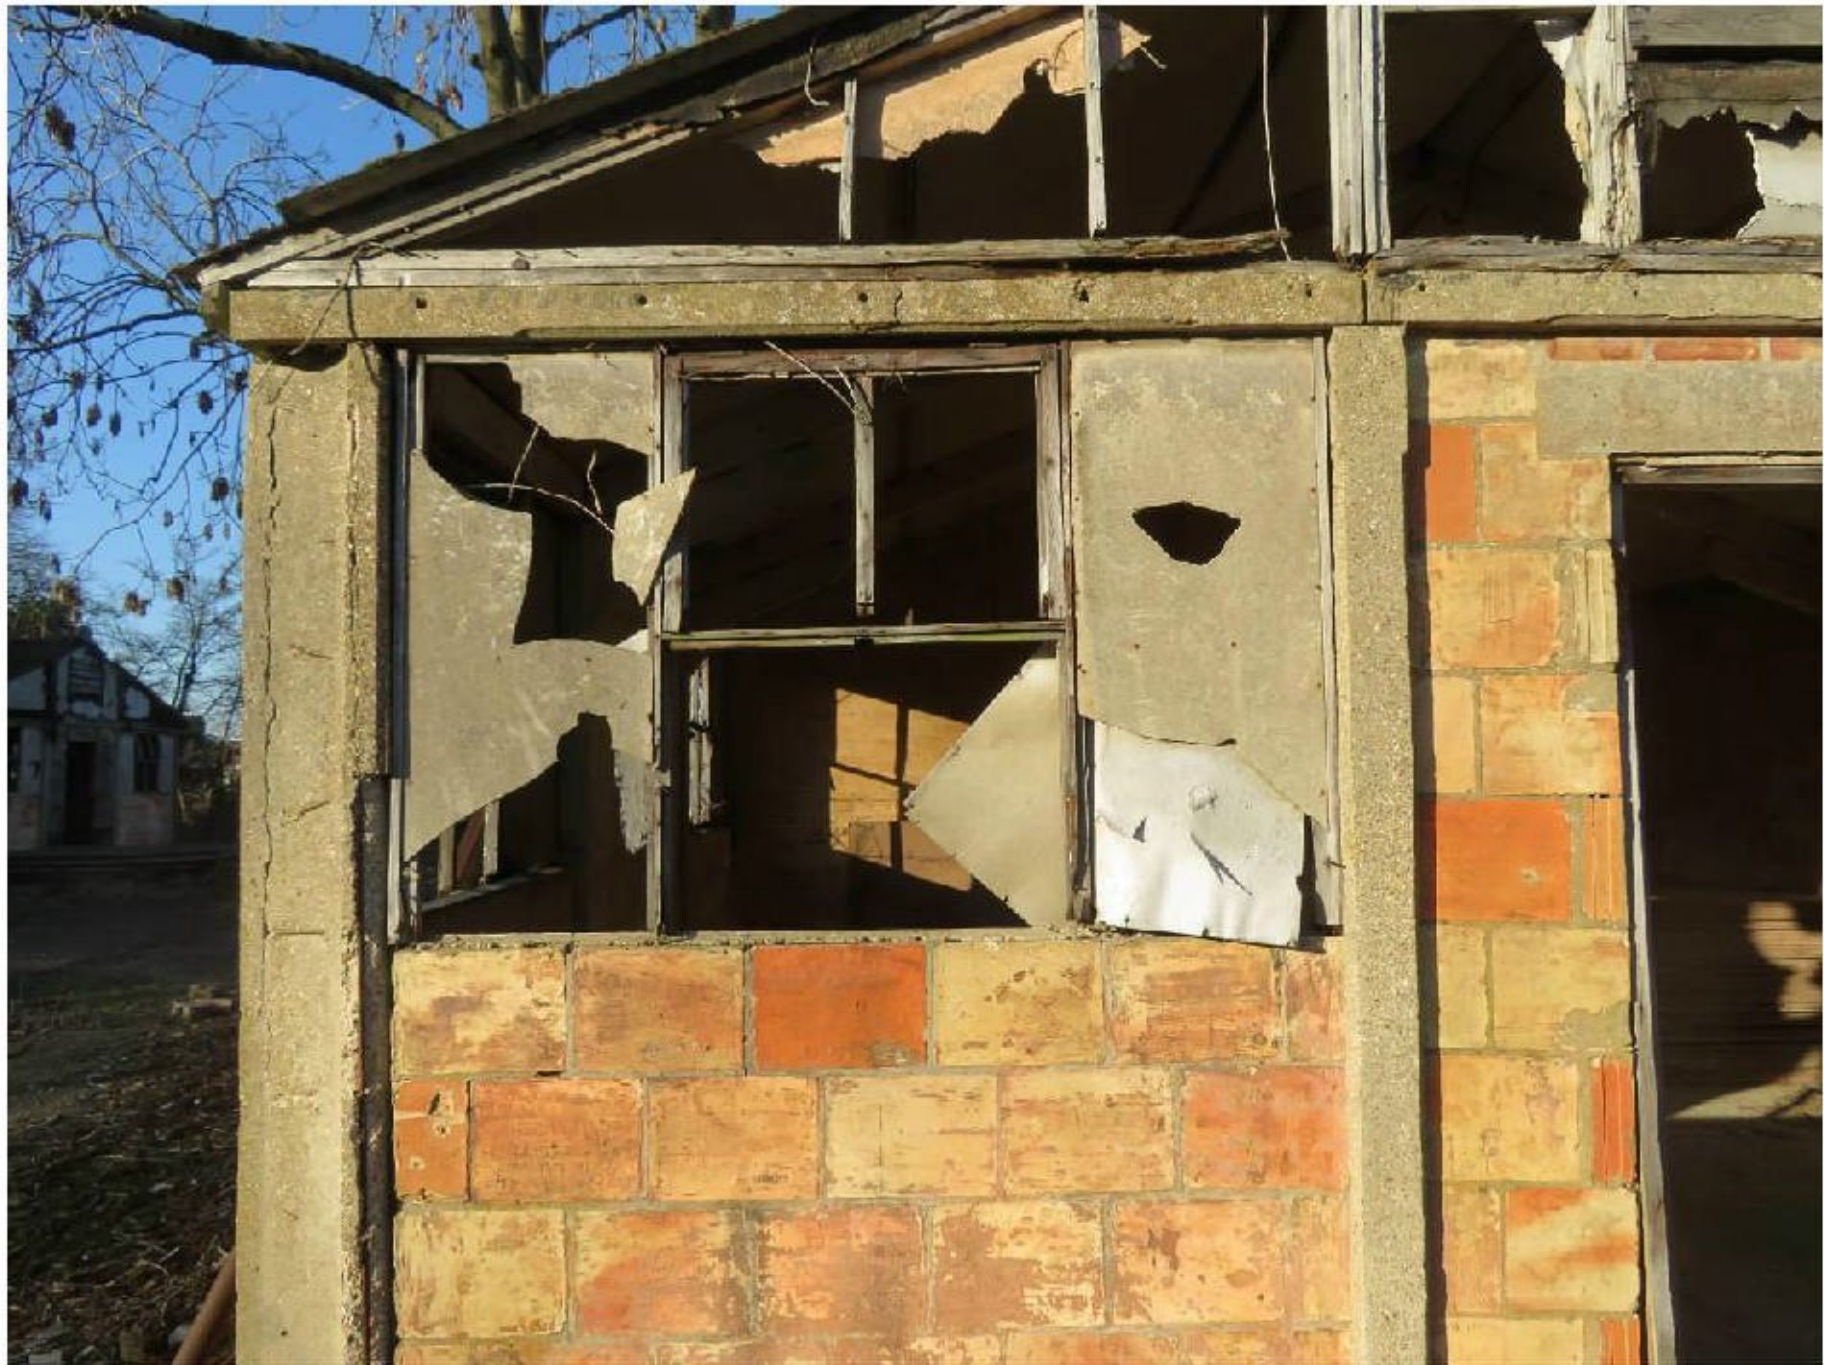
The windows are predominantly timber framed with asbestos side lights/panels (see photograph 9), although Building five has steel casements and security grills (see photograph 8), The gables are either timber framed and panel finished but with a central timber louvre ventilation (see photograph 5), although again there are some variations with hollow block (see photograph 1) or brick gables, again with venting.

Photograph 9: Timber windows with side panels in asbestos board

The timber framed windows have largely rotted out and will require replacement. Concrete slabs internally have quite a number of cracks and clear day work joints, and we suspect that the assumed screeds will need to be removed to allow insulation and new finishes.

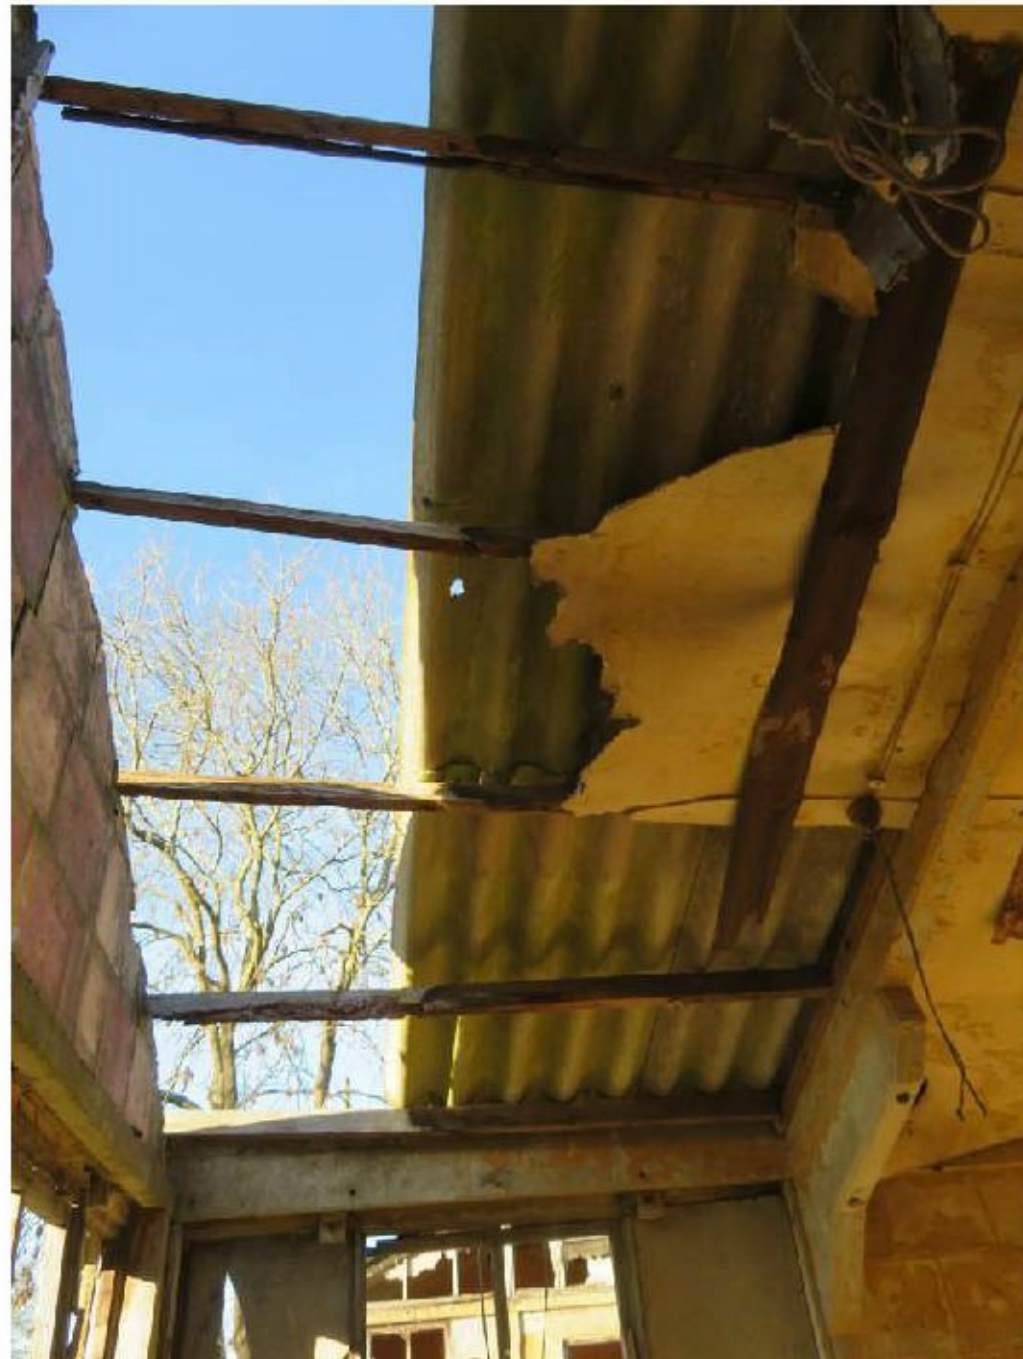
To the roofs there is inevitably decayed to some timber purlins, but where these can be seen, for instance in Building 2, these are at regular and comparatively close centres, and should be able to support new corrugated and insulated panels and ceiling finishes. If necessary additional purlins can be added.

Photograph 10: Purlins at regular centres to support roof covering and internal finishes

Roofs where the common purlins have not decayed can be retained and reused, if necessary supplemented with additional purlins of similar sizes if new insulated corrugated finishes require this related to their weight. Some timber framed gable panels may need to be rebuilt where they are affected by decay, and some connectivity between eaves elements will need to be improved.

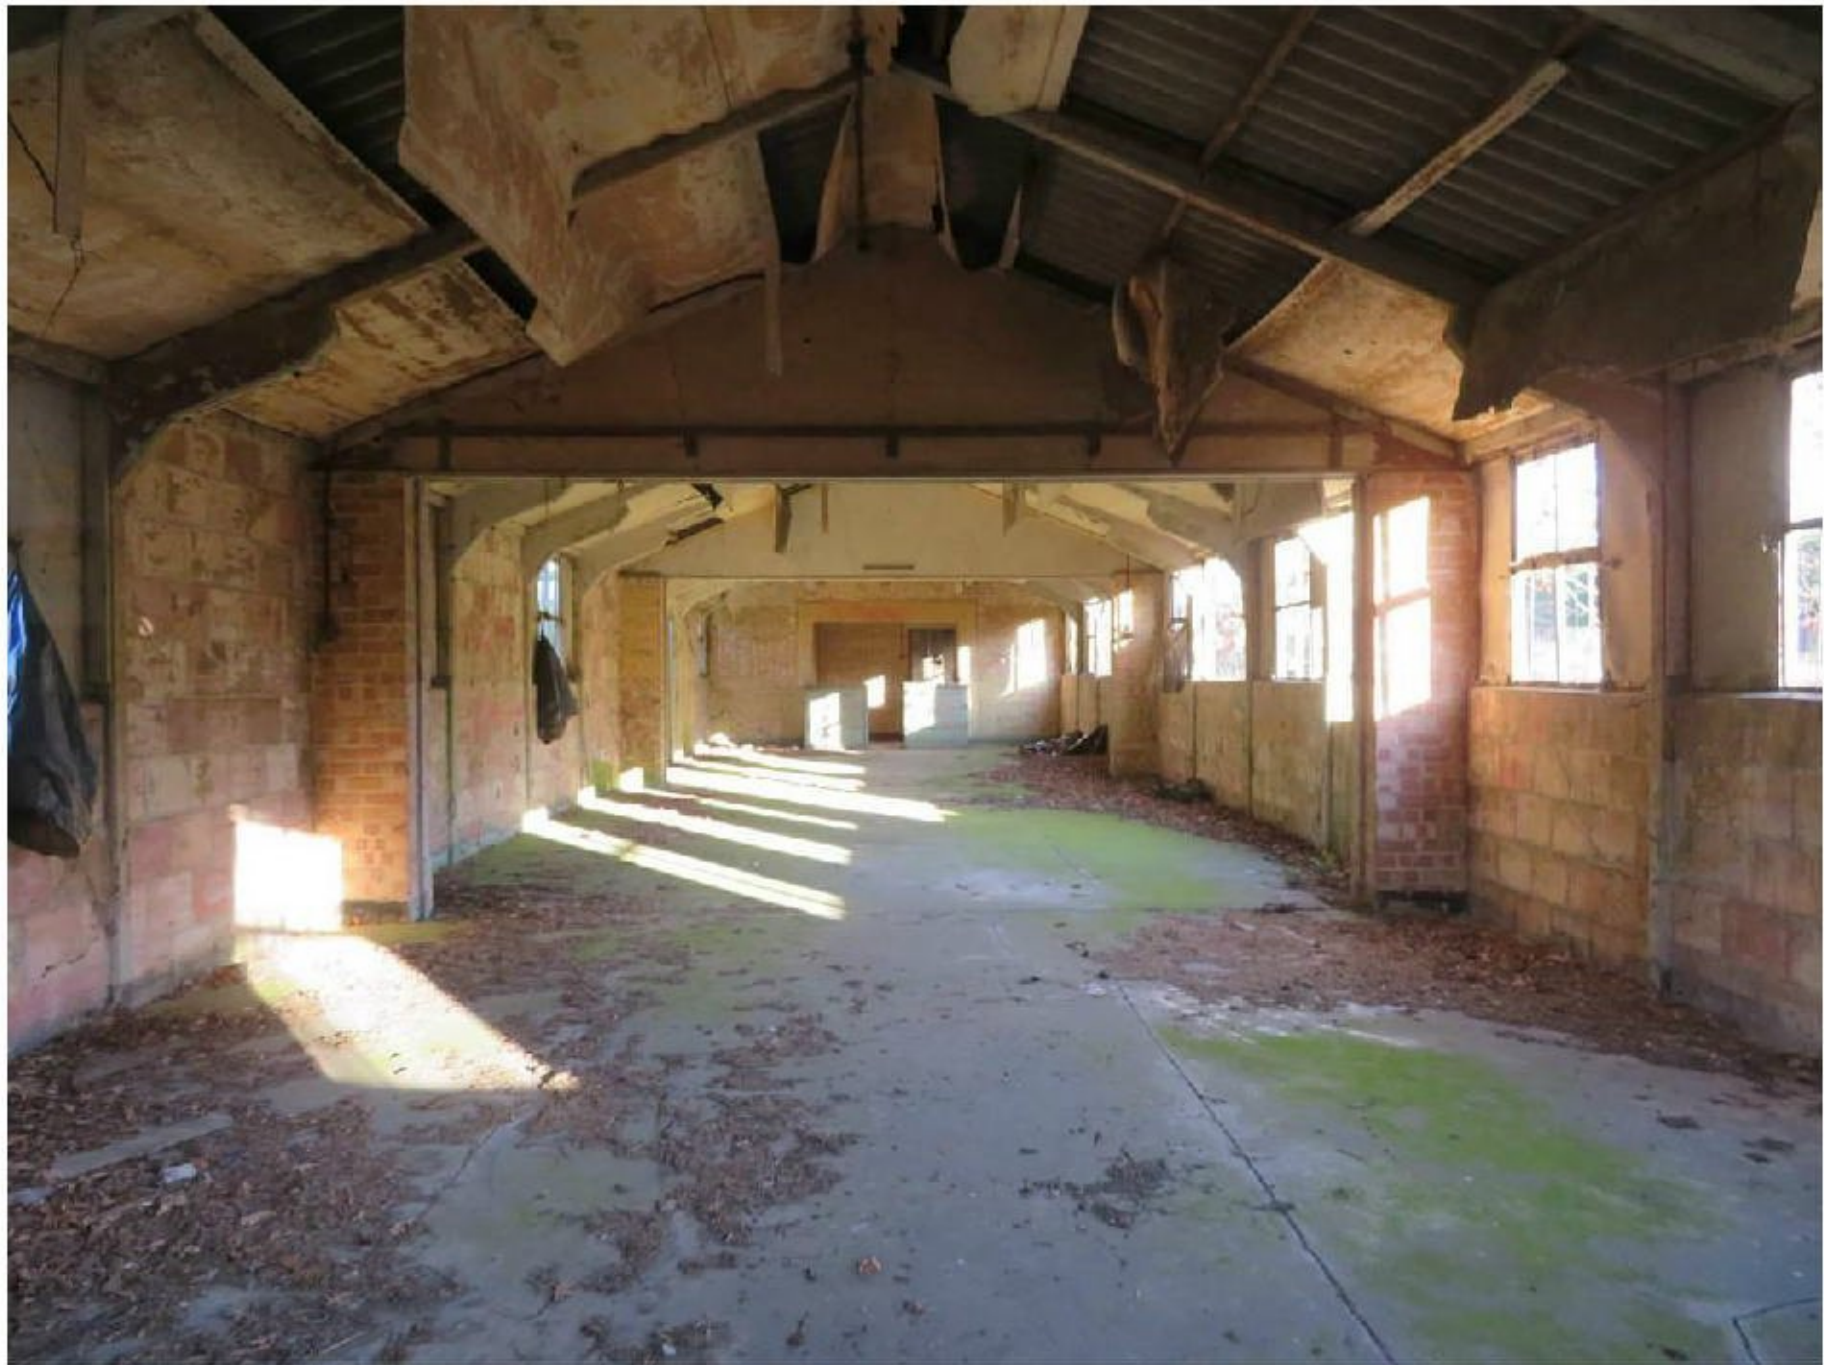
Photograph 13: Concrete floor in Building 3

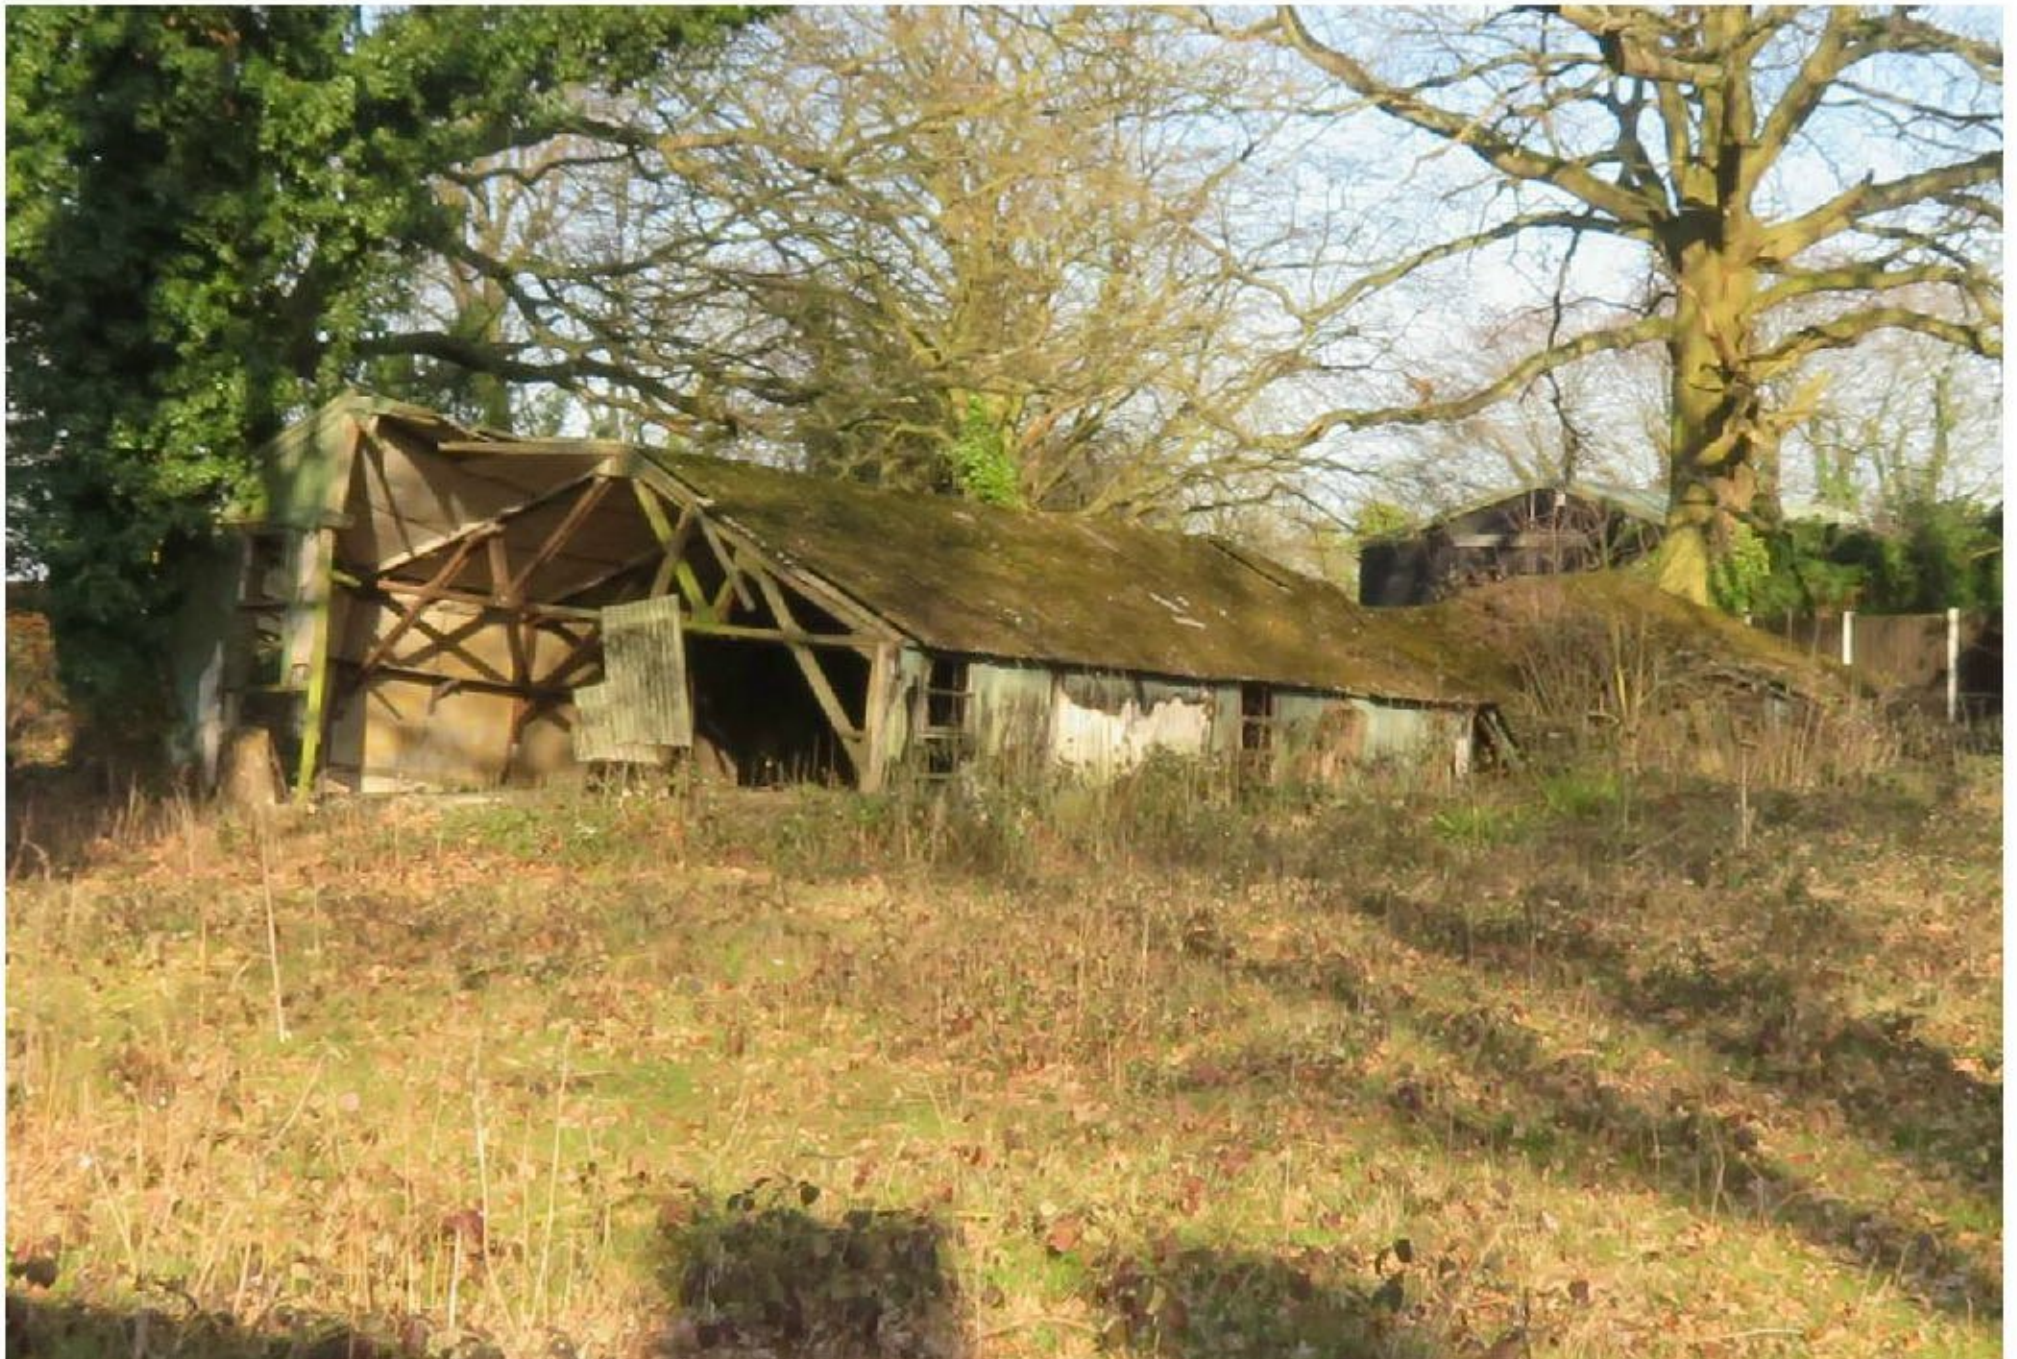
Building 7 is a Laing 16ft sectional timber building with lightweight timber trusses and timber framed walls (see photographs 14 and 15). The walls have partially collapsed with the building dropped down to half height.

Building 7 is of timber framed construction, and to which the whole lower section of the structure has collapsed so that the building is now at half height (see photograph 14). The roof frames largely survive intact, except two which have been affected due to collapse and then the west one with some decay (see photograph 15), but generally being salvageable for reuse with some repairs. This includes the down braces to the posts, then with the posts and wall panels requiring replacement.

Photograph 14: Building 8 with part collapsed walls

Of course, the building will need to be carefully lifted to undertake this work, but with roof finishes moved etc. this should be perfectly feasible. The gables to both end are lost and one further frame at the west end will need some repair.

With regards to the Laing type Building 8, it is possible to retain and jack up and reuse the majority of the roof trusses, although at least three of them would require some repairs or replacement. The walls will need to be largely rebuilt on a like for like basis and clearly a new sole plate ideally raised above ground level to prevent re-occurrence of low level decay.

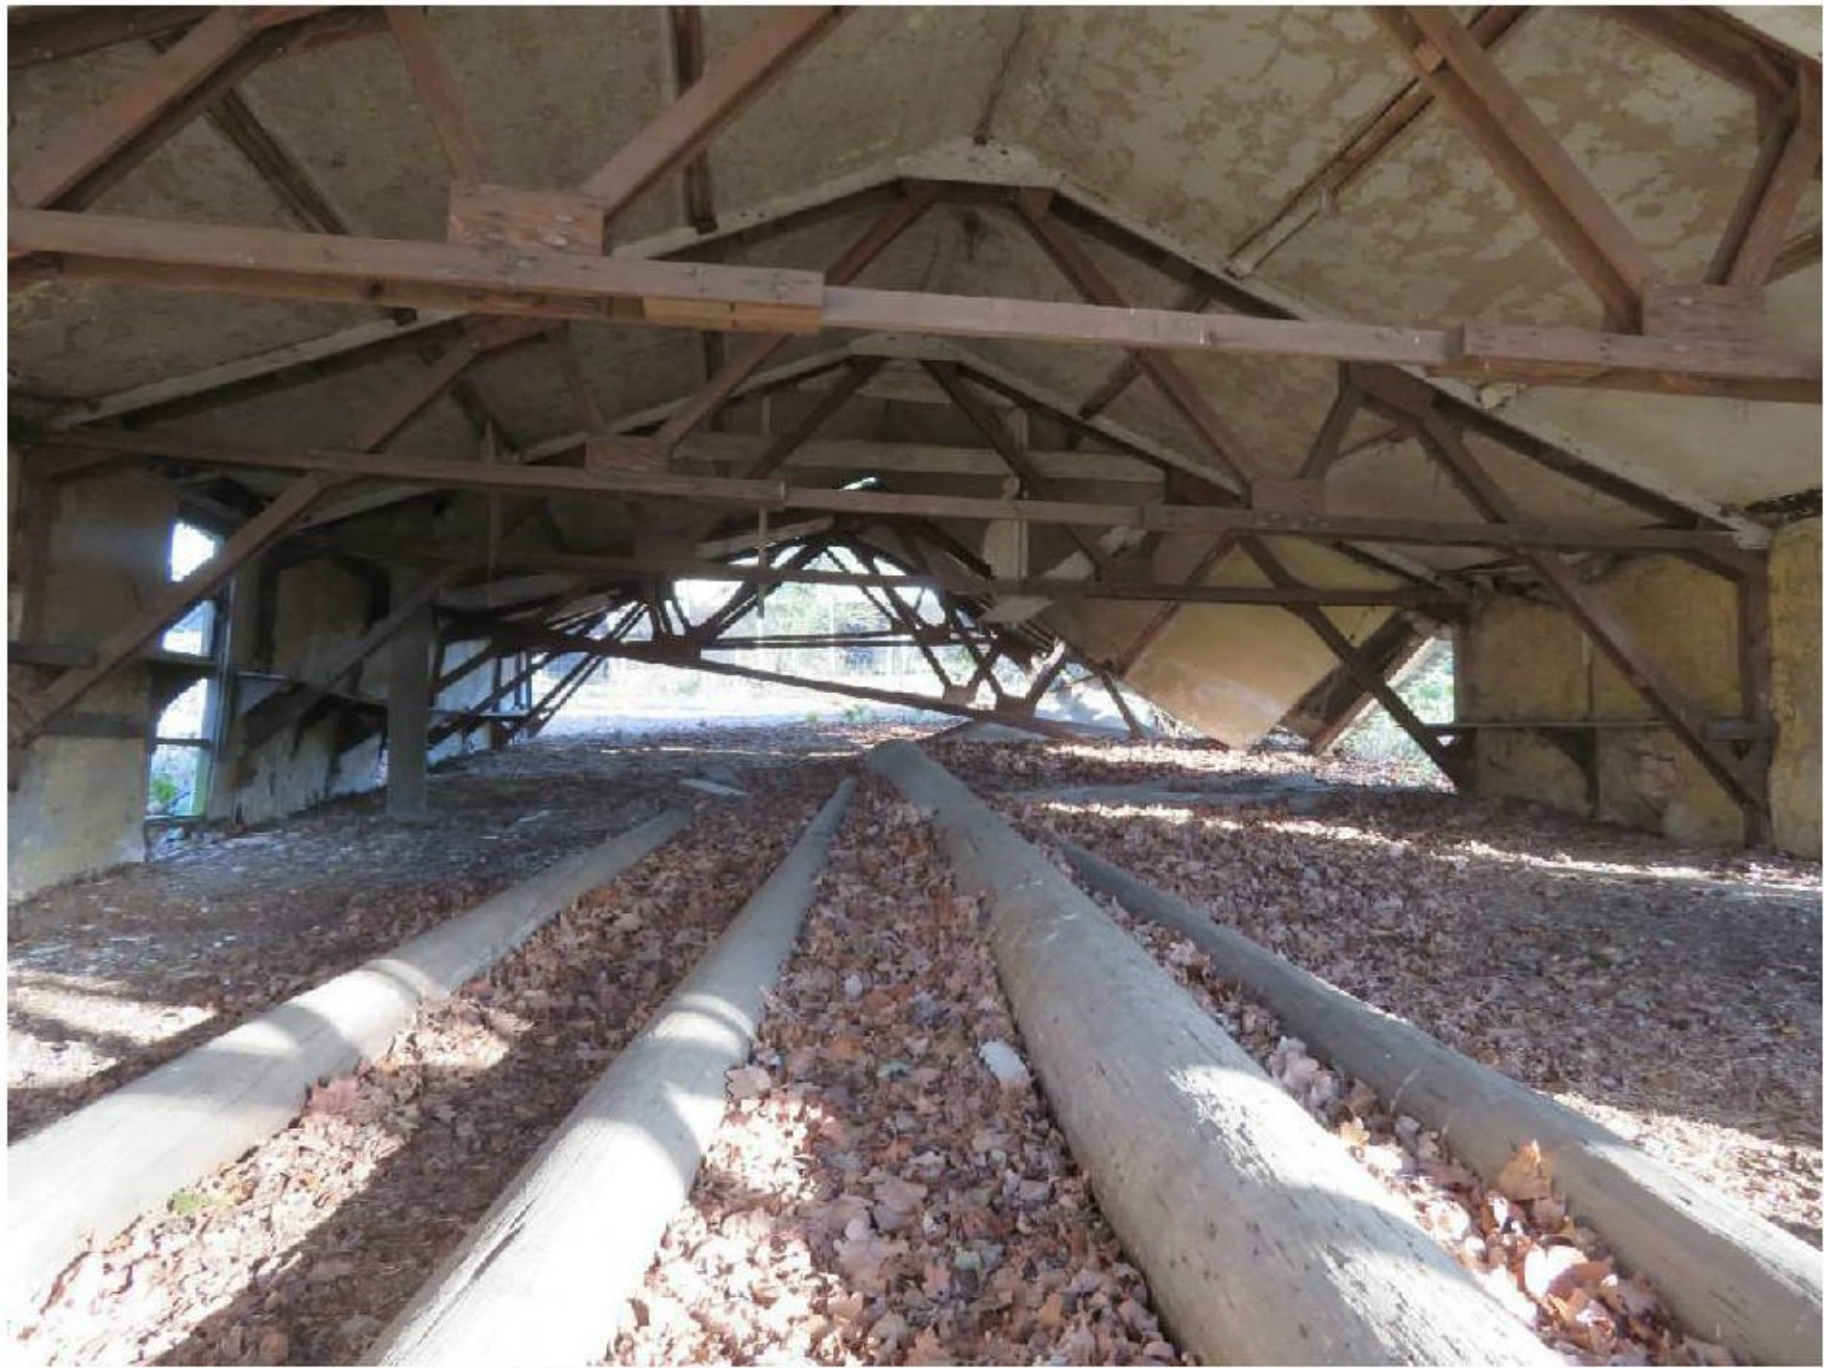
Photograph 15: Roof trusses to Building 8

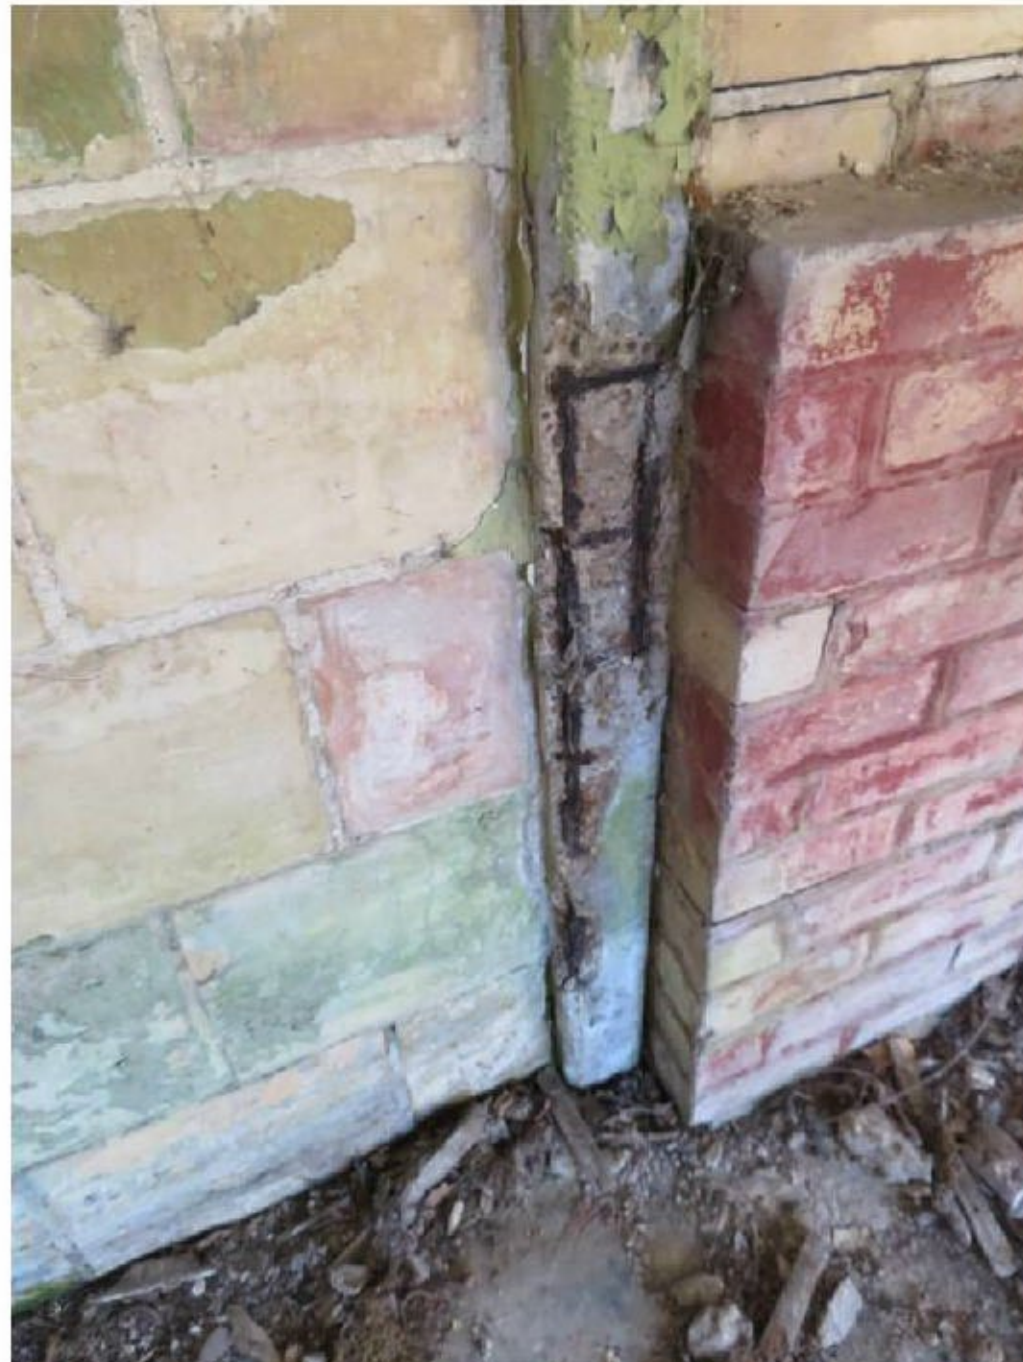
There are a number of defects with the MoWP buildings and in particular it can be seen that there is corrosion of reinforcement and failure of concrete cover to a reasonable number of reinforced concrete elements (see photographs 18 and 19). This is one of the most common defects with reinforced concrete particularly of this era and relates to carbonation of the concrete as well as moisture ingress.

Photograph 18: Reinforcement corrosion and concrete cover lost to post

However, it is possible to carry out traditional repairs, which would be to remove all loose and debonded concrete, cleaning back the reinforcement steel, paint treating this and then making good the concrete with either a proprietary mortar or a mix to match original. Alternatively, electro-chemical methods are available, such as cathodic protection to protect the bars from future corrosion, with associated concrete repairs. This defect is predominantly to posts, although there is some evidence of it also on eaves plates, eaves members and occasionally on roof principle rafters.

Clearly there are repairs needed to the reinforced concrete to a reasonable degree, which can be either traditional concrete repairs, using either proprietary mortars or like for like mixes, or alternatively cathodic protection, and then similar mortar repairs.

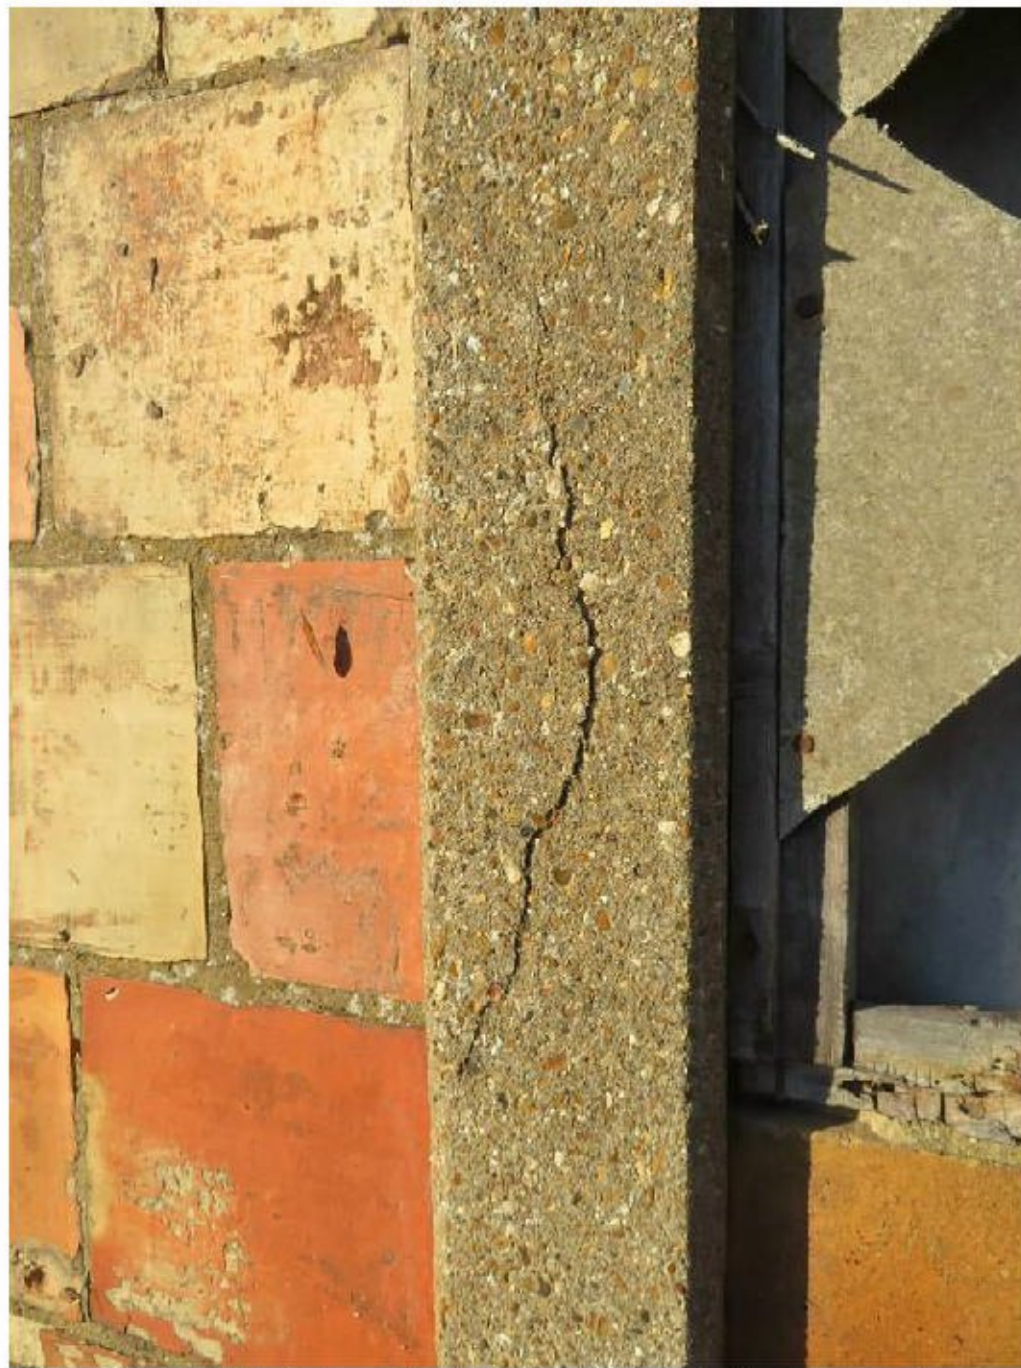
Photograph 19: Cracking to post suggesting reinforcement corroded below
