Our ref: EJM/CH/19553~01

22nd February 2019

RE: LAND TO WEST OF MILL LANE, HATFIELD HEATH, ESSEX

Further to your request I was able to visit the above site on 21st February 2019. The purpose was to inspect seven existing structures dating from WWII which are part of a former Prisoner of War Camp (No 116), and situated to the east of the access road, as well as the Water Tower. We have numbered the huts on the attached plan for ease of reference.

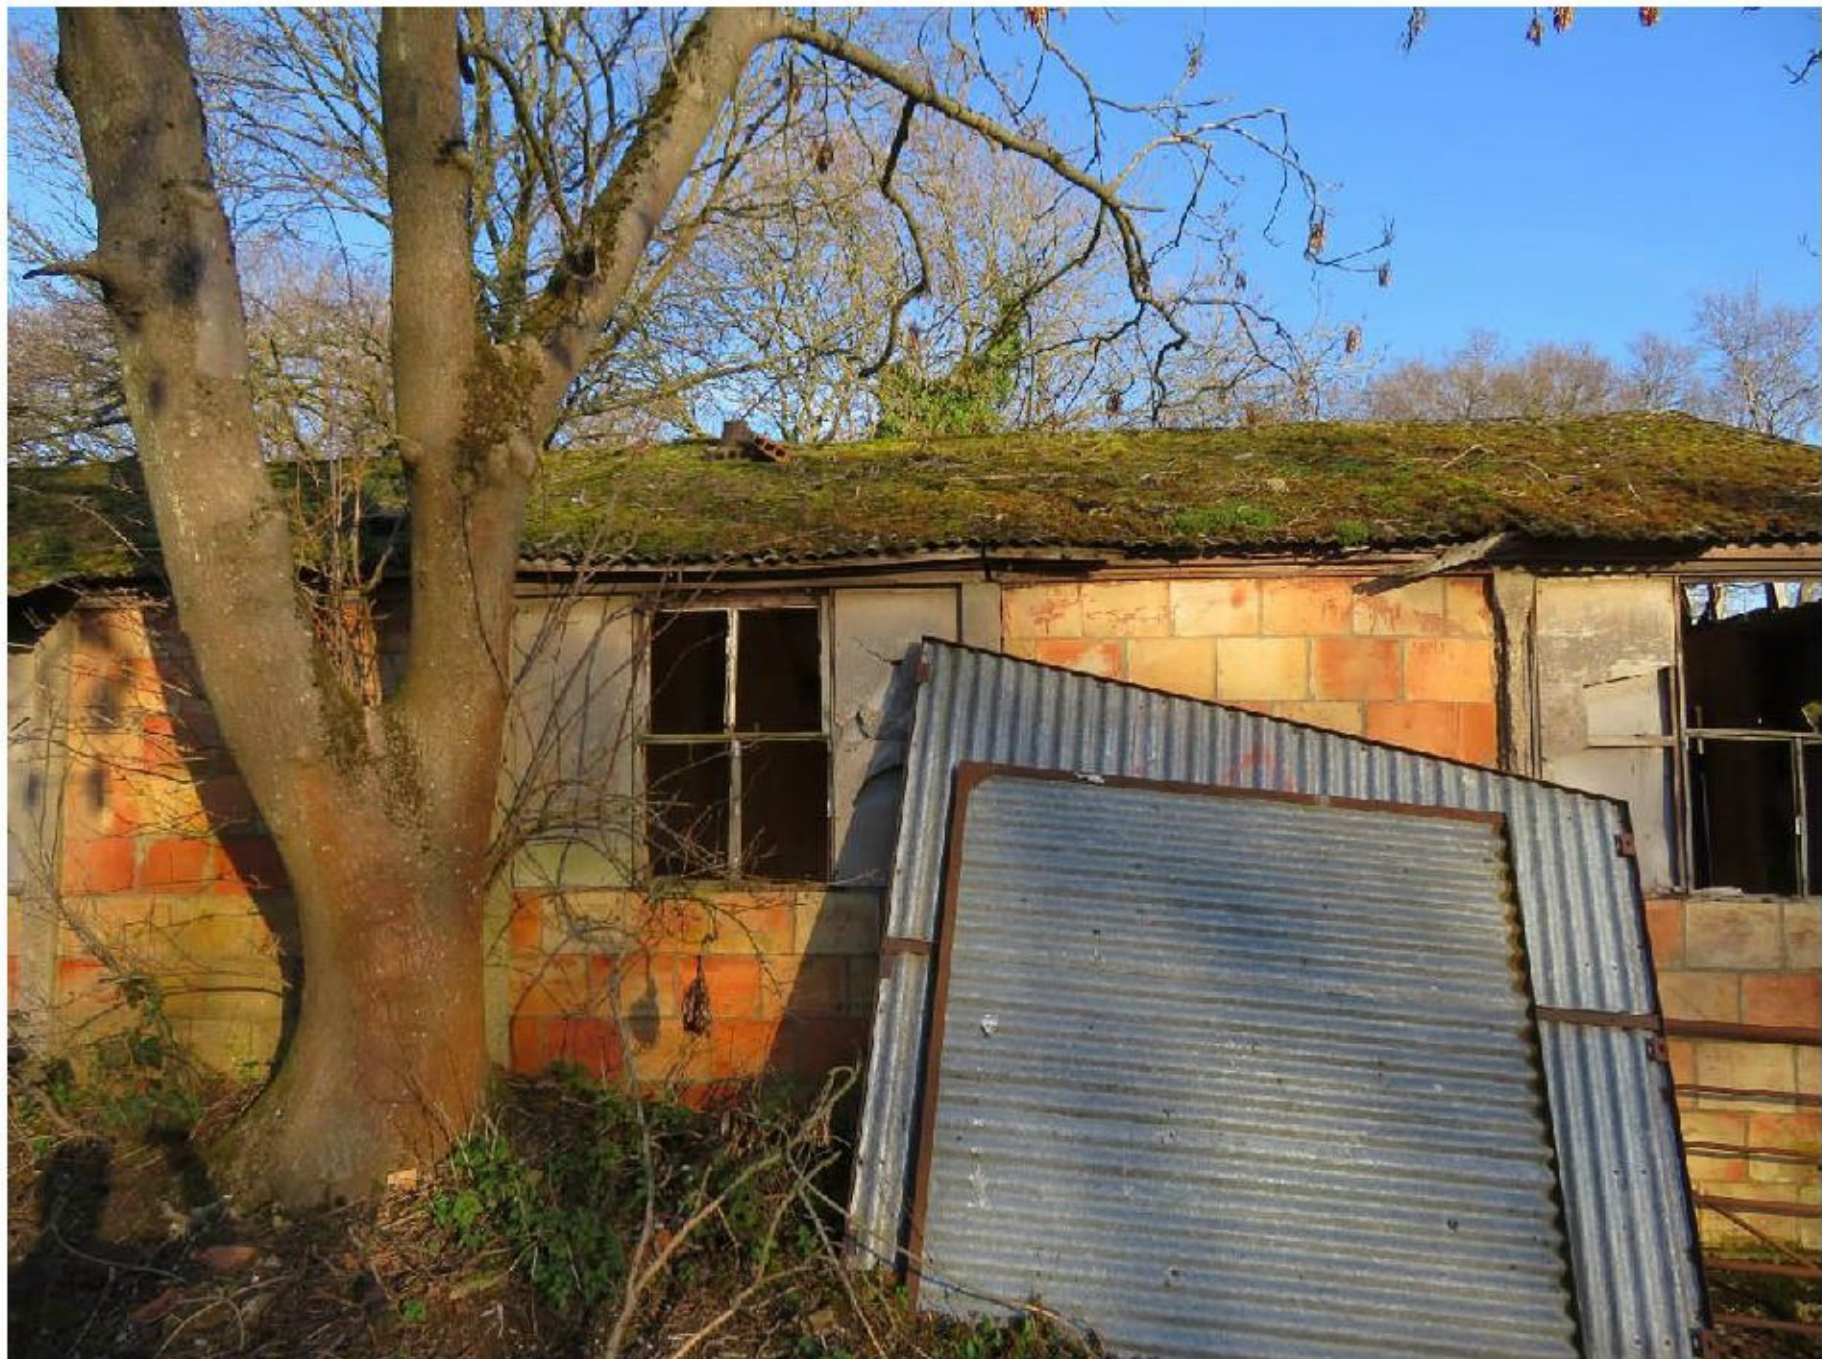
The infill panels are largely intact, although there are some areas of local disruption. For instance, Building 4 has been disrupted by the adjacent tree which has caused lifting of the structure centrally (see photograph 20), and some associated but surprisingly little damage to the infill. Local repairs will be needed in places at low level where blocks have been frost damaged and shattered (see photograph 21) and often caused where external ground levels have risen (see photograph 22). These should be lowered.

Photograph 20: Local damage to structure from self-sown tree

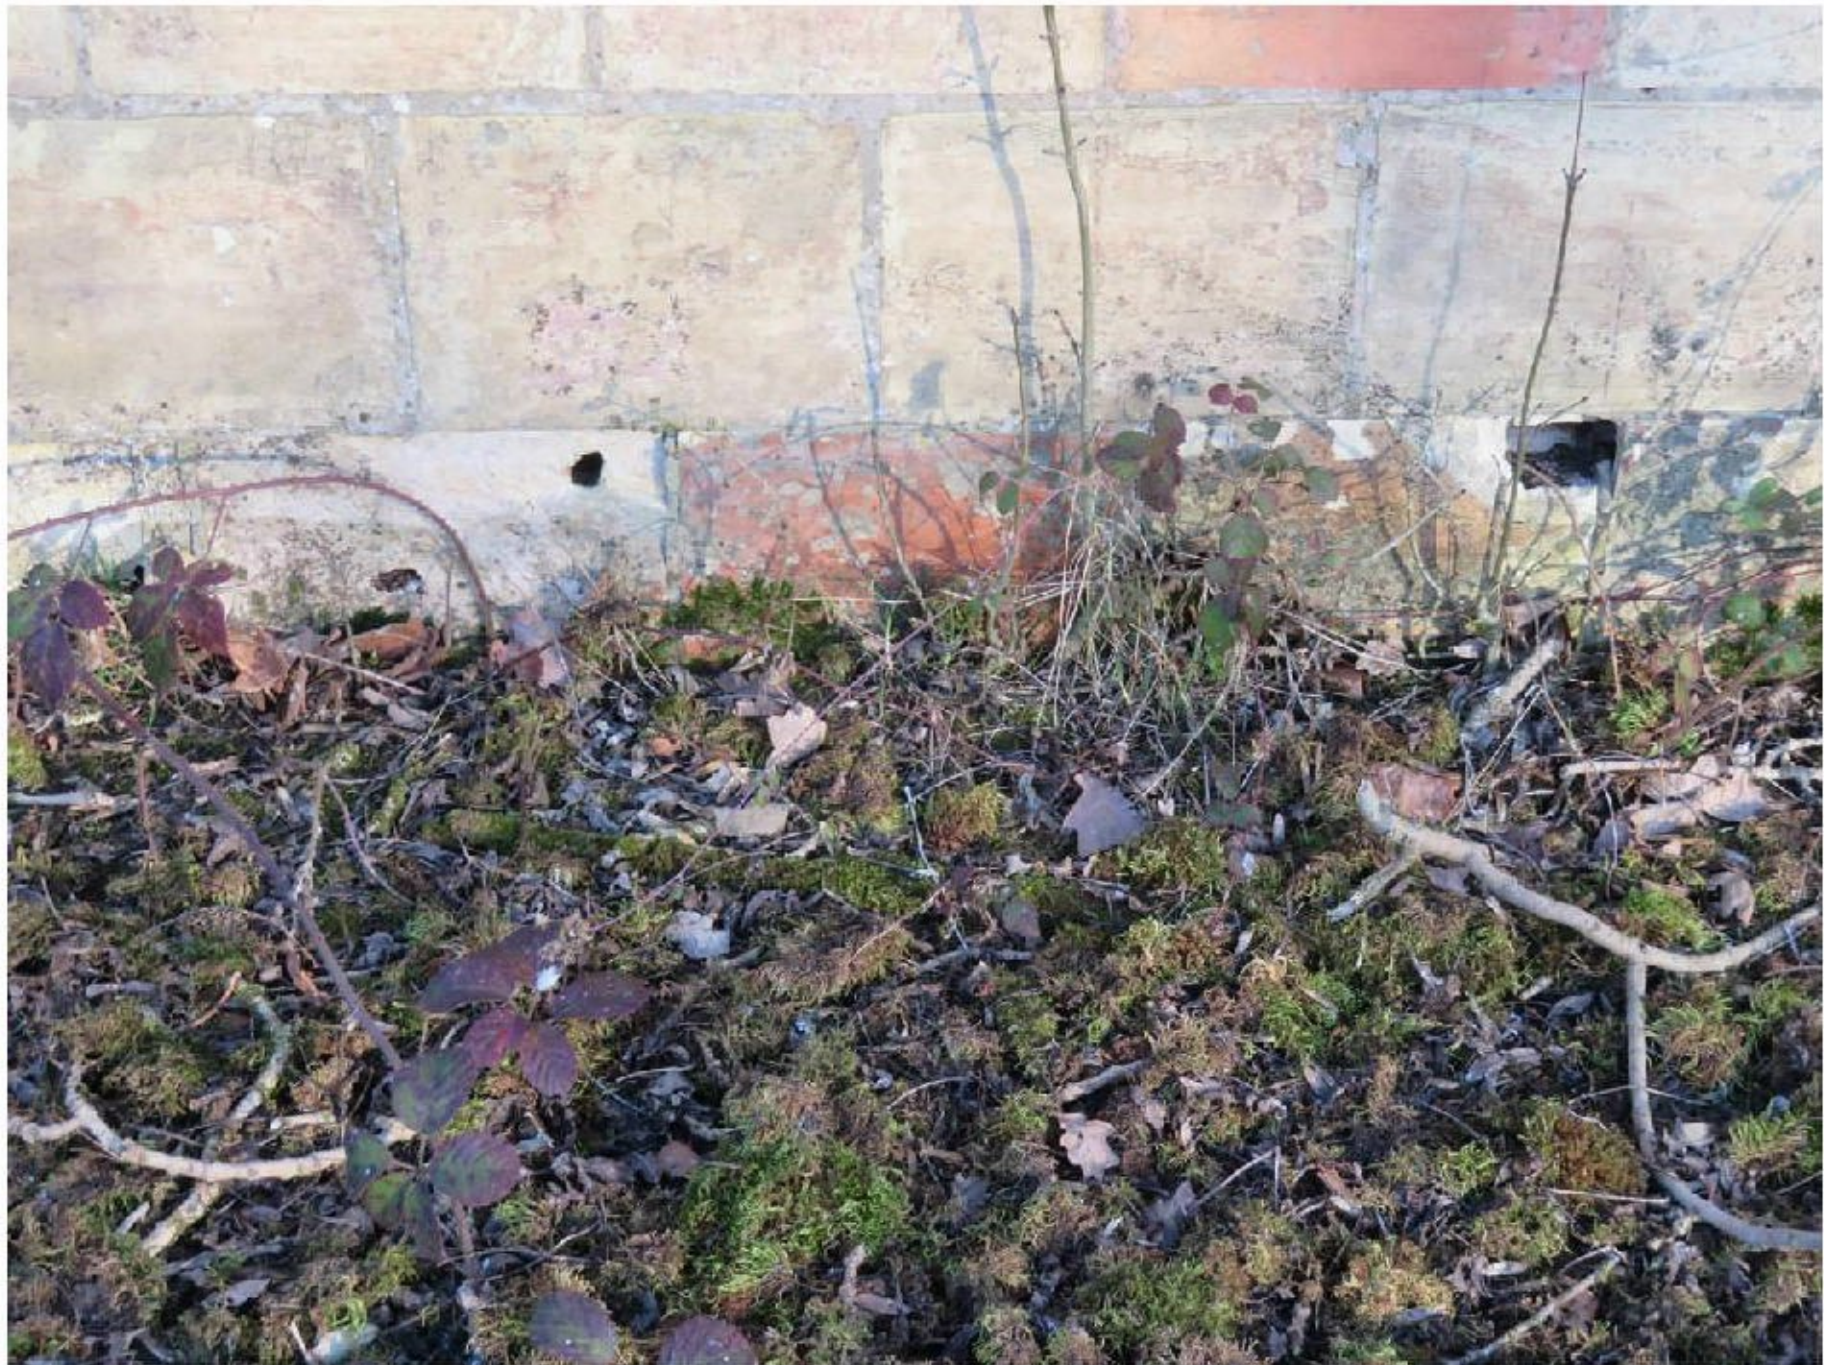
Photograph 21: Locally damaged hollow blocks due to damp

The infill clay hollow blocks or brick generally survive well although the hollow blocks, where ground levels have risen, have in cases shattered through frost or damp action and some local replacement will be needed. Windows will need to be replaced and where iron frames and/or grilles are built in, these will need to be removed to resist the cracking which can occur through corrosion jacking.

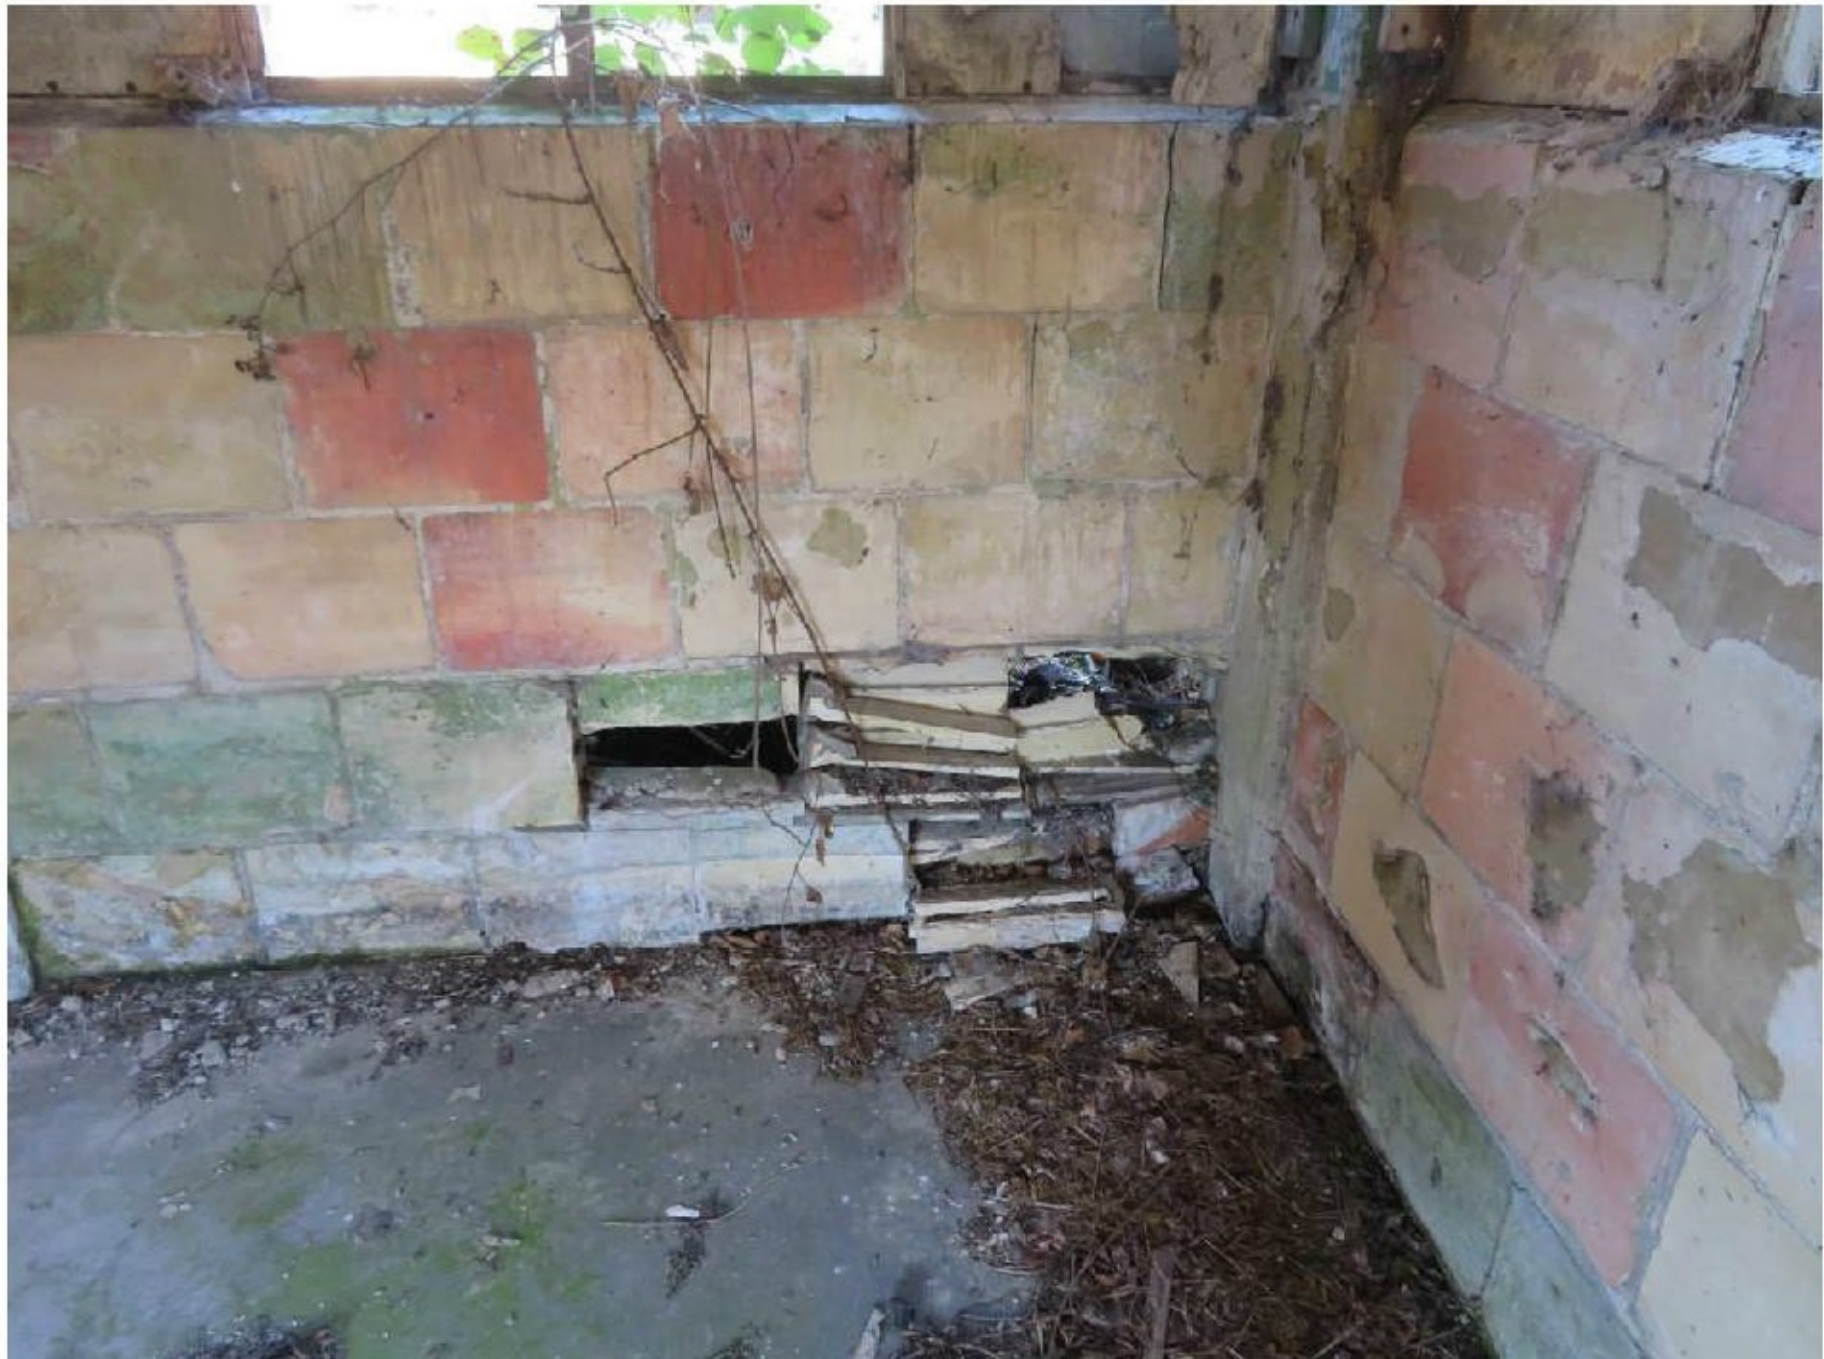
Photograph 22: Locally damaged blocks due to high external ground levels

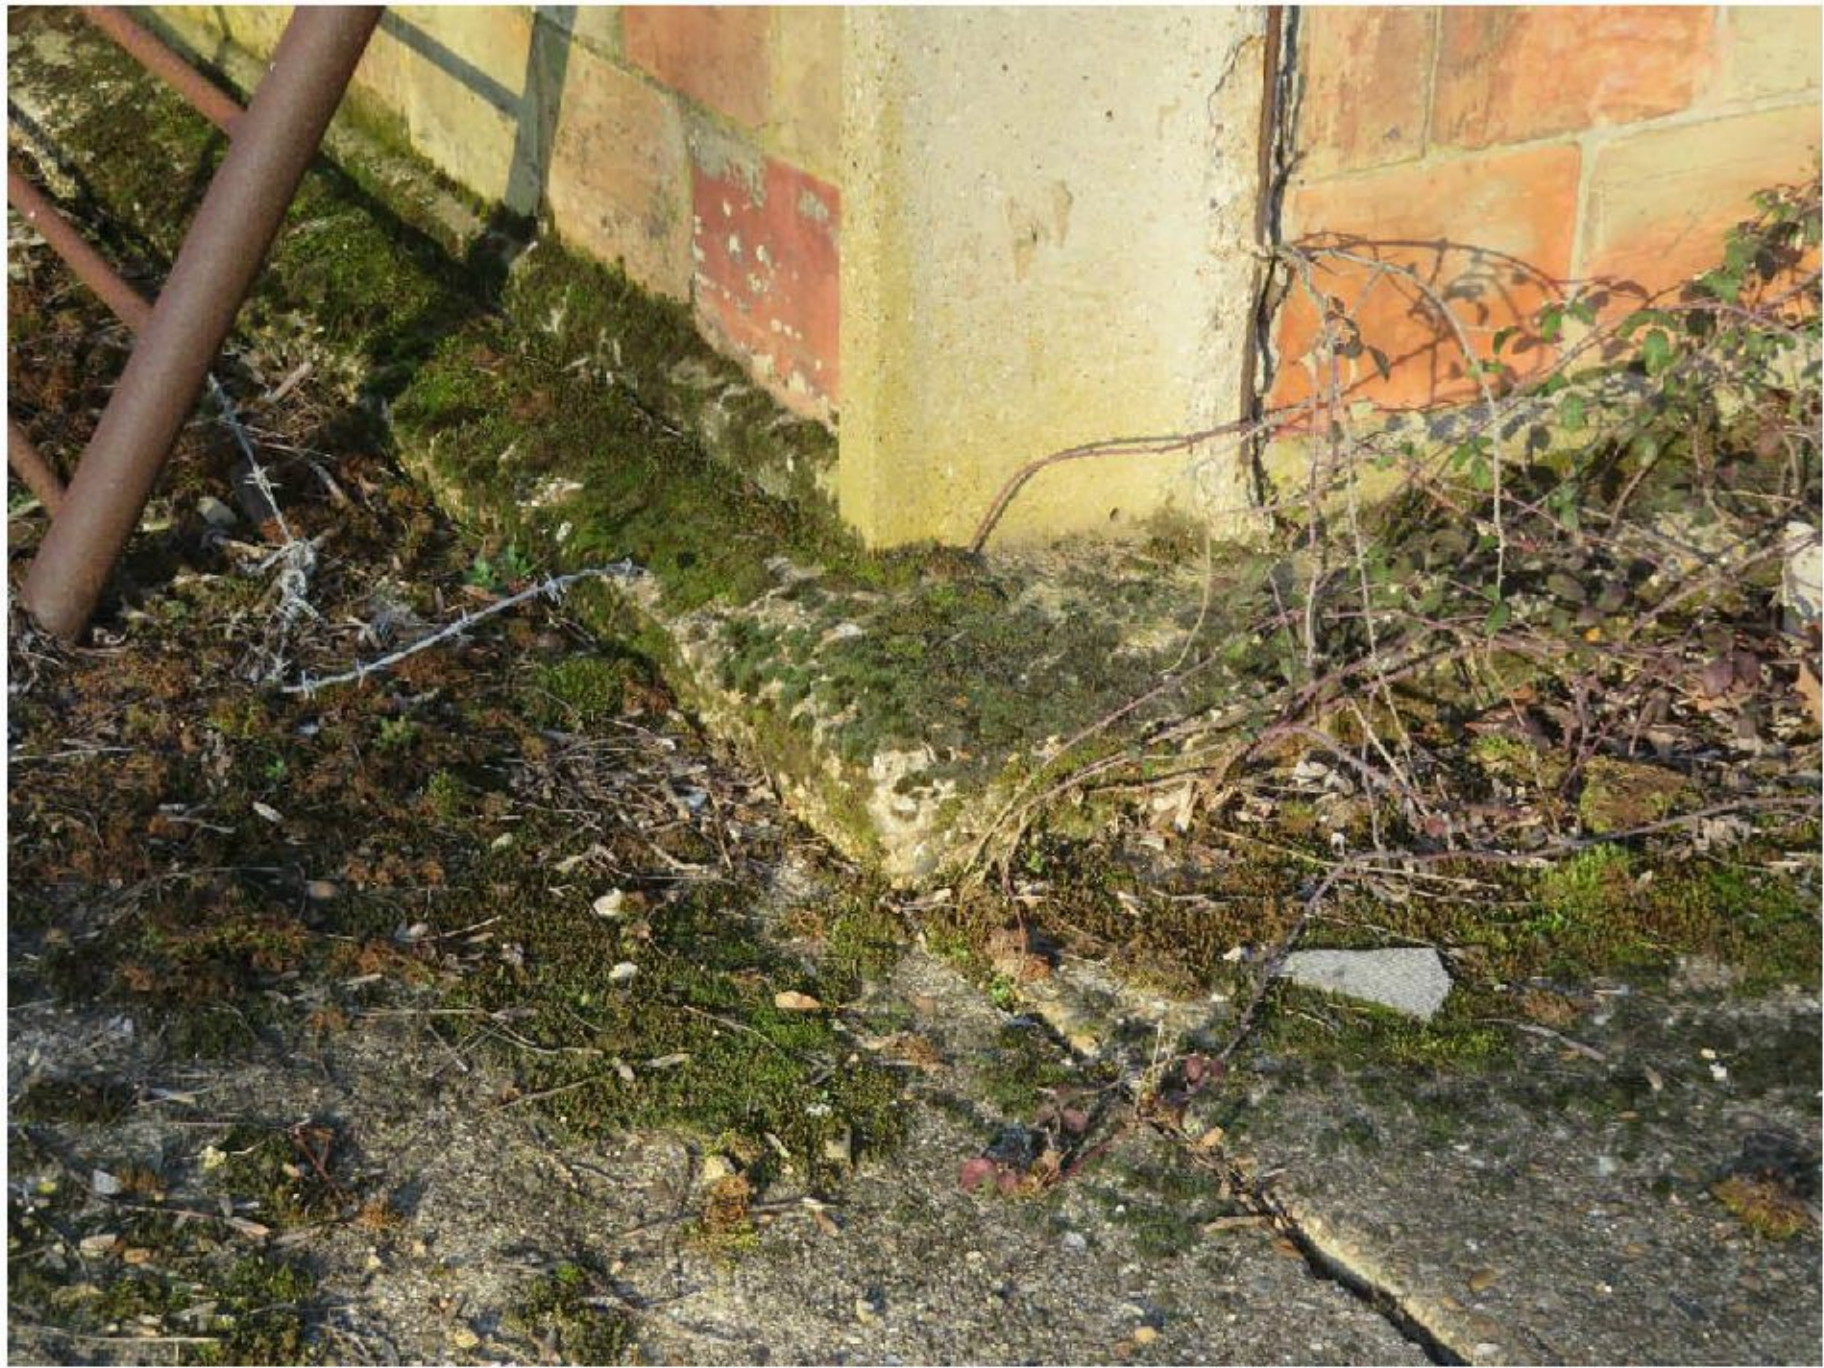
No inspections of the foundations were undertaken, although to the end of Building 1 to the south side, a projecting ledge can be seen, which can perhaps suggest a concrete raft foundation (see photograph 23). Historic drawings seem to also suggest a concrete raft with a toe to the edges supporting the walls. Generally there is very little evidence of movement, so whilst some investigation will be required, there is nothing to suggest that new foundations are necessary, based on a visual assessment and the past performance of the buildings over their lives.

Photograph 23: Projection at ground possibly suggesting concrete raft foundation

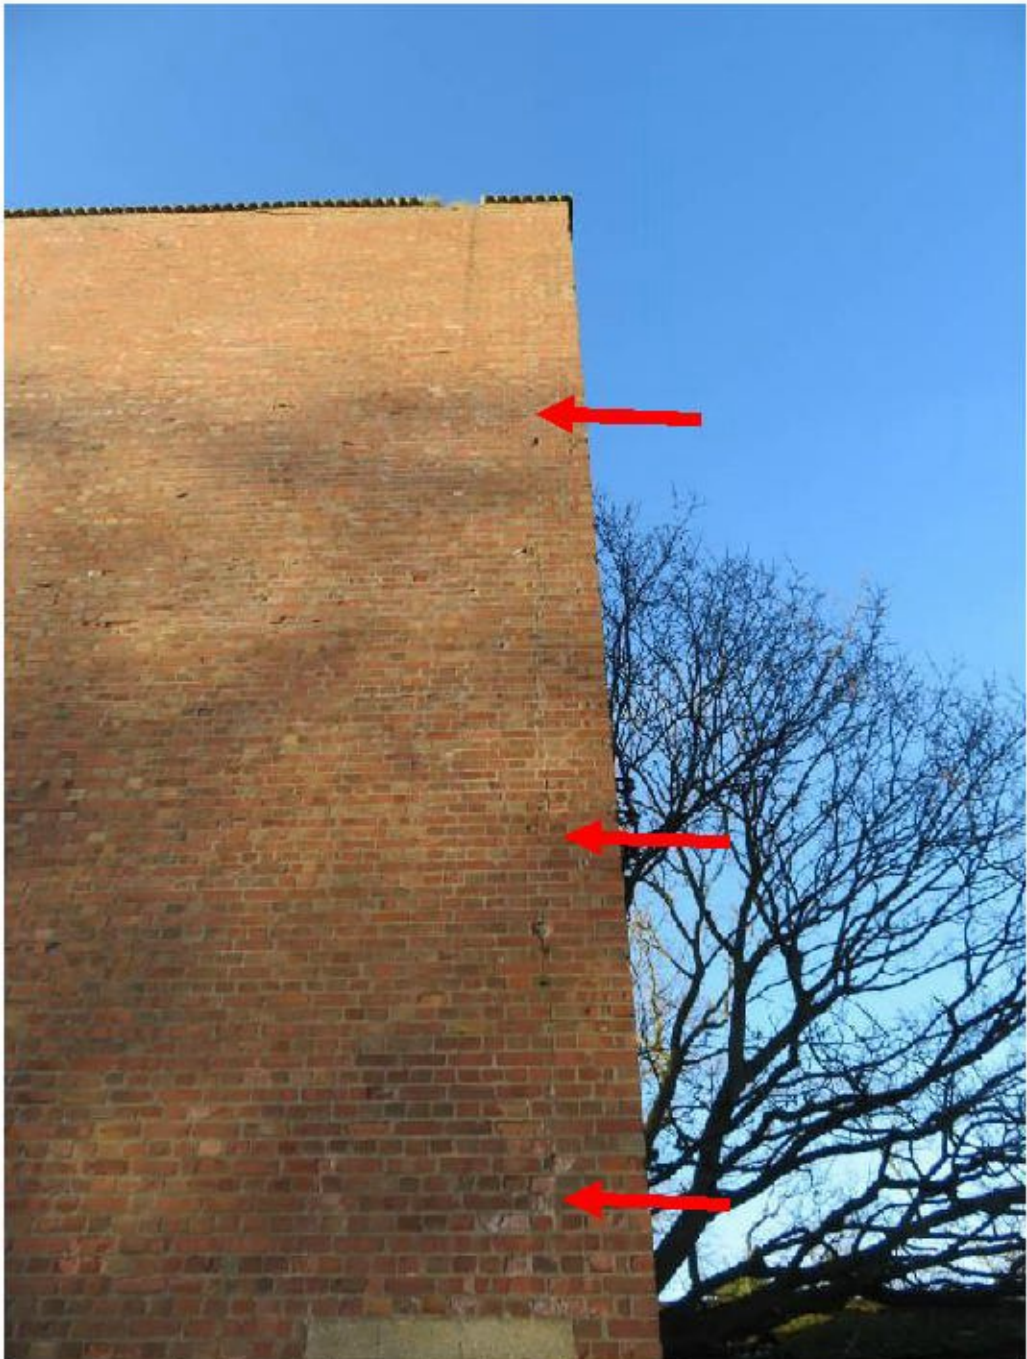
There is some slight movement about the slab new brickwork to the east end, where there are cut outs either side and which may be partly responsible for the reduced lateral restraint, but again structurally it is not significant.

Photograph 26: Movement to south elevation to east end

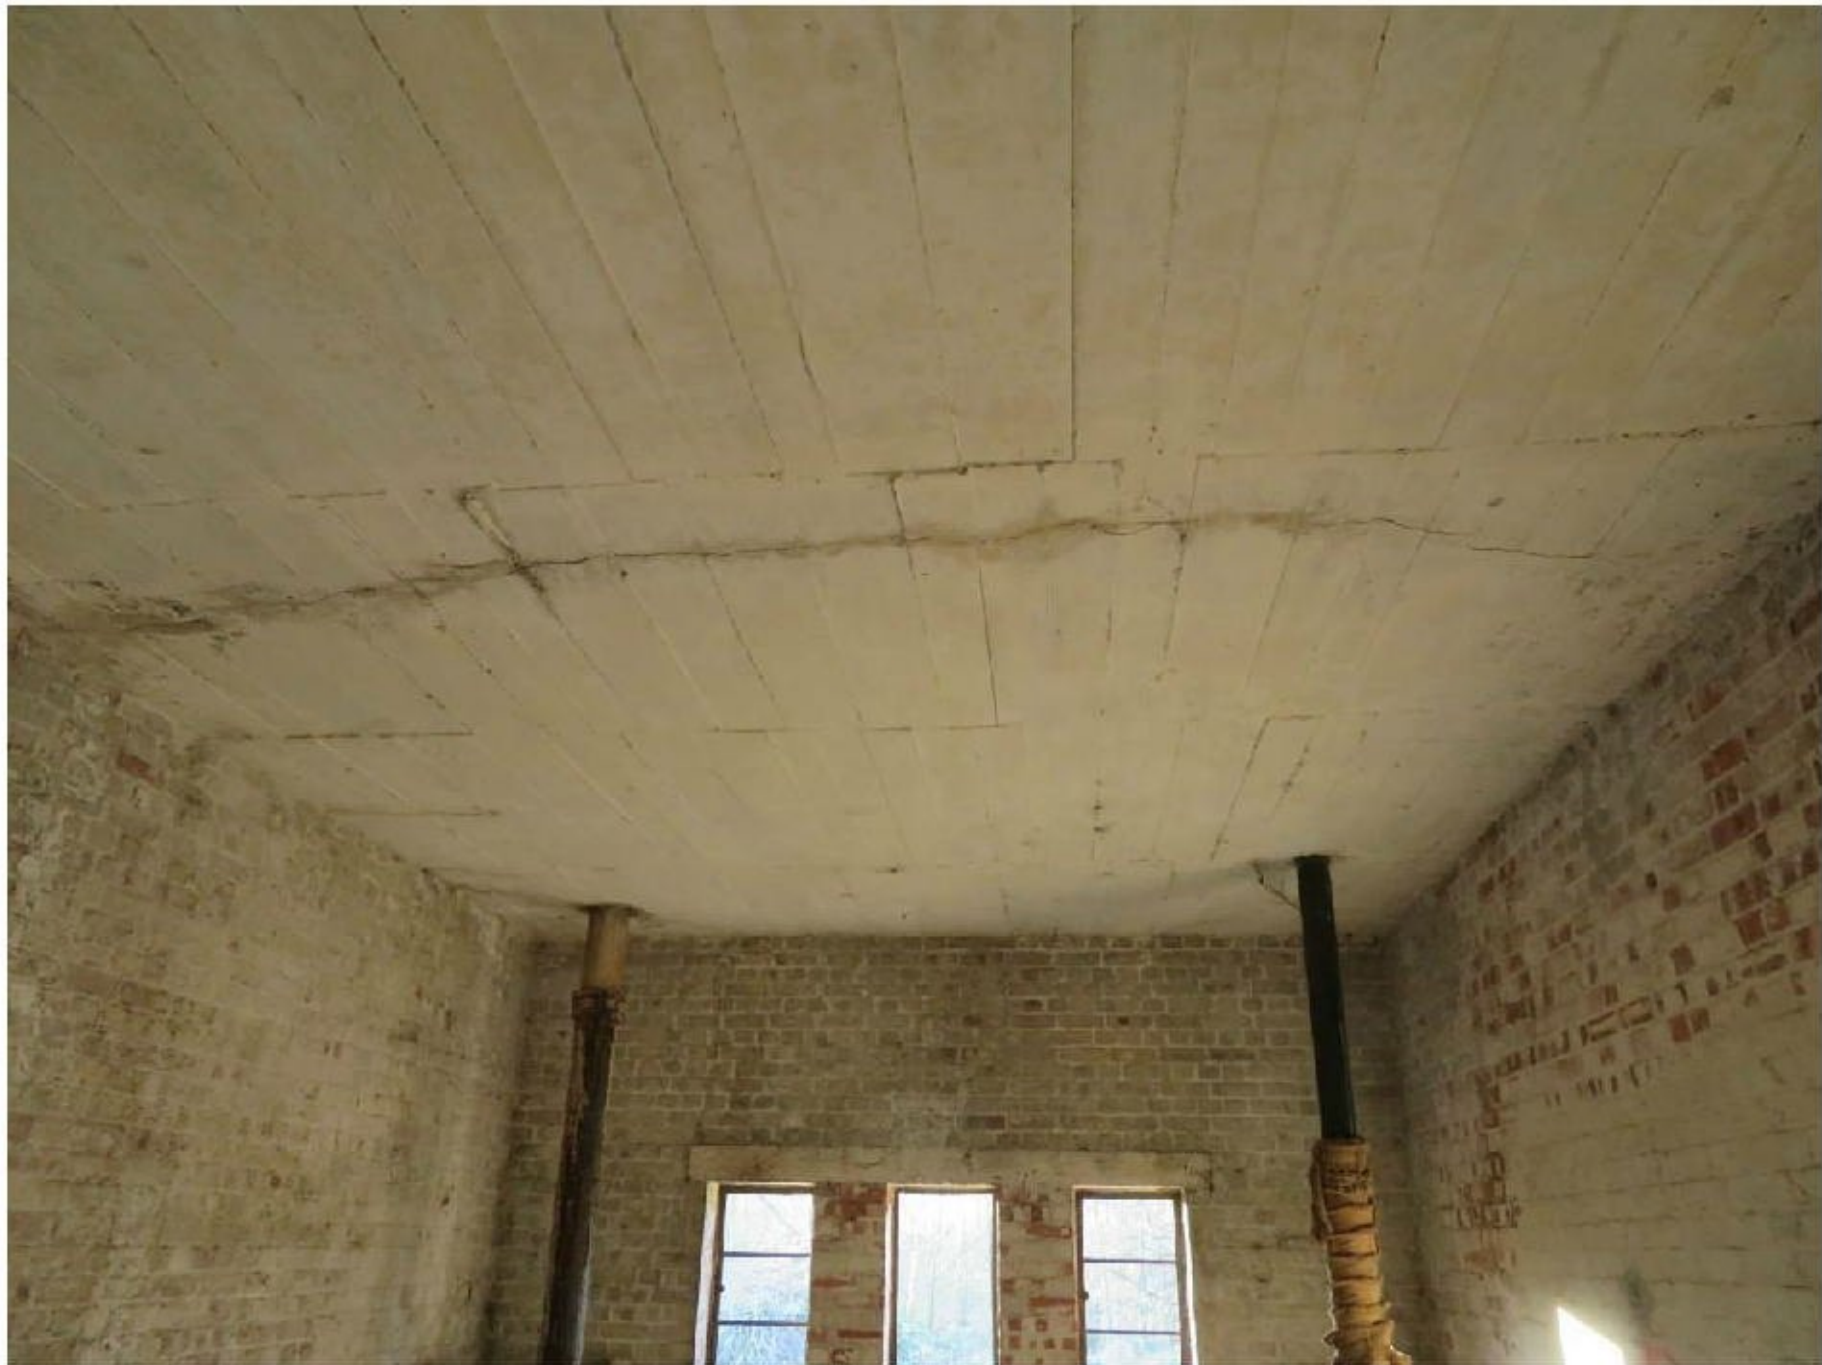
Both the first and second floor are of reinforced concrete construction with the timber form work lines seen clearly on the underside, and with a central crack running in both slabs, but again which is not of structural significance (see photograph 27).

Photograph 27: Internal concrete slab with central crack

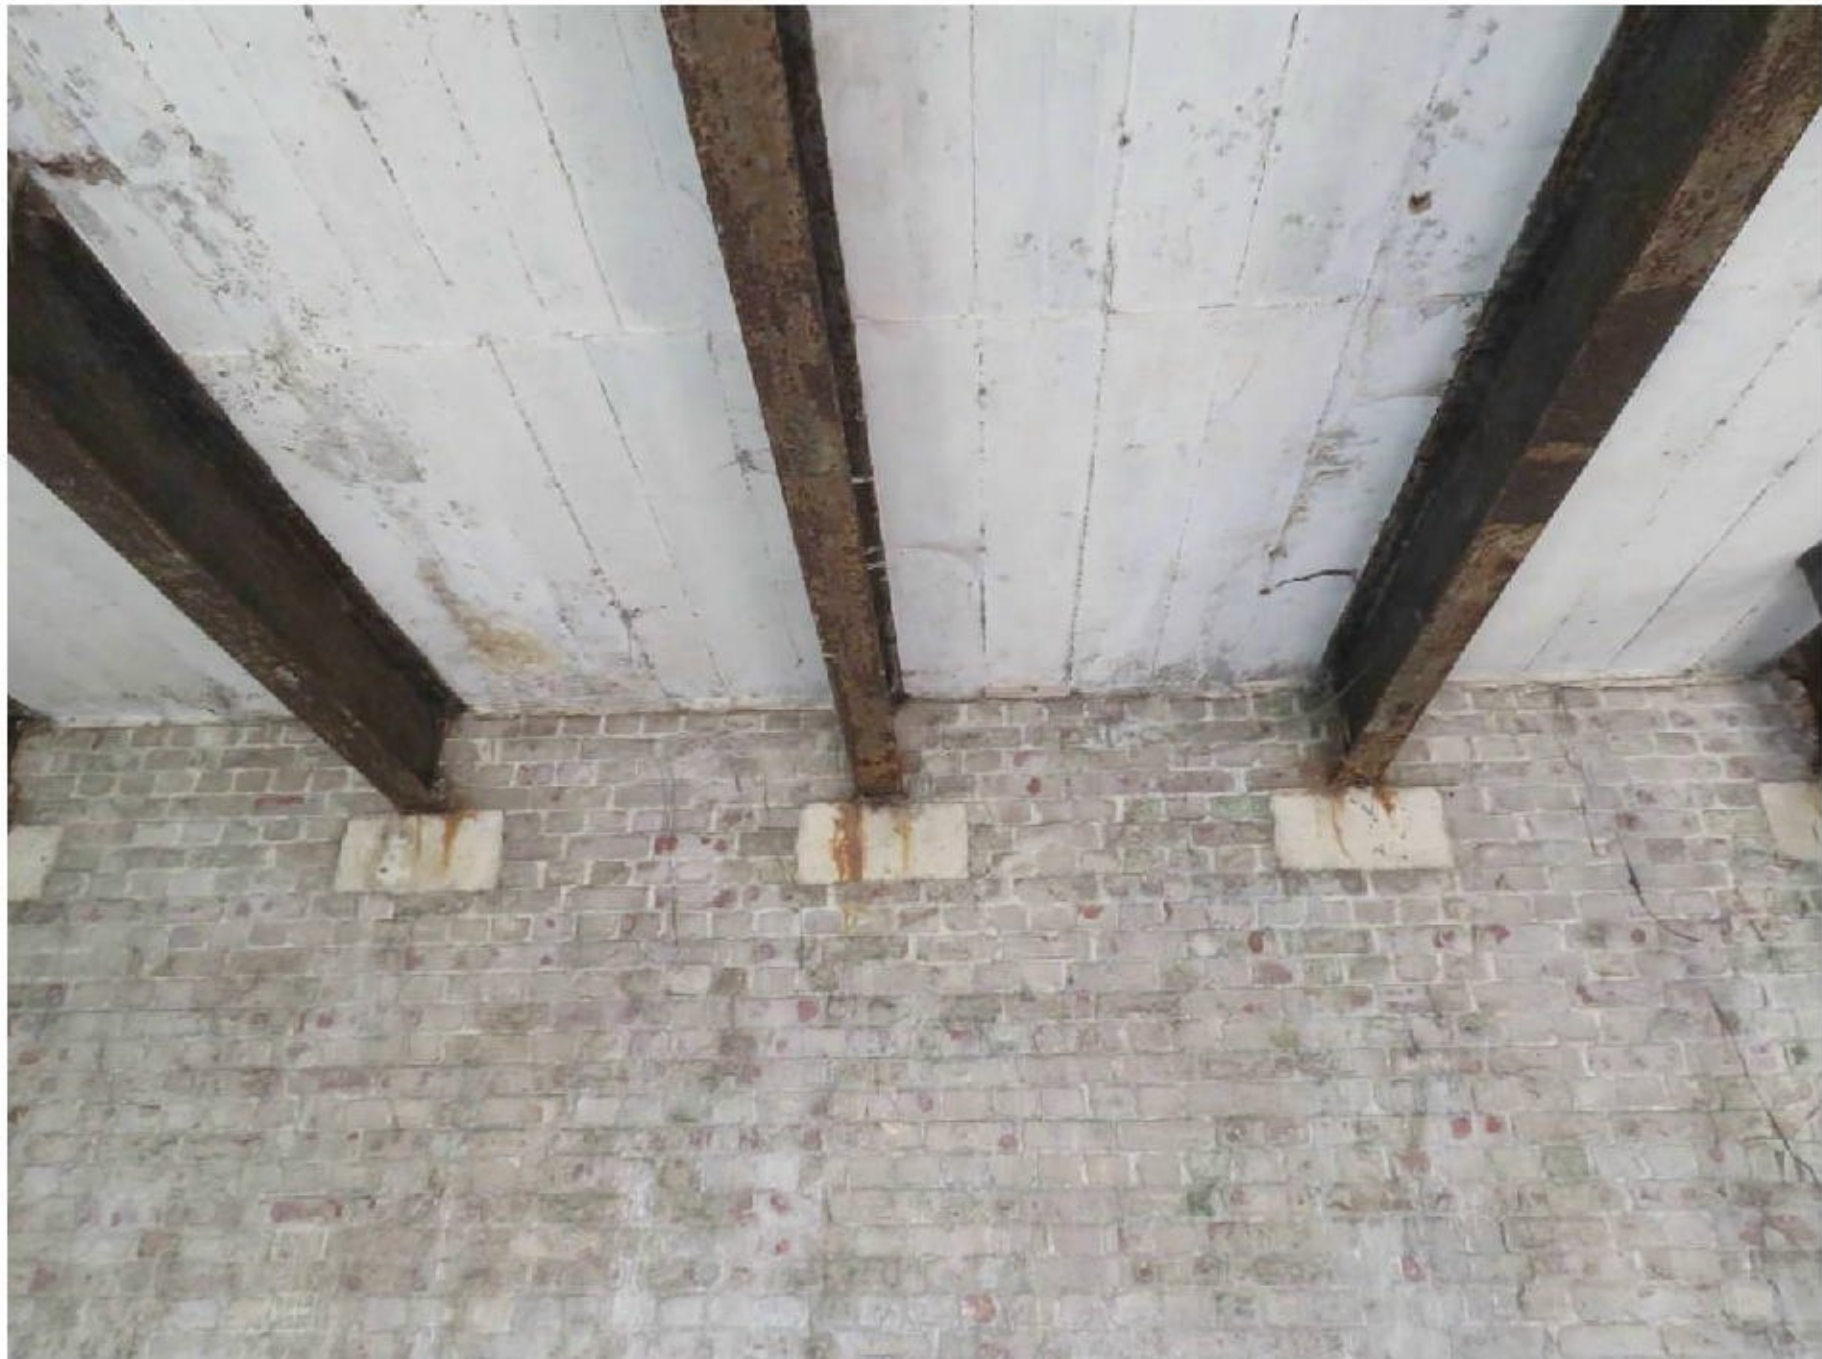
The tank level also has a reinforced concrete slab below which is also supported on five significant steel beams (see photograph 28). These are surface corroded but there does not seem to be any significant evidence of crack damage to the brickwork around the ends.

Photograph 28: Steel beams below water tank level with concrete floor over
