Accident

Aircraft Type and Registration:	EV-97 teamEurostar UK, G-IFLE	
No & Type of Engines:	1 Rotax 912-UL piston engine	
Year of Manufacture:	2004 (Serial no: 2113)	
Date & Time (UTC):	4 June 2023 at 1257 hrs	
Location:	Otherton Airfield, Staffordshire	
Type of Flight:	Private	
Persons on Board:	Crew – 1	Passengers – 1
Injuries:	Crew – 1 (Fatal)	Passengers – 1 (Fatal)
Nature of Damage:	Destroyed	
Commander's Licence:	National Private Pilot's Licence	
Commander's Age:	56 years	
Commander's Flying Experience:	134 hours (of which 134 were on type) Last 90 days – 3 hours Last 28 days – 2 hours	
Information Source:	AAIB Field Investigation

Synopsis

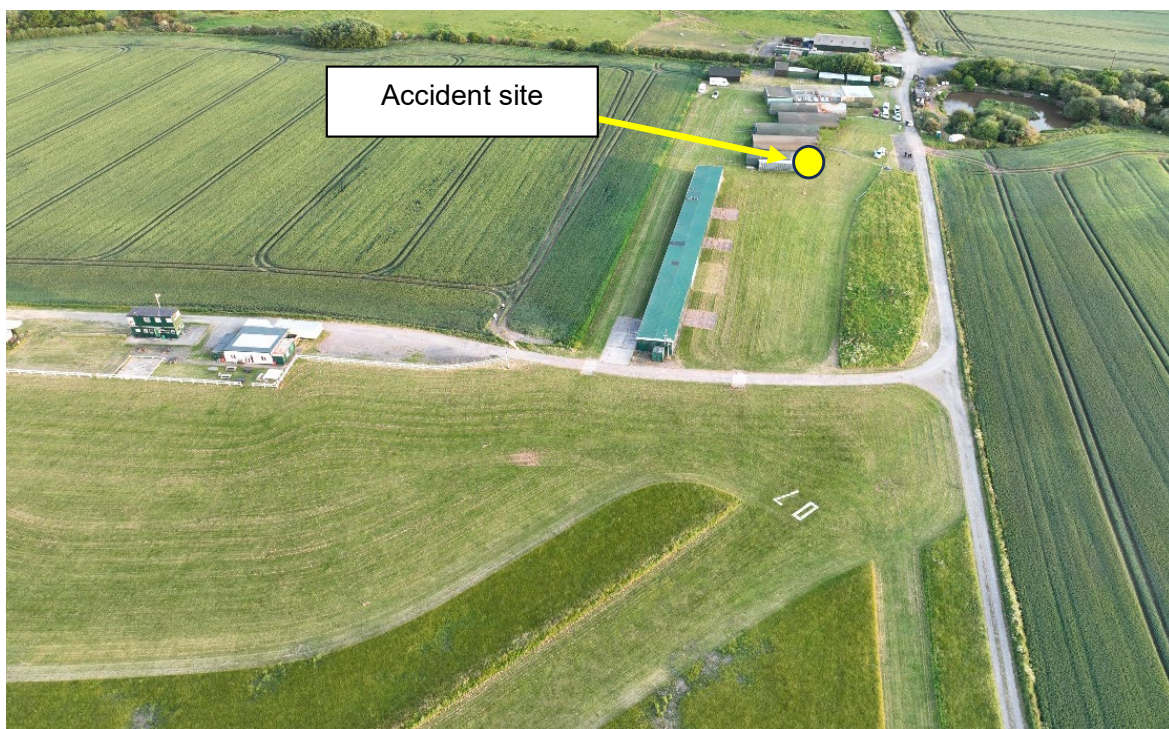
Figure 3

The accident site was approximately 140 m from the threshold of Runway 07 and adjacent to one of the hangars on the south side of the airfield (Figure 3).

Aerial view showing the location of the accident site relative to the Runway 07 threshold

The left-wing had struck the top of a metal shipping container and separated from the rest of the aircraft, which came to rest alongside. The fuel tank was split open and there had been a post-crash fire that consumed parts of the aircraft; no fuel remained in the tank.

Witness marks in the ground and damage on the wings indicated that the aircraft was in a steep nose-down attitude when the accident happened. From a review of the CCTV footage and examination of the wreckage the aircraft appeared to be intact when it struck the container.

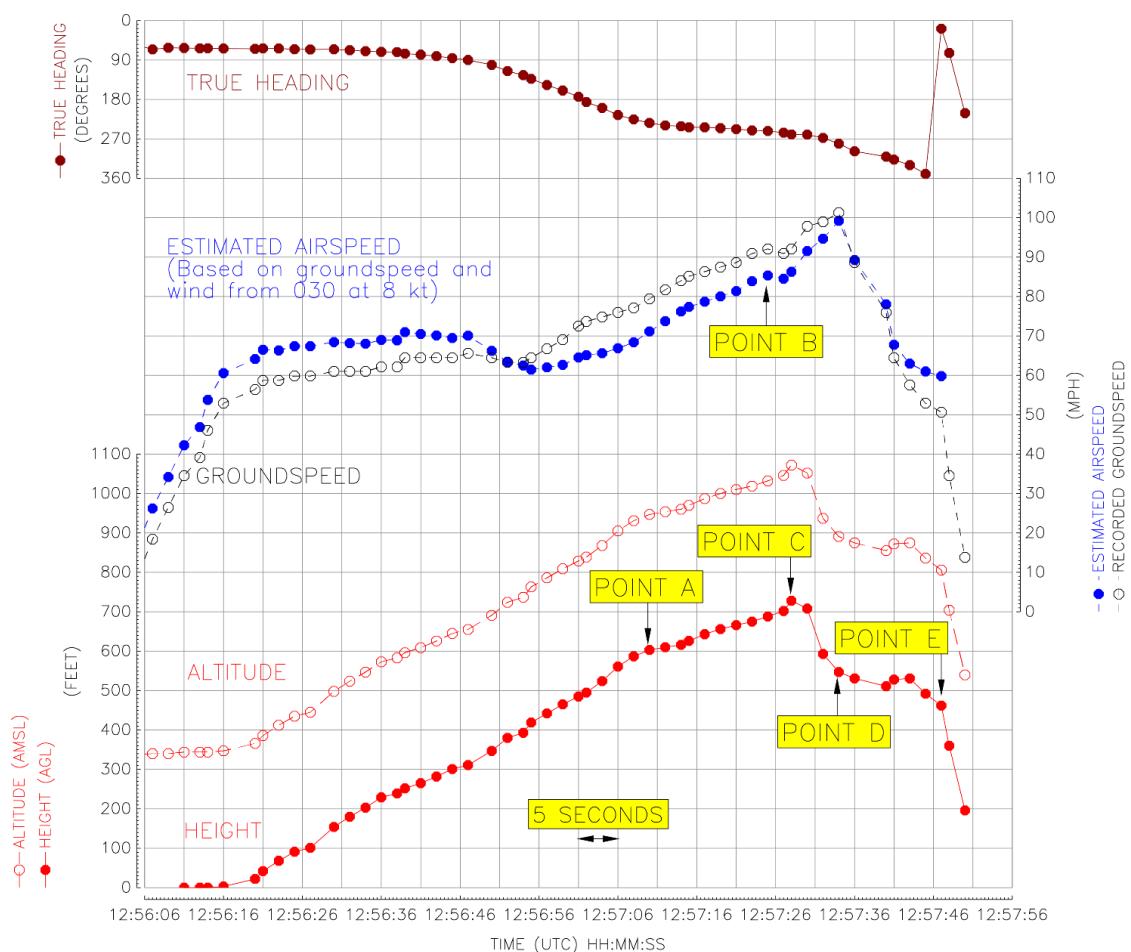
- As the aircraft climbed through 260 ft agl (600 ft amsl) it started a right turn onto a downwind heading and at 600 ft agl (940 ft amsl) the rate of turn was reduced with the aircraft rolling out onto a track of about 240° (Figure 5 and Figure 6 Point A).
- The climb rate then reduced to about 340 ft/min and the airspeed gradually increased to an estimated 85 mph (Figure 5 and Figure 6 Point B).
- At a height of about 740 ft agl (1,080 ft amsl) (Figure 5 and Figure 6 Point C) the aircraft started to descend and its airspeed increased to an estimated 100 mph; the aircraft was laterally positioned about 550 m from the threshold of Runway 07 at this time. As the aircraft descended it turned to the right,

- As the aircraft descended to about 550 ft agl (880 ft amsl) (Figure 5 and Figure 6 Point D) its rate of descent reduced from about 1,800 ft/min to an average of 360 ft/min. As the aircraft gradually descended its airspeed also reduced.
- After about 10 seconds the estimated airspeed of the aircraft had reached about 60 mph at which point the data indicates that the rate of turn had also increased quickly with the estimated bank reaching more than 45°.
- At a lateral distance of about 200 m from the threshold of Runway 07, the aircraft then entered a rapid descent from a height of about 480 ft agl (Figure 5 and Figure 6 Point E). The first CCTV image of the aircraft as it descended was captured shortly after.

Figure 5
Data plot of accident flight

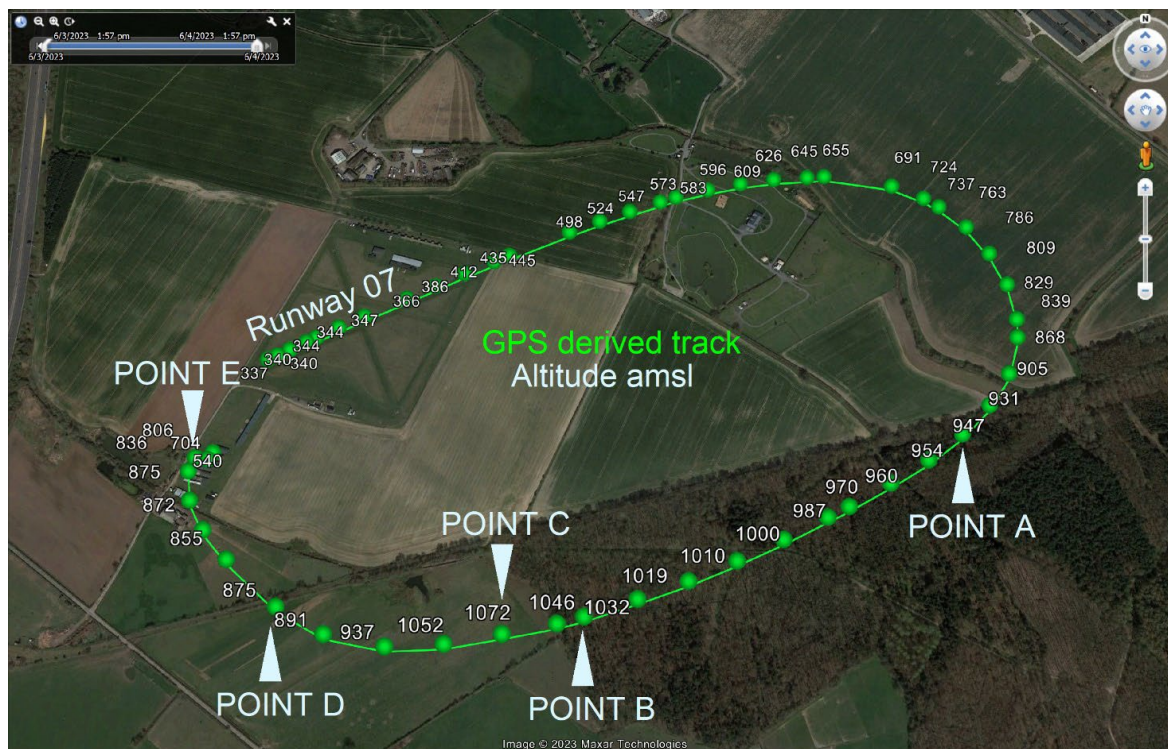
Figure 6

GPS derived track and altitude
(© 2023 Google, Image © Maxar Technologies)

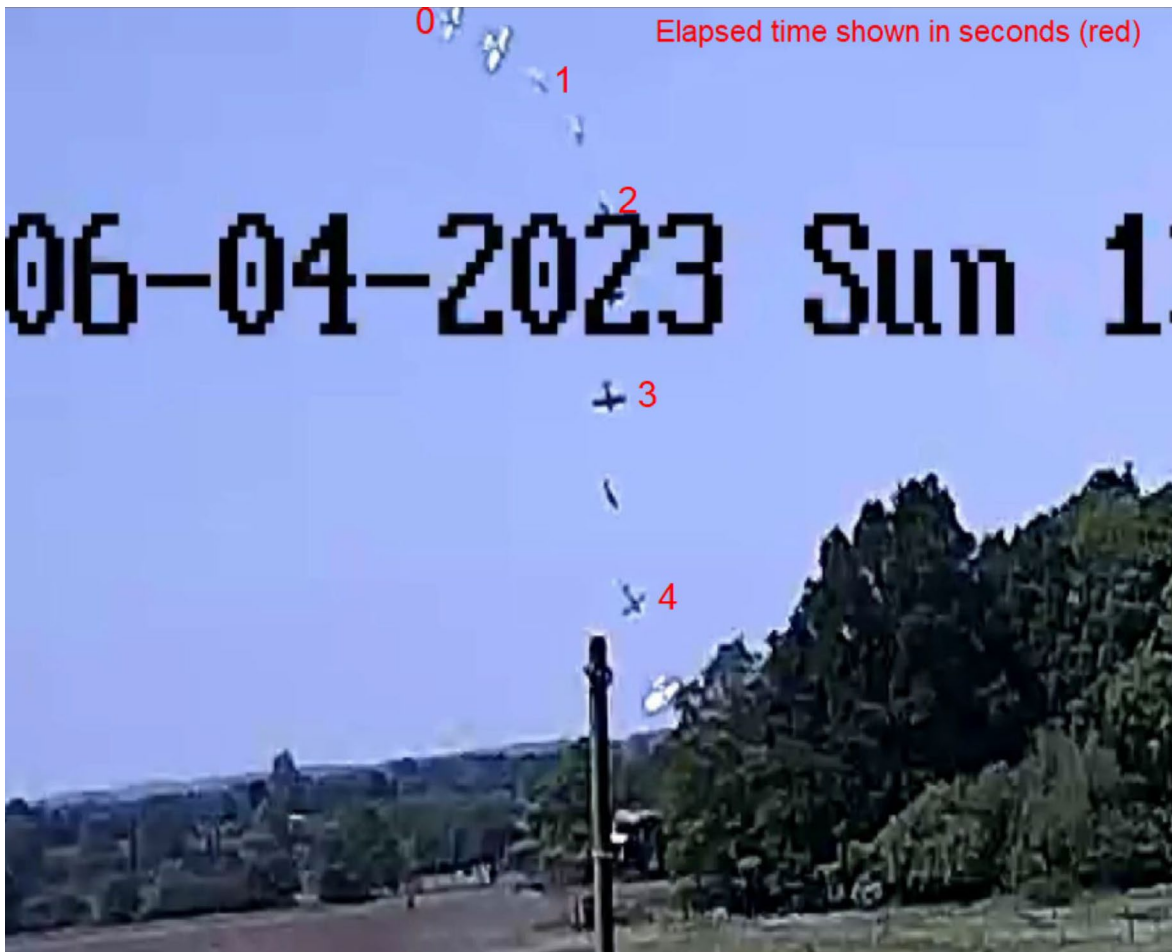
Figure 7

A composite image of the descent footage is provided in Figure 7; each image of the aircraft is 0.5 second apart.

At the beginning of the CCTV footage the aircraft's pitch attitude was at about 35° nose-down and the bank angle was about 80° right wing down. The aircraft turned to the right as it descended, and its nose-down attitude increased to about 70°. The average descent rate was about 5,000 fpm (57 mph) with one complete rotation of the aircraft taking about 4.5 seconds. The aircraft remained in a steep nose-down attitude until it struck the ground, which was captured by CCTV at the airfield.

The time from the aircraft departing from controlled flight to crashing was approximately six seconds during which it made around 1.5 rotations. There was no evidence of the aircraft starting to recover from the spin.

Composite CCTV image of the descent
