**Serious Incident**

| <b>Aircraft Type and Registration:</b> | ATR 72-212A 600, EI-GPN | |
| <b>Location:</b> | Belfast City Airport | |

**Synopsis**

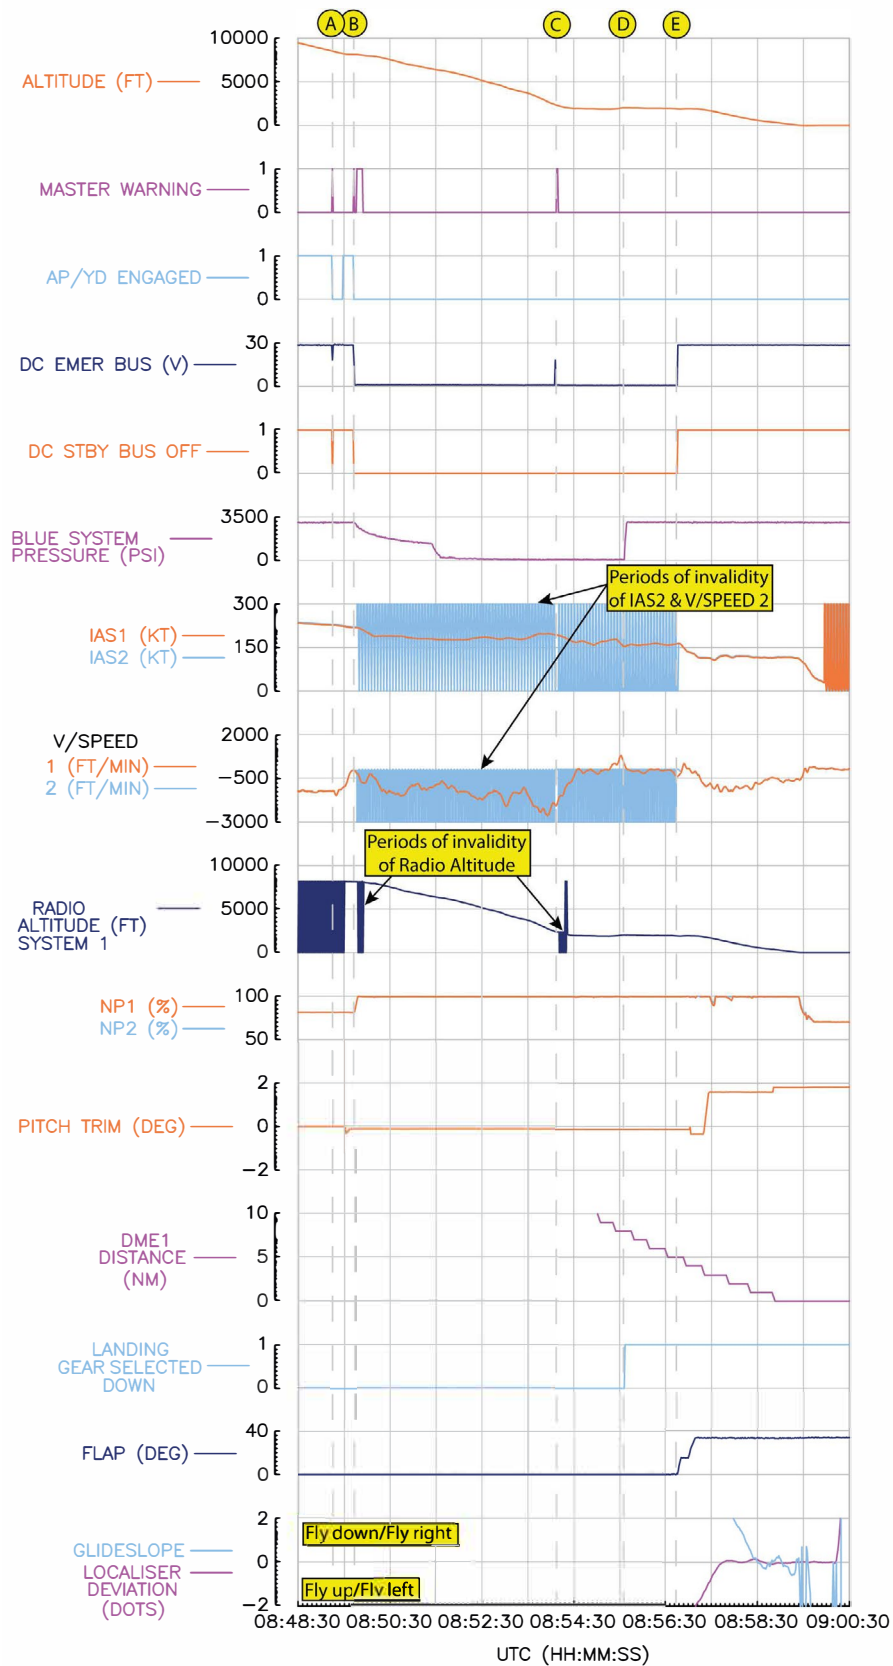
Figure 6

Twenty-eight seconds later, at 0849:43Z, a further master warning was generated as the AP and YD disengaged again (point B), and the DC EMER BUS and DC STBY BUS dropped off-line. Simultaneously, the propeller speed for both engines increased towards 100%<sup>12</sup>, as the propellers' governors were affected by the reconfiguration of the aircraft's electrical network caused by the loss of the buses. The radio altimeter signal also became invalid and the change in status of this signal triggered a master warning, associated with the landing gear not being selected down, as this alert relies upon the radio altimeter to sense proximity to the ground. However, unlike the previous occurrences, the DC EMER BUS and DC STBY BUS did not recover and both buses then remained unpowered for the next four and half minutes.

Flight data for the incident flight from just prior to the loss of AP and YD, until after landing.

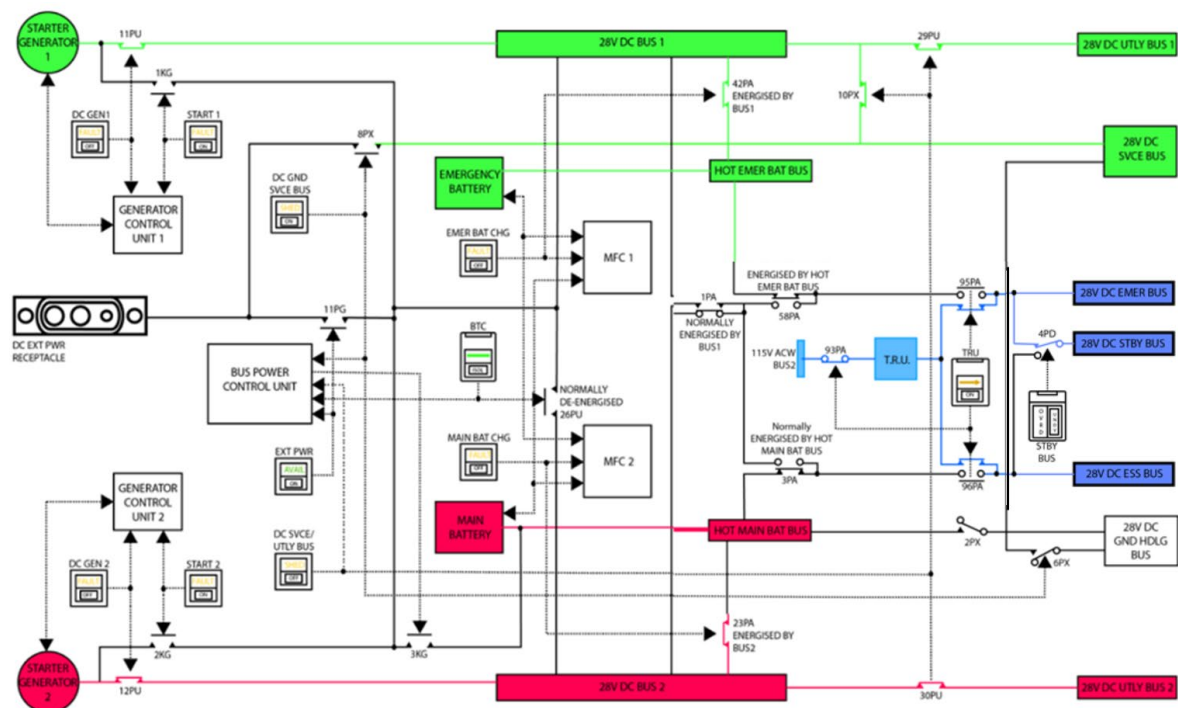
**Figure 8**

As a result of two previously reported temporary losses of the cockpit display units and IESI, an EASA Emergency Airworthiness Directive E-AD 2021-0120-E was released. It identified that the probable cause was likely to be the failure of battery master toggle switch, known as functional ident number (FIN) 7PA, or a failure of contactor FIN 1PA. To mitigate the risk of the ATR 42-500 post MOD 05948 ("600 version") and ATR 72-212A post MOD 05948 ("600 version"), ATR required physical testing and examination of these components and replacement if necessary. In addition, to reduce the risk further, all flights were to be carried out with the TRU selected ON from initial start-up of the aircraft to shut down on completion of the flight. The QRH was amended accordingly. This applied to EI-GPN which was being flown within the requirements of this AD. In this configuration the DC generators supply the main BUS 1 & 2 and the TRU supplies the DC EMER, ESS and STBY BUS. Figure 8 shows the DC system with the TRU in operation.

DC power supply configuration during the flight.

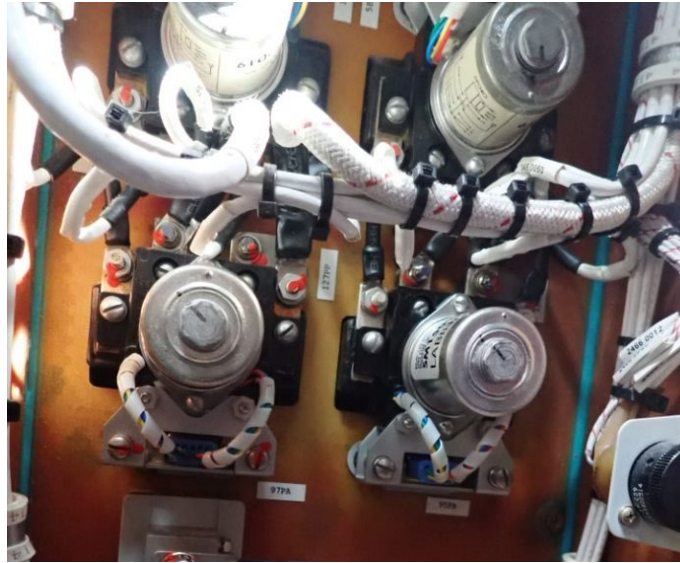
**Figure 9**

The 95PA contactor as fitted to EI-GPN

the TRU was selected OFF, the systems returned to normal. With the aid of the aircraft circuit diagrams and the assistance of the operator's line engineer, a malfunction of the 95PA contactor was identified as the most likely cause. System functional checks carried out on the aircraft confirmed this was the case. The 95PA contactor was replaced and further testing of the systems and operation of the TRU corroborated this. The aircraft was released back to the operator and placed back into service; there has been no recurrence of the malfunction.

The contactor was disassembled and it was found that the contact surfaces on the contact plate and on the A1/A2 contacts showed evidence of arcing and poor connection. Further examination found that the pin had slipped 0.0196 inches out of the plunger hole. A pull-out test was also carried out and the pin moved with a force of 18 lbs. The minimum pull-out force should have been 80-100 lbs.

The electrical system failures during the approach to Belfast City Airport was caused by a malfunction within the SM150D19 contactor designated as the 95PA contactor. Within the circuit, it supplies 28 V DC output from the TRU to the STBY and EMER BUS bars. On this occasion, whilst 95PA was in the energised condition continuity was lost between the A1 and A2 terminal contacts. This was caused by the pin carrying the contact plate slipping out of its correct position as a result of its movement within the plunger.

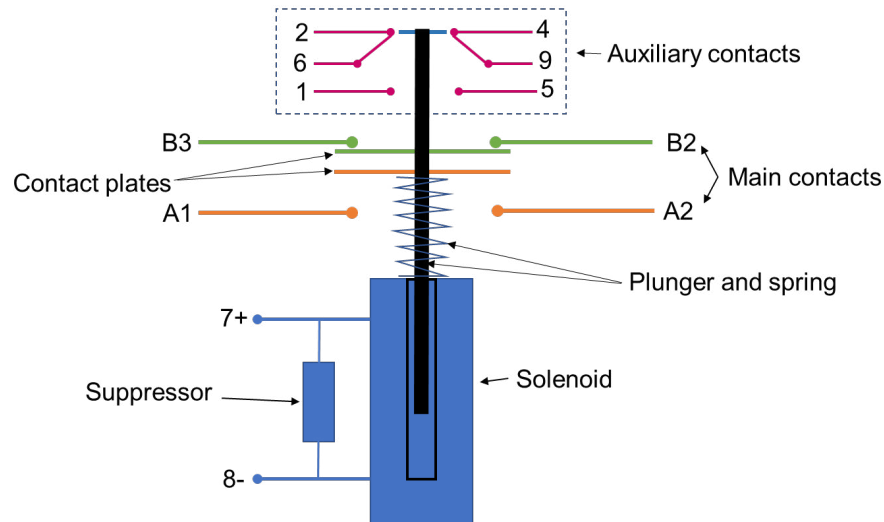
**Figure 10**

A schematic of the SM150D19 contactor is shown in Figure 10. In the dormant or deenergised condition, a small spring holds the plunger carrying the contact plate (shown in green) against main contacts B3 and B2. The auxiliary contacts operate simultaneously with the main contact plates as the contactor is energised and de-energised. They direct voltage to illuminate status indication graphics within the electrical system cockpit control switches.

Contactor schematic diagram (shown de-energised)

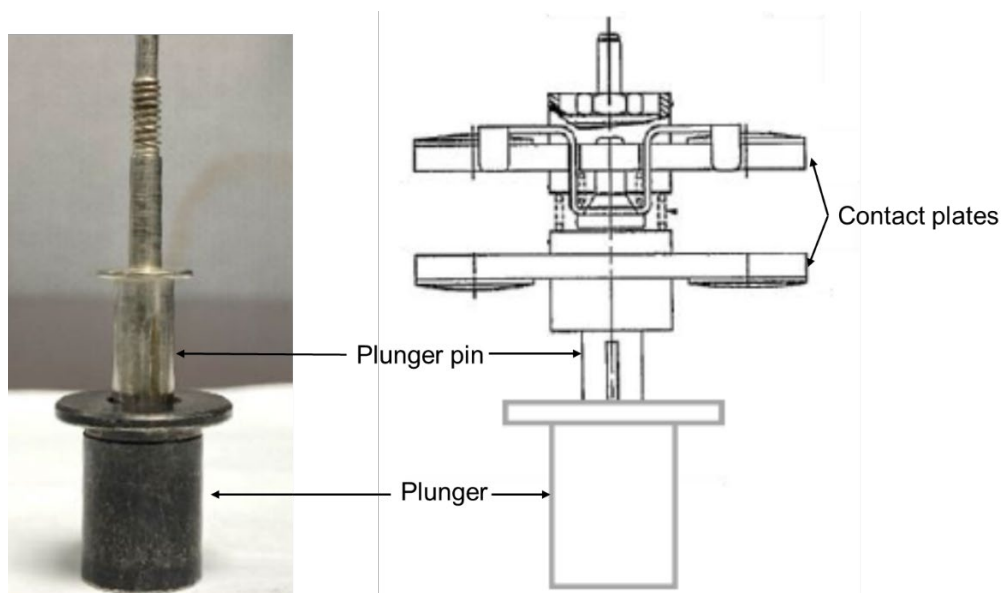
**Figure 11**

The plunger assembly consist of two parts; the plunger and plunger pin. The plunger pin is held in a hole drilled in the plunger by a form of interference<sup>18</sup> fit. (Figure 11). During manufacture the minimum force required to insert the pin into the hole is 70 lbs. When correctly assembled, the force required to withdraw the pin, known as the pull-out force, is 80-100 lbs.

Plunger and pin assembly

The failure of this 95PA contactor fitted in EI-GPN was caused by a slippage between the plunger and pin assembly operating under increased cycles. The slippage resulted in poor connection, localised arcing and subsequent loss of continuity across its A1 and A2 terminals. A definitive cause of the pin and plunger slippage with the 95PA contactor fitted to EI-GPN and several other contactors manufactured during 2015, could not be fully determined.

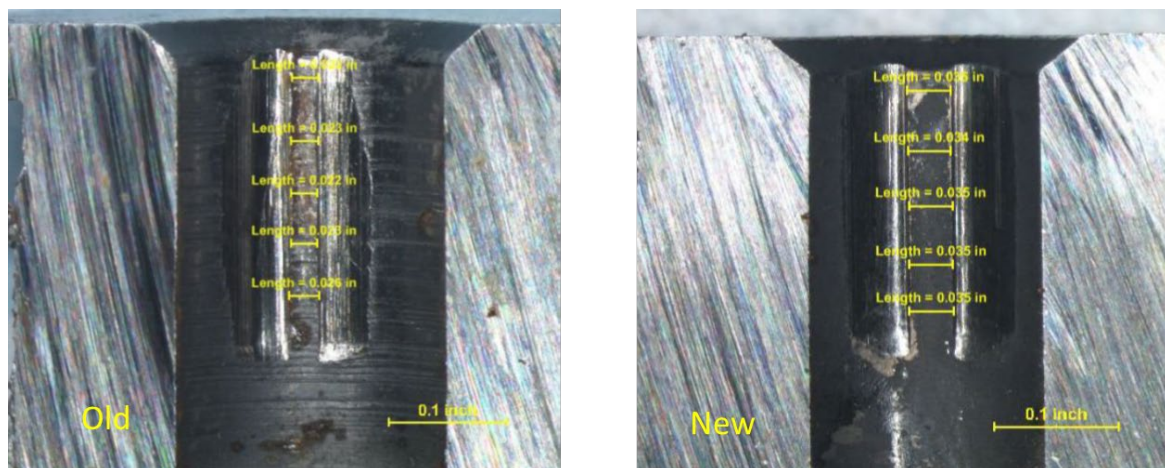
**Figure 12**

Example plungers taken from older and newer assemblies were sectioned and measured. This found the dimensions of some of the older pin groove indentation marks left in the bore of the plunger were less than those marks in newer plungers. Figure 12 shows the difference in the dimension with a mean of 0.0245 inches in the older plunger and a mean 0.0319 inches in the newer plunger.

Plunger bore dimensions of the grooves left by the pin
