Runaway of an engineering train at London Liverpool Street station, 2 October 2022

Summary of the incident

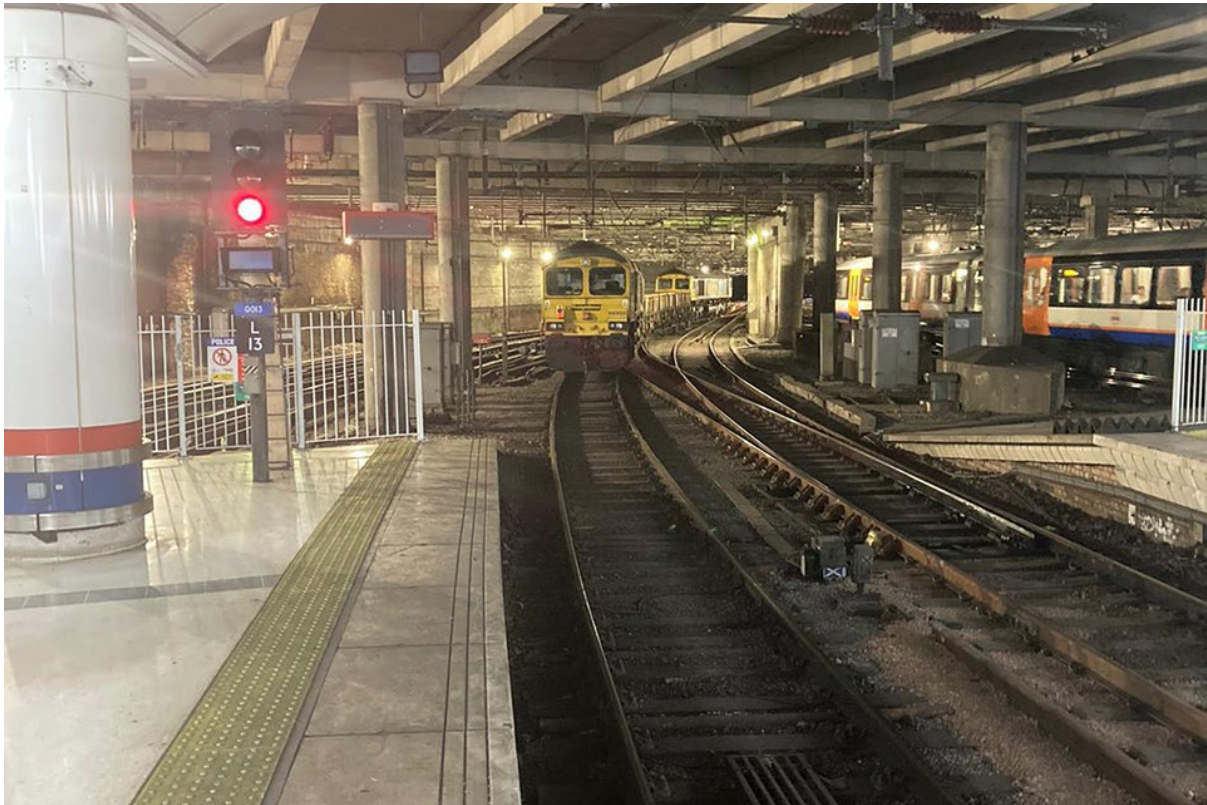
At about 11:52 hrs on 2 October 2022, an unattended engineering train ran away from platform 3 at London Liverpool Street station. The signaller was alerted to the train's movement by track sections in the throat of the station unexpectedly showing occupied on the signaller's display. The incident happened within a part of the station that was, at the time, under possession for engineering work. The unattended train travelled about 150 metres, before coming to a stop within the limits of the possession. No one was injured, although the train damaged a set of points.

The engineering train post-incident, stopped in the throat of the station (courtesy of Network Rail).

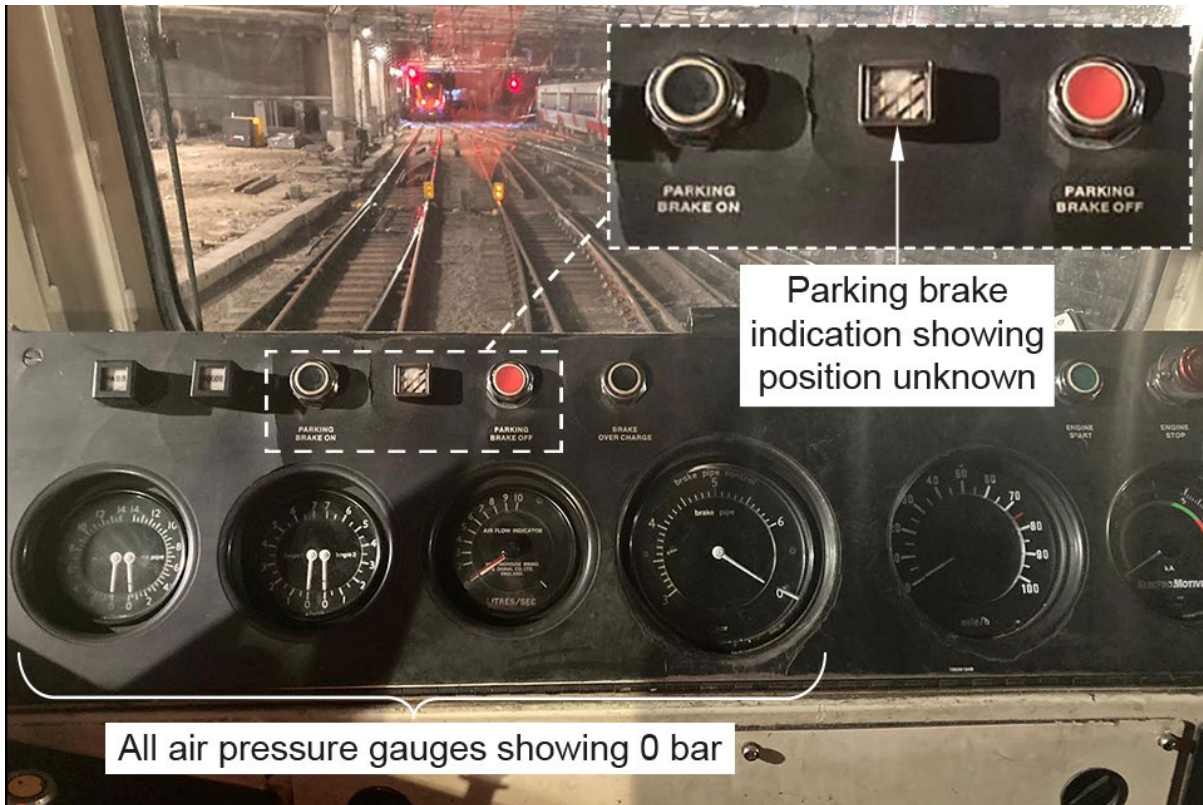
The parking brake indicator in the cabs of both locomotives showed an 'unknown' indication. However, the parking brake indicator is controlled by an onboard computer, and about 30 minutes after the batteries have been isolated, the indicator reverts to showing the 'unknown' indication, irrespective of the actual state of the parking brake.

The parking brake indicator and pressure gauges on locomotive 66953 (courtesy of Network Rail).

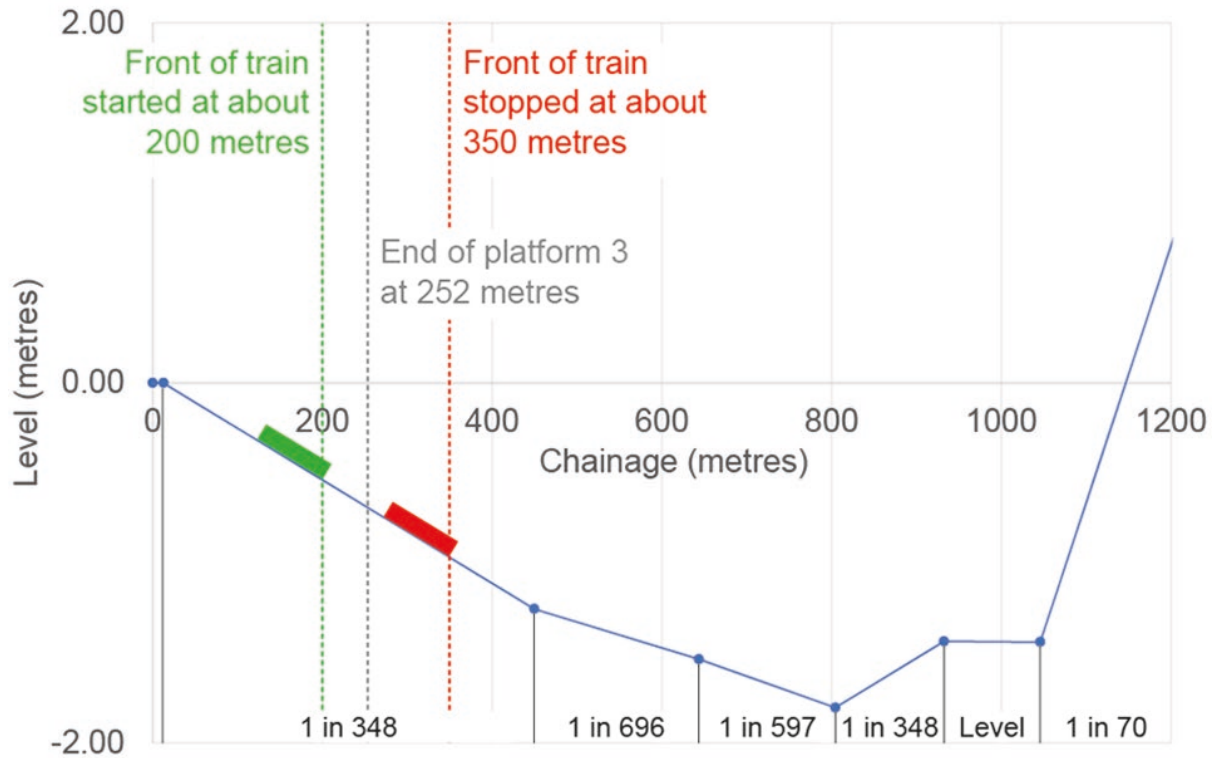
Network Rail data sources state that there is an average falling gradient of 1 in 348 (0.29%) from the position where the train was left in platform 3 to where it stopped. RAIB calculated that the train would not move on this gradient with more than 9.5 kilonewtons (kN) of brake force available, suggesting that less than this amount was available on 2 October. With just under 9.5 kN of brake force available, RAIB calculated that, on plain line track, the train would roll away very slowly and stop about 450 metres from the station, soon after the gradient changed to a shallower falling gradient.

Track gradients in the area.

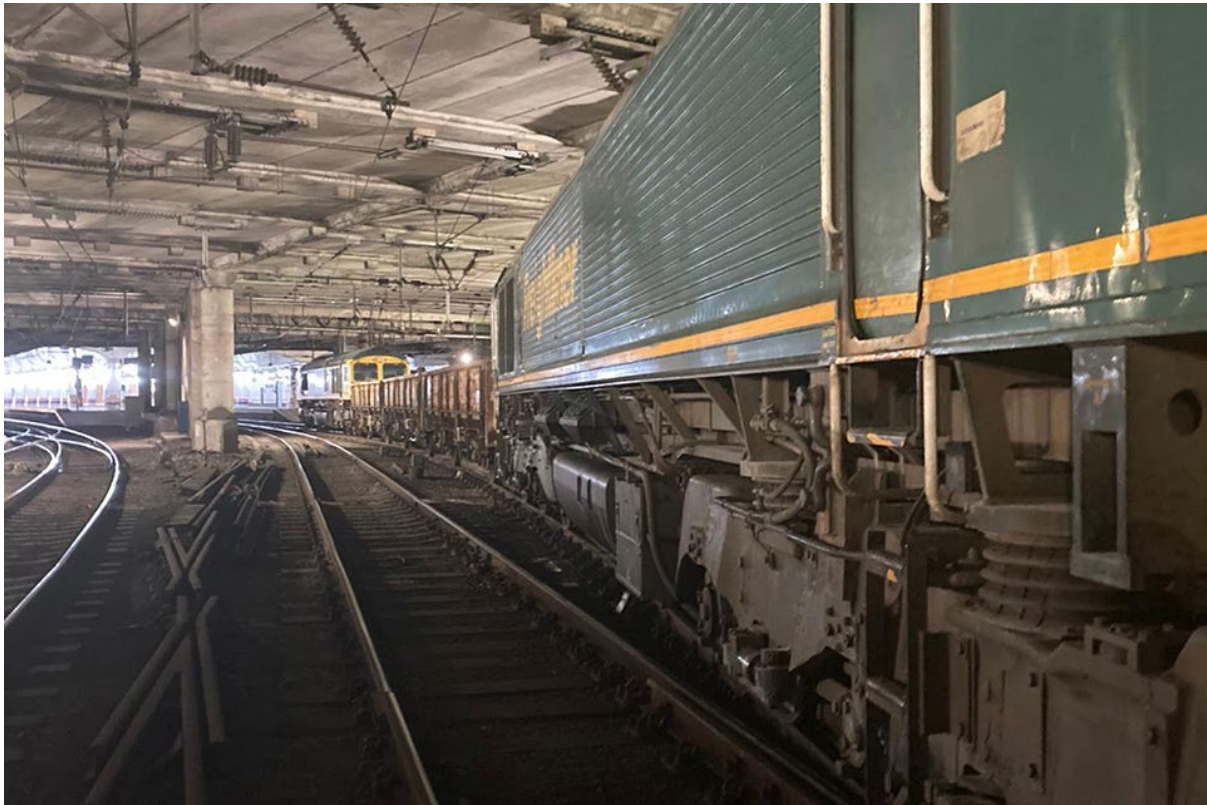
However, the train only travelled about 150 metres when it ran away, with locomotive 66953 stopping on the set of points that it damaged. These points were in the opposite position for the train’s movement, so the train ran through them in the trailing direction. It is likely that, when the leading wheels of locomotive 66953 forced their way through the closed switch rail at the points, this additional resistance caused the train to slow to a stop, meaning it did not run away for the full distance calculated. This stopped the train from exiting the area under possession and entering open lines where trains were running.

The position of the train on the set of trailing points as found afterwards (image looking back towards the station platform courtesy of Network Rail).
