## Serious Incident

<b>Aircraft Type and Registration:</b>	ATR 72-212A-600, EI-HDK	
<b>No &amp; Type of Engines:</b>	2 Pratt & Whitney Canada PW127M turboprop engines	
<b>Year of Manufacture:</b>	2016 (Serial no: 1334)	
<b>Date &amp; Time (UTC):</b>	14 August 2023 at 1327 hrs	
<b>Location:</b>	Liverpool Airport	
<b>Type of Flight:</b>	Commercial Air Transport (Passenger)	
<b>Persons on Board:</b>	Crew – 5	Passengers – 66
<b>Injuries:</b>	Crew – None	Passengers – None
<b>Nature of Damage:</b>	Main landing gear changed due to hard landing	
<b>Commander's Licence:</b>	Airline Transport Pilot's Licence	
<b>Commander's Age:</b>	43 years	
<b>Commander's Flying Experience:</b>	3,160 hours (of which 2,927 were on type) Last 90 days – 82 hours Last 28 days – 28 hours	
<b>Information Source:</b>	Aircraft Accident Report Form submitted by the commander and further enquiries by the AAIB

## Synopsis

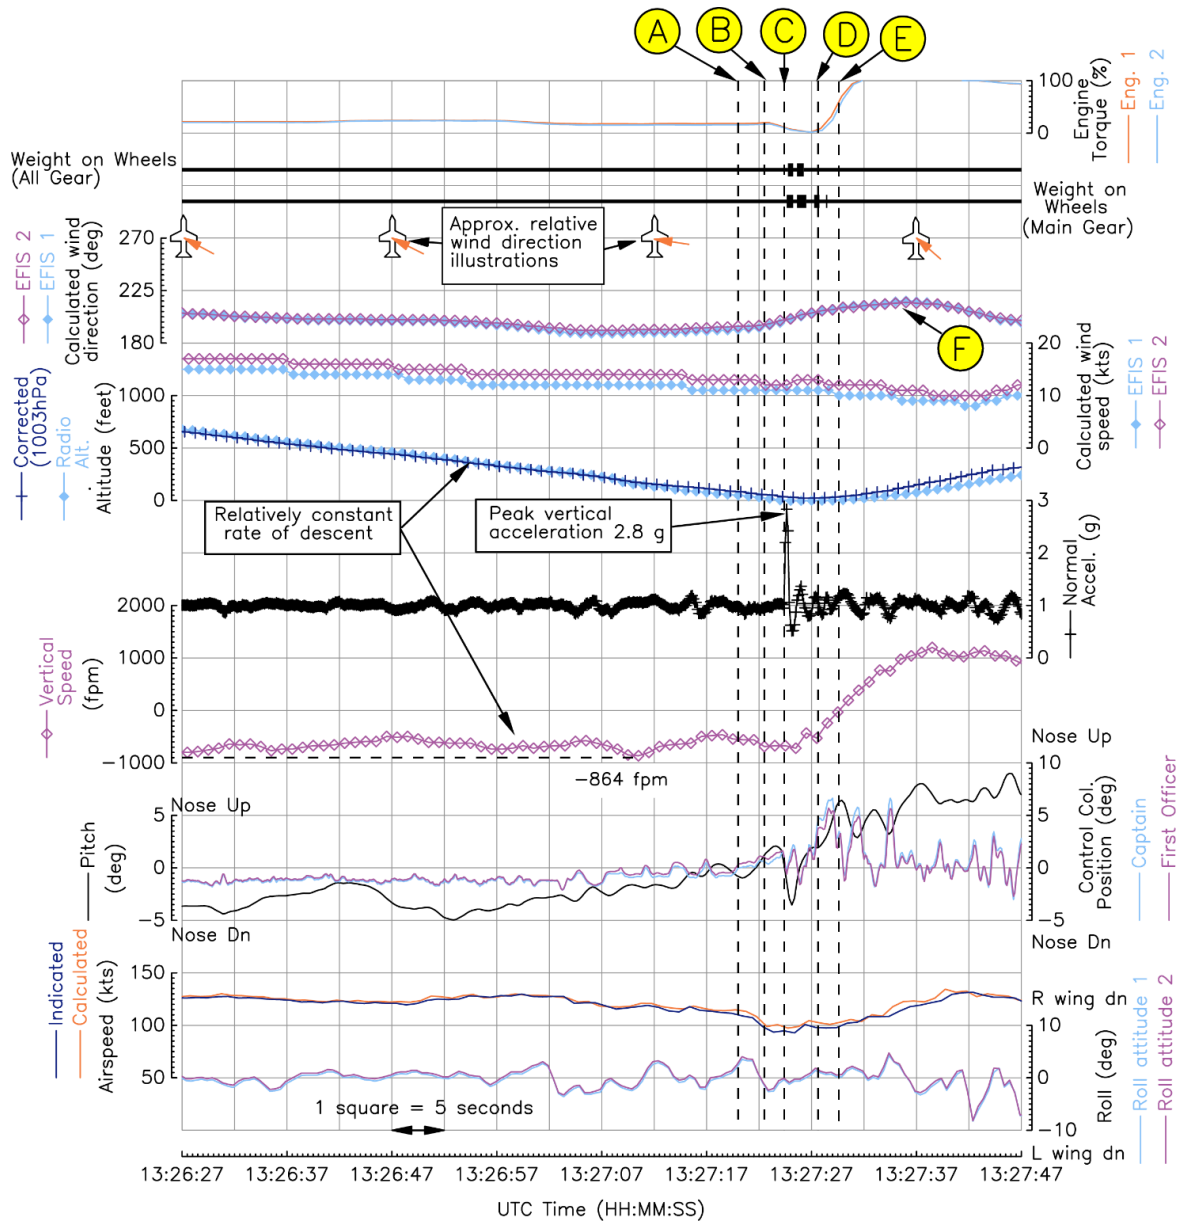
**Figure 1**  
Pertinent parameters recorded by the FDR.

Figure 1 shows pertinent FDR parameters recorded from 1,000 ft agl until the go-around after the hard landing.

It indicates that EI-HDK was in a stable descent with no significant airspeed or engine torque changes until the aircraft descended through 50 ft agl at point A. FDR parameters recorded a small and gradually increasing pitch-up input on the control column from this point. The flare was initiated at point B, where the aircraft reached 30 ft agl at an airspeed of 109 kt.

The FDR recorded vertical acceleration data eight times per second. It recorded a vertical acceleration of 2.8 g when the aircraft touched down (point C). The recordings indicate that the vertical speed was around -670 fpm and the airspeed reduced to 95 kt at this point. Increasing engine torque and pitch attitude are shown at point D, consistent with the commander's call to go-around recorded on the CVR. Point E, approximately 5 seconds after the hard landing, shows a positive vertical speed as the aircraft climbed away from the runway.

The recordings indicate that the aircraft was flying with a crosswind from the right, which changed direction between points B and F to give an increasing tailwind component. After point F, the recordings indicate that the wind returned to a crosswind from the aircraft's right. There was no significant change in the aircraft's heading during this time.

The recorded windspeed and direction suggests that the tailwind component increased at the time of the hard landing. The gradual variation around point F in Figure 1 is typical of instantaneous wind direction changes, appearing as a “smooth curve” in the recording due to the wind calculation algorithm. The start of the change coincides with a reduction in airspeed after point A in Figure 1, suggesting that the airspeed reduction as EI-HDK crossed the runway threshold may have been due to an increased tailwind.
