Accident

Aircraft Type and Registration:	Piper PA-28-181, G-CCAV
No & Type of Engines:	1 Lycoming O-360-A4M piston engine
Year of Manufacture:	1980 (Serial no: 28-8090353)
Date & Time (UTC):	3 May 2023 at 1120 hrs
Location:	London Biggin Hill Airport
Type of Flight:	Private
Persons on Board:	Crew – 1 Passengers – 1
Injuries:	Crew – None Passengers – None
Nature of Damage:	Damage to nose landing gear and propeller
Commander's Licence:	Private Pilot's Licence
Commander's Age:	54 years
Commander's Flying Experience:	355 hours (of which 355 were on type) Last 90 days – 38 hours Last 28 days – 16 hours
Information Source:	Aircraft Accident Report Form submitted by the pilot and further enquires by the AAIB.

Synopsis

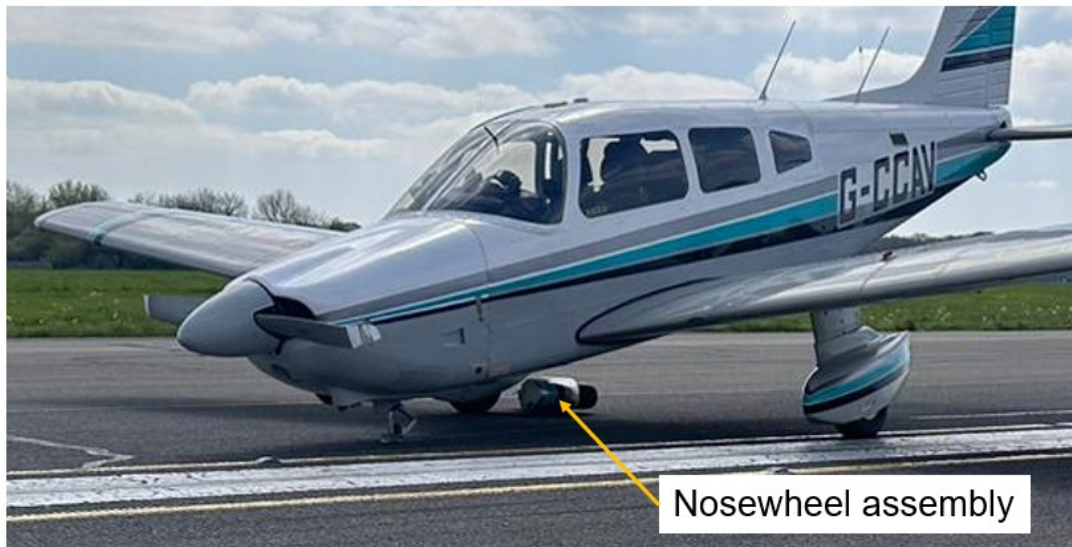
Figure 1

While taxiing, following a normal landing, part of the nose landing gear failed (Figure 1) and the propeller struck the runway surface, stopping the engine.

G-CCAV after nose landing gear failure

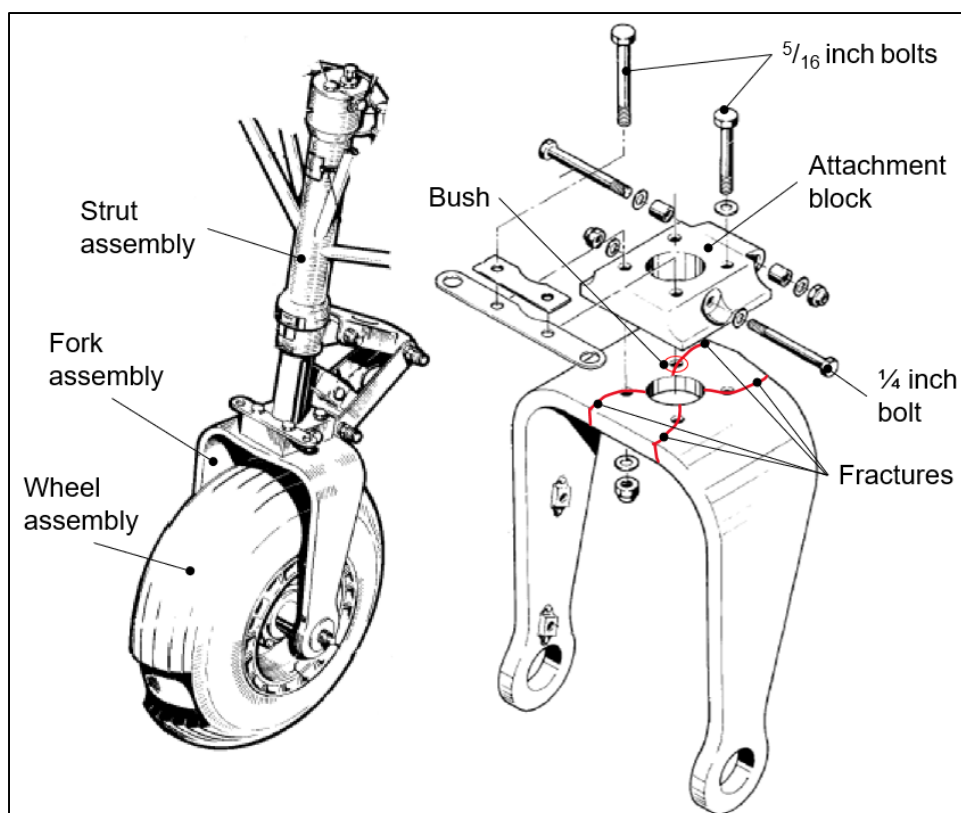
Figure 2

PA-28 Nose landing gear

The fork and strut assembly were inspected and it was determined that the fork assembly had fractured through all four of the attachment block bolt holes (Figure 2). Two pieces of the fork and all the bolts remained attached to the strut assembly and showed evidence of heavy abrasion from the runway surface. There was wear and paint loss on the upper surface of the fork where it was in contact with the attachment block.

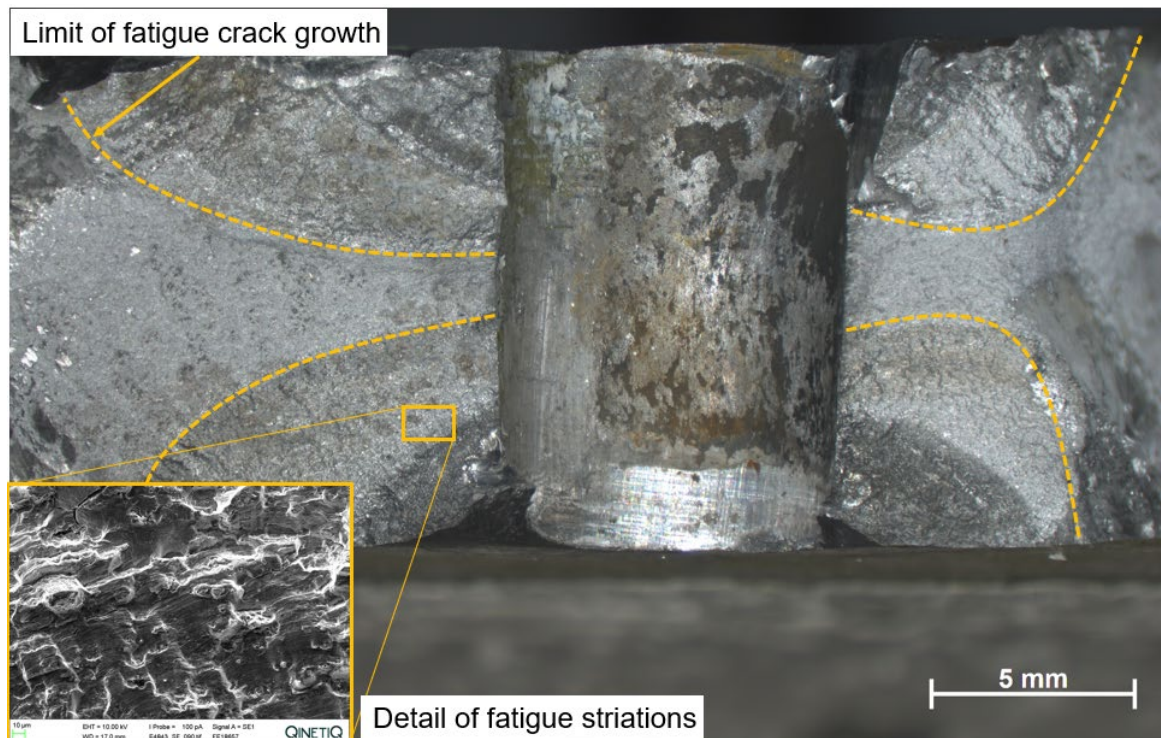
Figure 3

The four pieces of the fork were examined using a Scanning Electron Microscope. While most of the surface detail of the fracture faces had been damaged by corrosion, it was possible to observe fatigue striations characteristic of fatigue crack growth. Corrosion pits and additional cracks were observed (Figure 3) in all the bolt holes.

Detail of typical bolt hole showing limits of fatigue crack growth

The failure of the nose landing gear of G-CCAV was caused by fatigue cracks propagating simultaneously from the four attachment bolt holes in the aluminium wheel fork. It was not possible to identify the initiation points for the fatigue cracks due to the level of corrosion on the fracture faces, but there was sufficient evidence to suggest that they would all have started from corrosion damage. The justification for a steel bush could not be determined but it was suspected that it was fitted in 2009 following the heavy landing accident. The lack of protective coating on the bush is likely to have caused galvanic corrosion between the dissimilar metals and exfoliation corrosion of the fork. It was deemed unlikely that this bush would have been a factor in the initiation of fatigue cracks in the other holes.

The CAA intend to issue a Safety Notice to advise operators and maintenance organisations on the inspection of the fork assembly at the interface between the fork and attachment block as part of their routine maintenance programme. The visual inspection is to find corrosion or cracking in the fork and report any findings to the CAA.

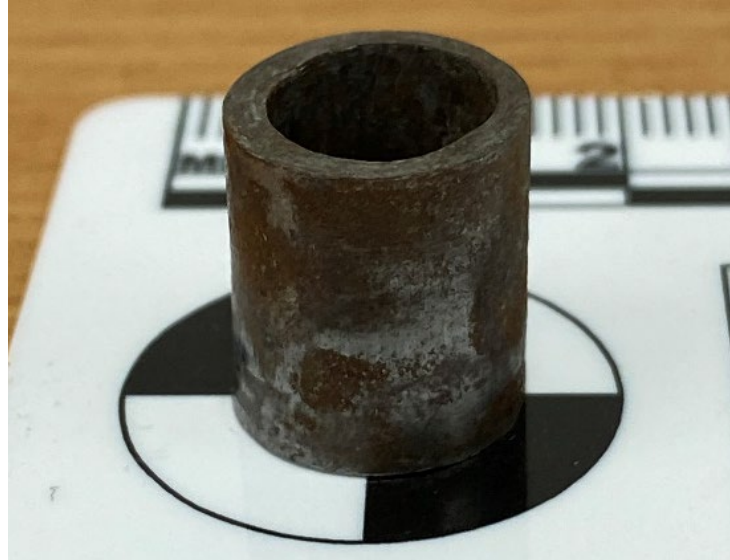
Figure 4
Steel bush

In the aft right hole, there was a steel bush which had corroded (Figure 4); there was no visible evidence of a corrosion protective coating on the bush.

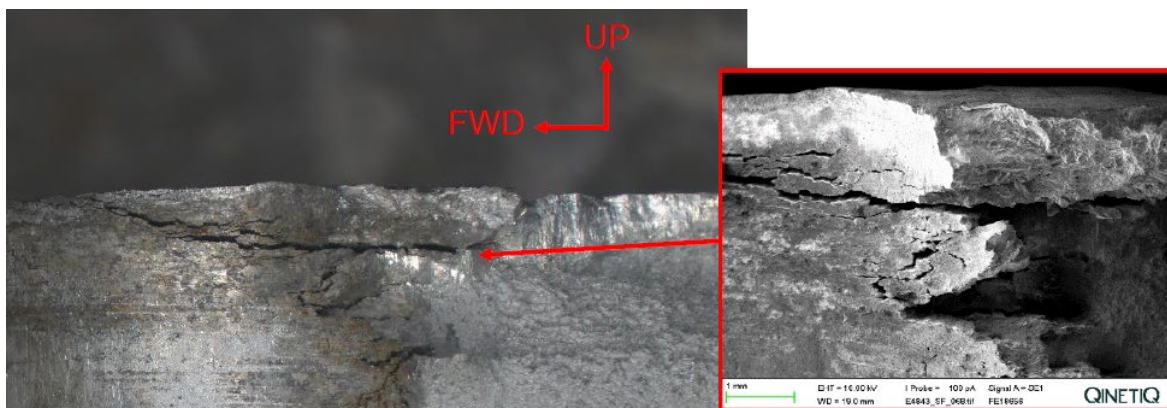
Figure 5
Detail view of right side, aft hole

The upper part of this hole exhibited a delaminated structure characteristic of exfoliation corrosion, and it is possible that galvanic corrosion between the aluminium fork and the steel bush may have caused the exfoliation corrosion (Figure 5). The investigation could not find any documentation regarding the installation of this bush.
