# ***AAIB Bulletin***

***3/2024***

| AW189 | G-MCGT | 26-Jul-21 | 3 |

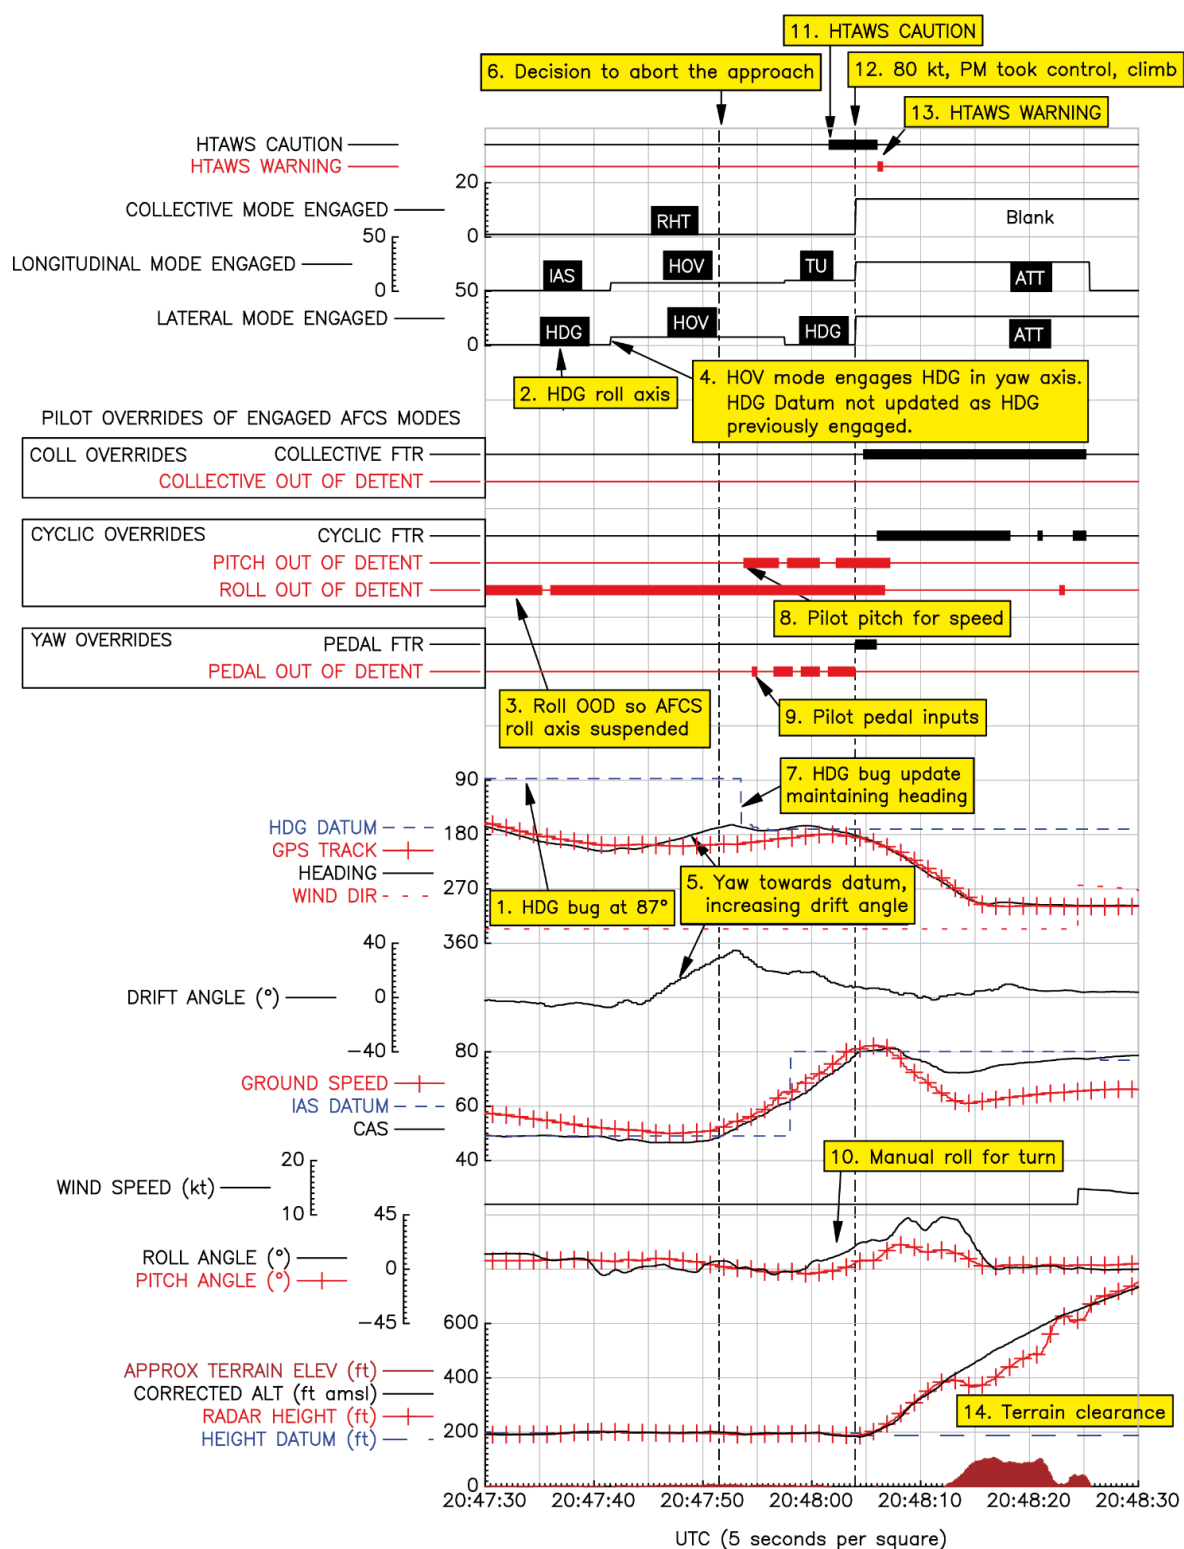
**Figure 11**

- Two seconds later, just after the helicopter started to climb, a HTAWS WARNING TERRAIN (13) briefly triggered. The climb rate reached a peak of 2,000 ft/min and the bank angle peaked at approximately 43° to the right.

- The lowest recorded radio height over terrain was 380 ft (14).
- The helicopter headed out to sea climbing, and returned to Prestwick.

Recorded data for the later stage of the third approach and HTAWS alert

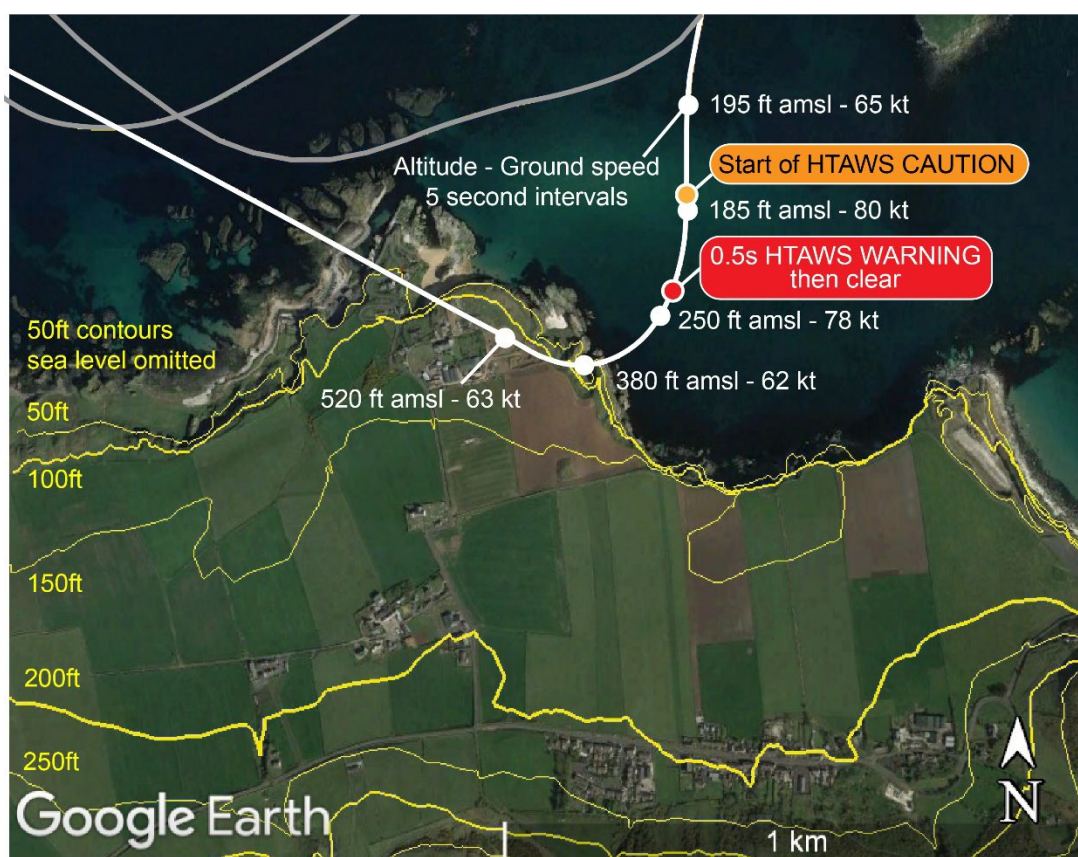
**Figure 13**

During the three circuits, the HTAWS was in OFF AIRPORT and LOW ALT sensitivity mode. The timing of the alerts during the third circuit indicates that these were triggered by the presence of the cliff. The approach altitude leading up to the HTAWS alerts was above the elevation of the cliffs, but level with terrain approximately 0.5 km further inland (Figure 13). At the point of transitioning to flying over land, the helicopter was at about 380 ft amsl and climbing. The highest terrain overflown was at an elevation of approximately 130 ft. The lowest radio height recorded while overflying the terrain was 380 ft.

Flight path and speeds relative to terrain with associated HTAWS alerts  
(The go-around decision was made while just north of the area shown)

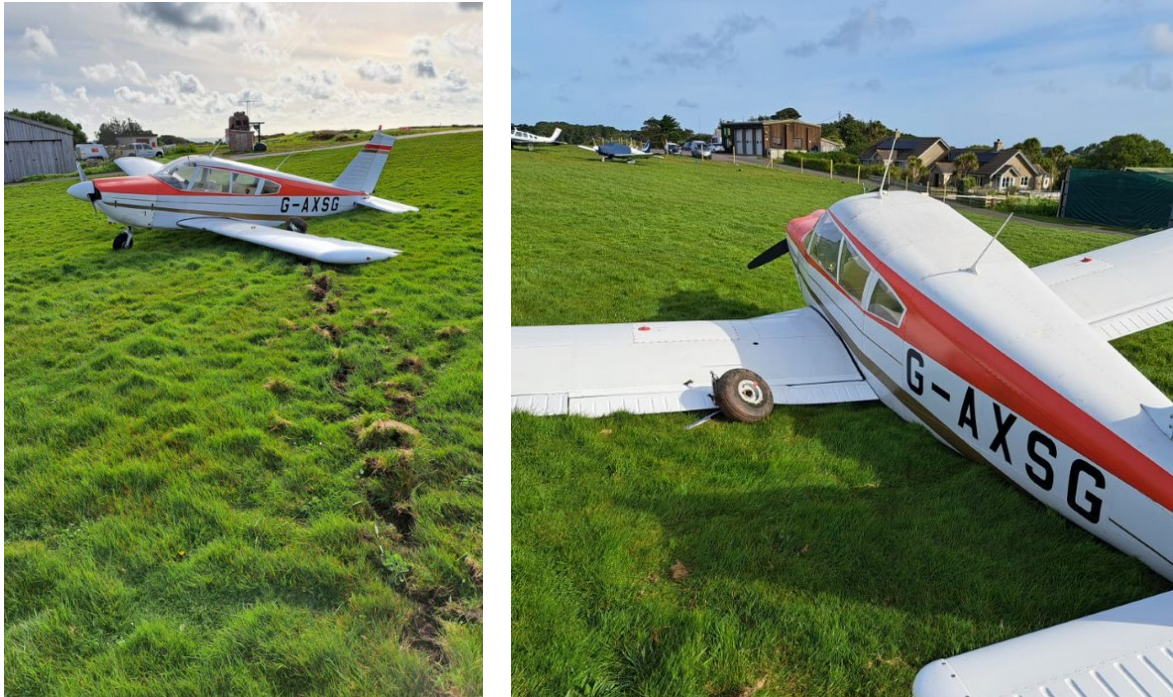
**Figure 1**

As the pilot applied the brakes after touching down, the aircraft veered to the left onto the grass where the left main landing gear leg collapsed. The remaining portion of the landing gear dug into the grass, turning the aircraft through 180° before it came to a stop (Figure 1). The pilot and passengers were uninjured.

G-AXSG following the landing

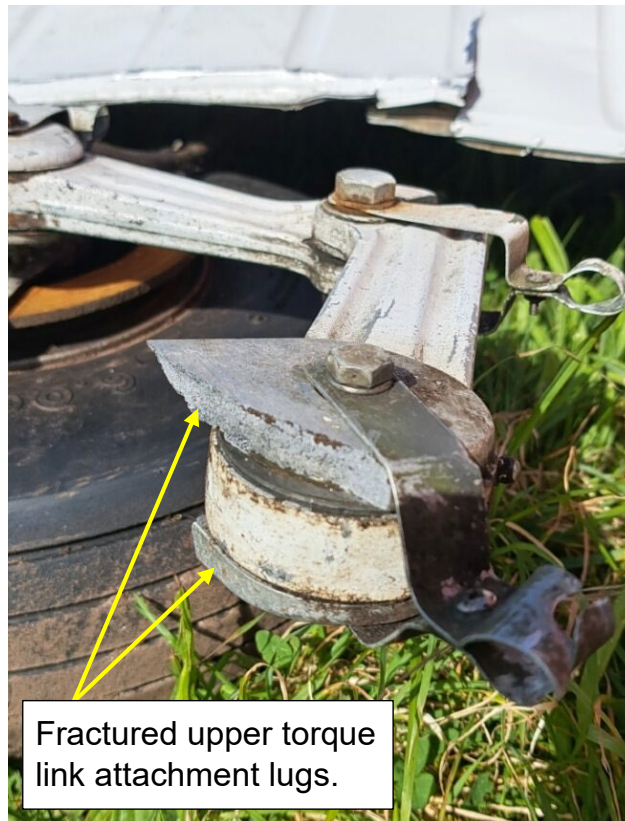
**Figure 3**

- The left landing gear wheel, torque link and oleo strut assembly had detached from the landing gear cylinder but remained attached to the aircraft by the brake hose.
- The torque link attachment lugs had broken from the main landing gear cylinder and remained attached to the upper torque link (Figure 3).
- The base of the main landing gear cylinder had fractured into several smaller pieces near to the upper torque link attachment lugs (Figure 4).
- There was damage to the left flap and wing surface sustained from the oleo leg and wheel assembly during the accident sequence.
- The left wheel brake disc surface was corroded and did not show witness marks from the brake pad rubbing against the disc.

Detached torque link lugs and wheel assembly

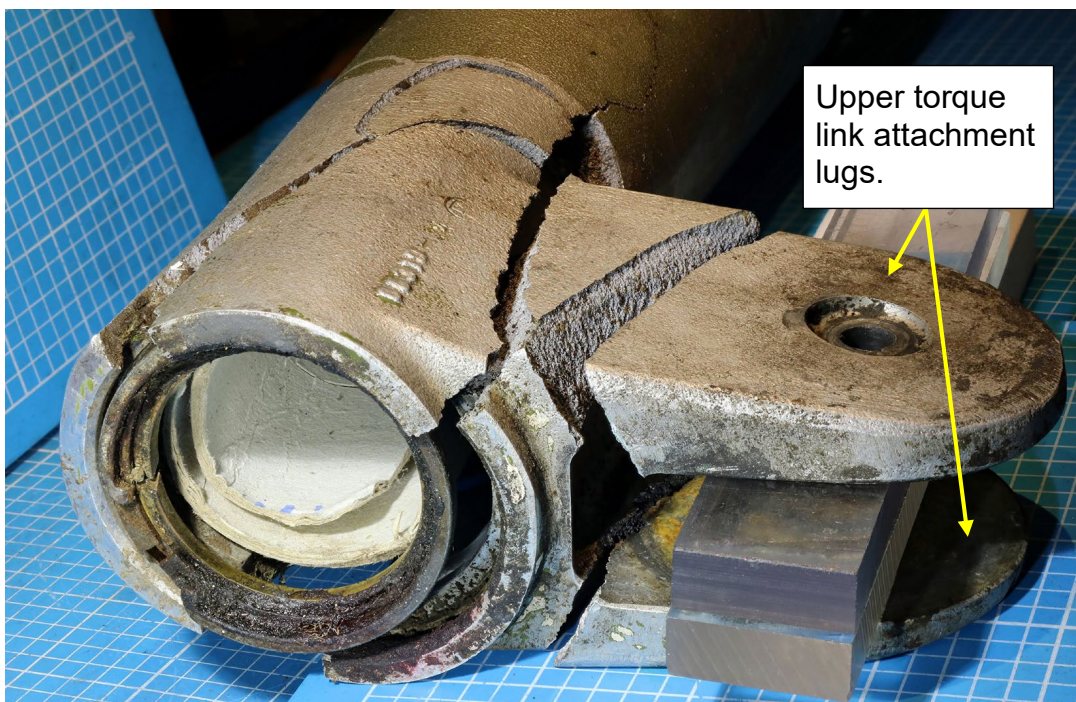
**Figure 4**

Fractured lower left main landing gear cylinder fragments

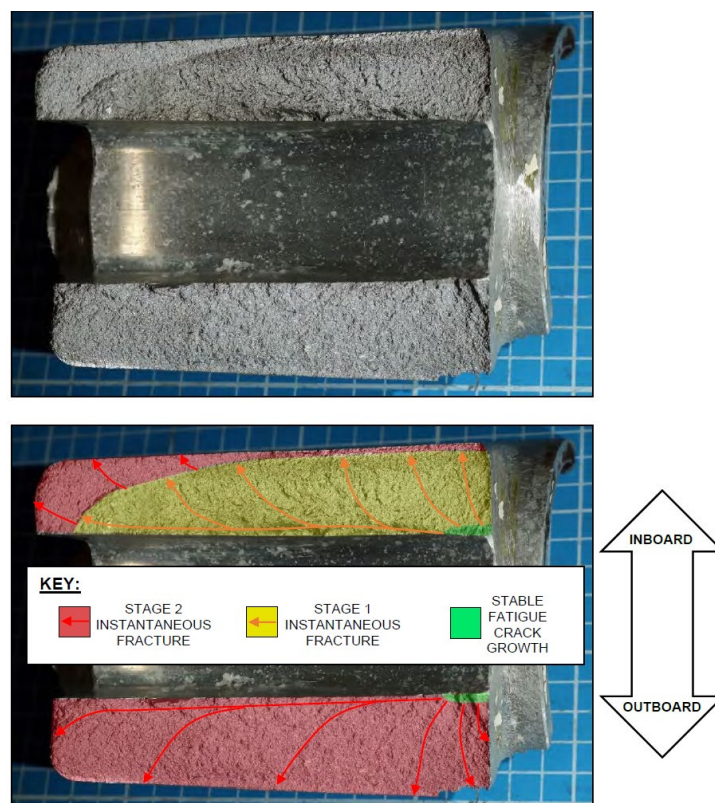
**Figure 5**

Following the period of stable fatigue crack growth, the inboard lug showed evidence of having fractured in two stages. The first fracture (stage 1) extended to approximately three quarters of the lug's surface area, identified by slight oxidation of the fracture surface. Subsequent final separation of both the inboard and outboard lugs due to the secondary fracture (stage 2) are as assessed as having occurred at the same time.

Torque link attachment lug fracture surface analysis

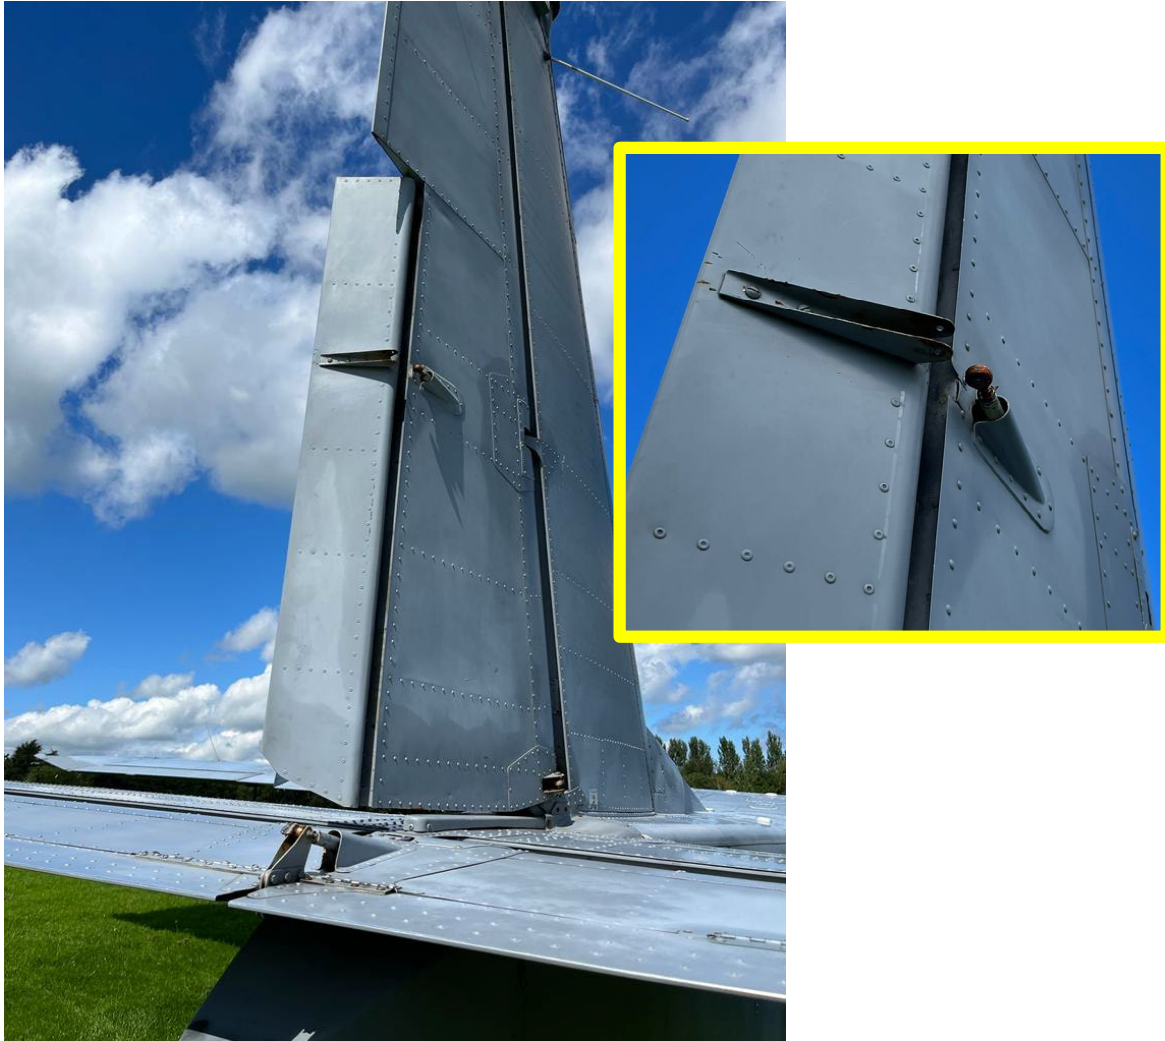
**Figure 1**

Visual examination found that the rudder trim tab was not connected to its control rod (Figure 1). The two items are normally connected using a bolt, nut and split pin, but none of these components were recovered. The bearing in the control rod eye-end was reported to be free to rotate, and it was deemed to be acceptable for further flight.

Photographs taken after the aircraft landed showing the rudder trim tab bolt missing

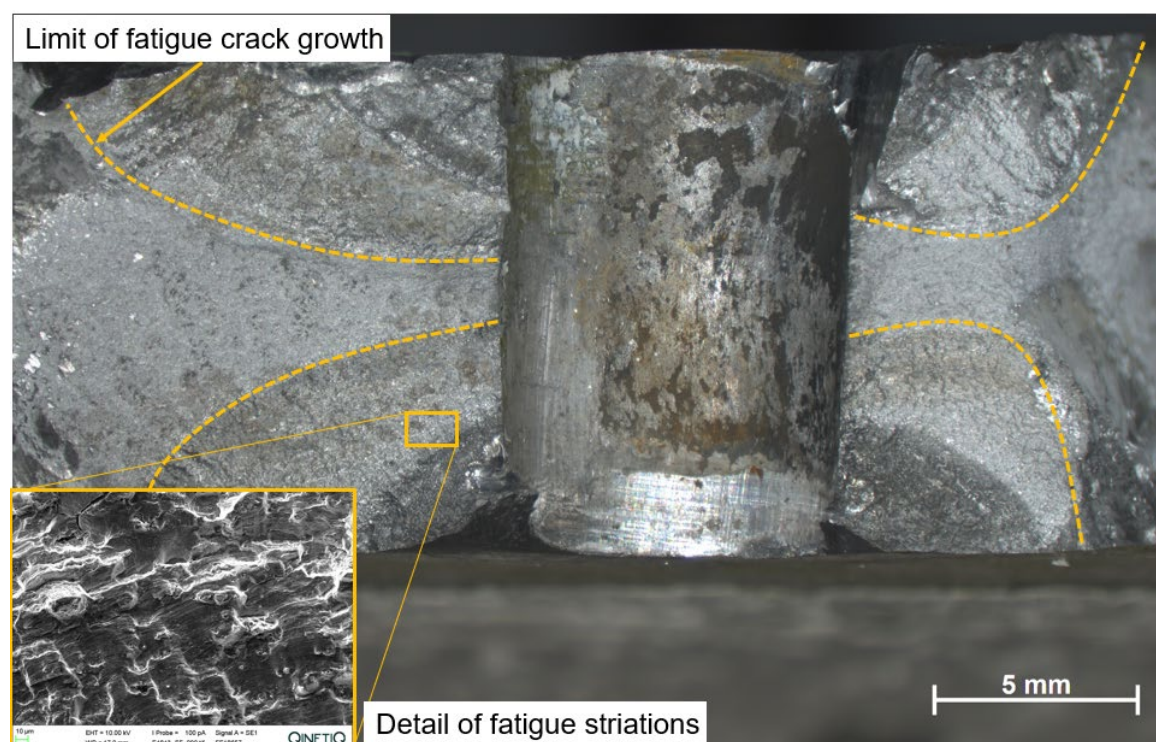
**Figure 3**

The four pieces of the fork were examined using a Scanning Electron Microscope. While most of the surface detail of the fracture faces had been damaged by corrosion, it was possible to observe fatigue striations characteristic of fatigue crack growth. Corrosion pits and additional cracks were observed (Figure 3) in all the bolt holes.

Detail of typical bolt hole showing limits of fatigue crack growth

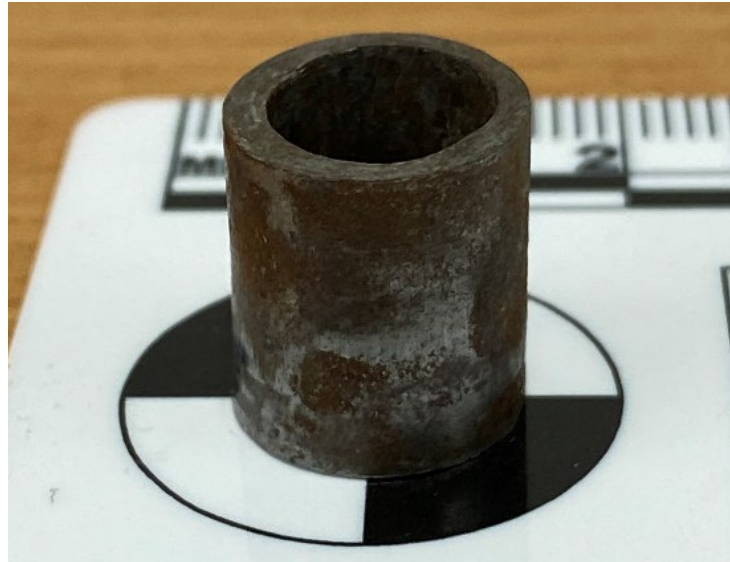
In the aft right hole, there was a steel bush which had corroded (Figure 4); there was no visible evidence of a corrosion protective coating on the bush.

**Figure 4**  
Steel bush

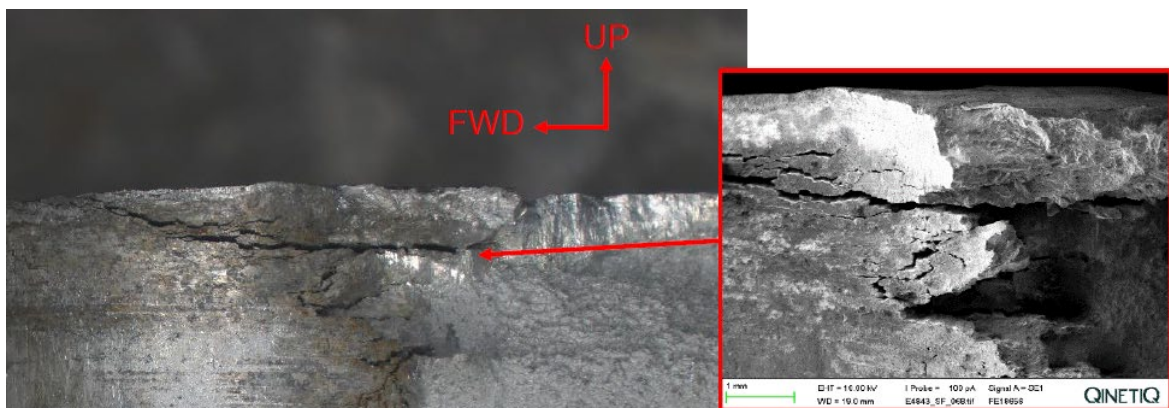
The upper part of this hole exhibited a delaminated structure characteristic of exfoliation corrosion, and it is possible that galvanic corrosion between the aluminium fork and the steel bush may have caused the exfoliation corrosion (Figure 5). The investigation could not find any documentation regarding the installation of this bush.

**Figure 5**  
Detail view of right side, aft hole
