**SERIOUS INCIDENT**

<b>Aircraft Type and Registration:</b>	MBB-BK 117 C-2, G-MPSB	
<b>No &amp; Type of Engines:</b>	2 Arriel 1E2 turboshaft engines	
<b>Year of Manufacture:</b>	2005 (Serial no: 9068)	
<b>Date &amp; Time (UTC):</b>	12 March 2021 at 1150 hrs	
<b>Location:</b>	North Weald Airfield, Essex	
<b>Type of Flight:</b>	Private	
<b>Persons on Board:</b>	Crew - 2	Passengers - None
<b>Injuries:</b>	Crew - None	Passengers - N/A
<b>Nature of Damage:</b>	Distorted aft crosstube between skids	
<b>Commander's Licence:</b>	Airline Transport Pilot's Licence (Helicopters)	
<b>Commander's Age:</b>	52 years	
<b>Commander's Flying Experience:</b>	7,170 hours (of which 2,196 were on type) Last 90 days - 28 hours Last 28 days - 14 hours	
<b>Information Source:</b>	AAIB Field Investigation

**Synopsis**

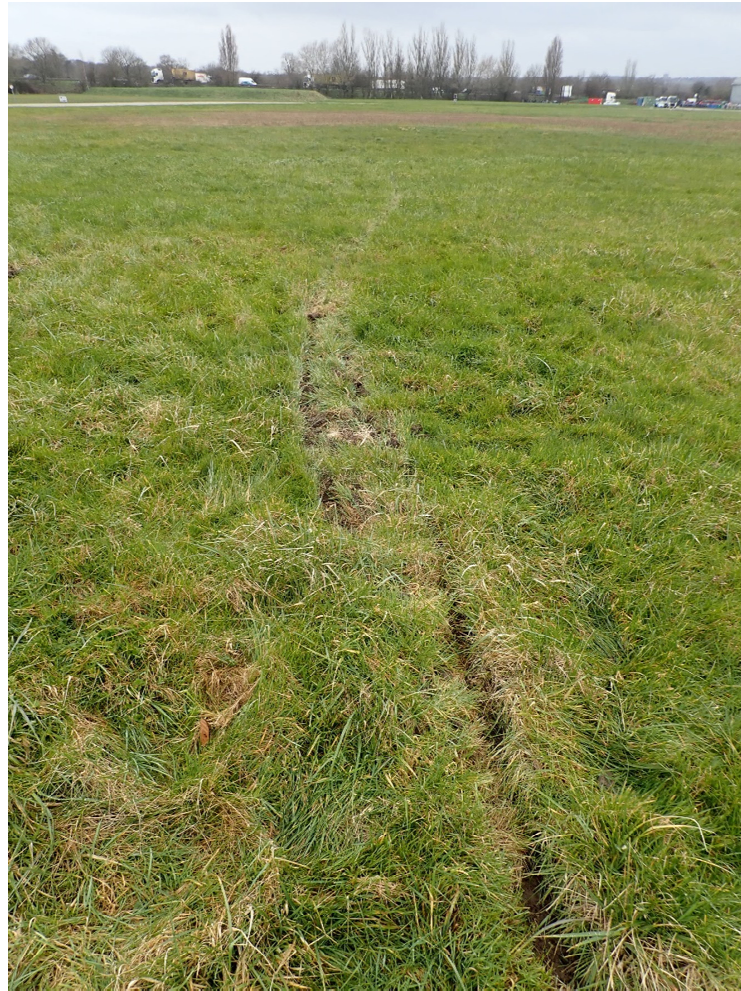
**Figure 3**

The helicopter landed on an area of grass to the north of the south-western taxiway. Ground marking caused by both skids extended for approximately 17 metres in a westerly direction. The initial landing point was identified by deep furrows which were left in the turf by the helicopter's skids. The markings indicated that the right skid bounced after the initial contact with the ground before it slid and came to rest (Figure 3). The ground marking became less visible as the ground slide progressed.

Ground markings from right skid

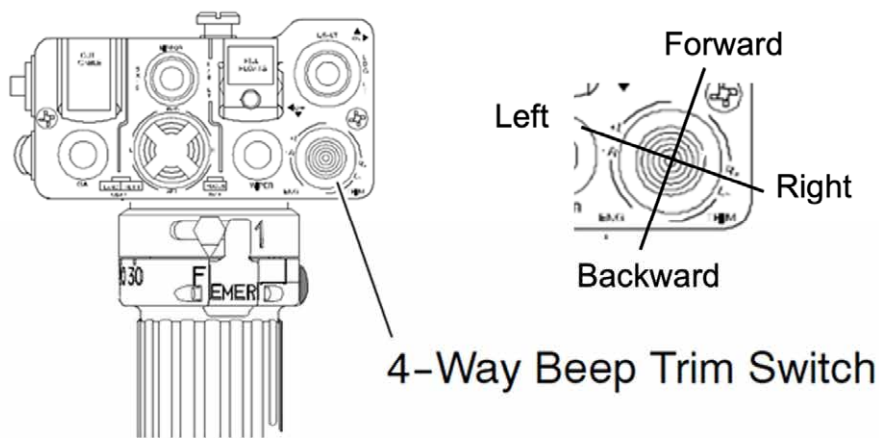
**Figure 5**

Ground running trials conducted on behalf of the AAIB indicated that, with no faults detected in the helicopter's engine control systems, the most likely cause of Engine No 1 failing to respond to the commander's increased throttle demand was an inadvertent initial RIGHT, rather than FORWARD, trim selection on the 4-way beep trim switch. There was no evidence the incorrect selection was caused by the design of the switch.

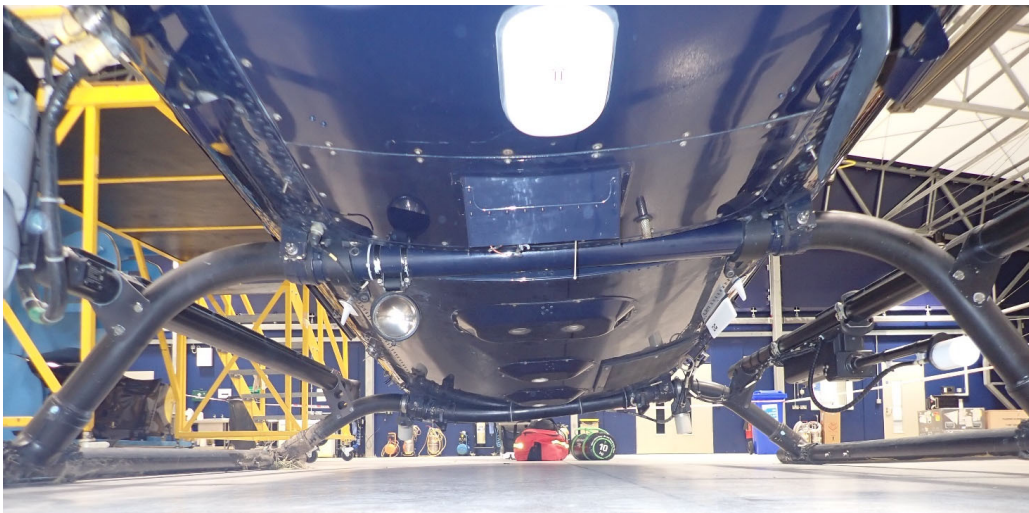
**Figure 9**

The helicopter was moved to a hangar after it had landed. External examination identified significant deformation of the aircraft landing gear (Figure 9). The aft crosstube had bowed, resulting in both skids moving outboard. The right skid had deflected further than the left. Other than the aft crosstube damage, no other physical damage was identified with the aircraft.

G-MPSB landing gear (viewed from front looking rear)

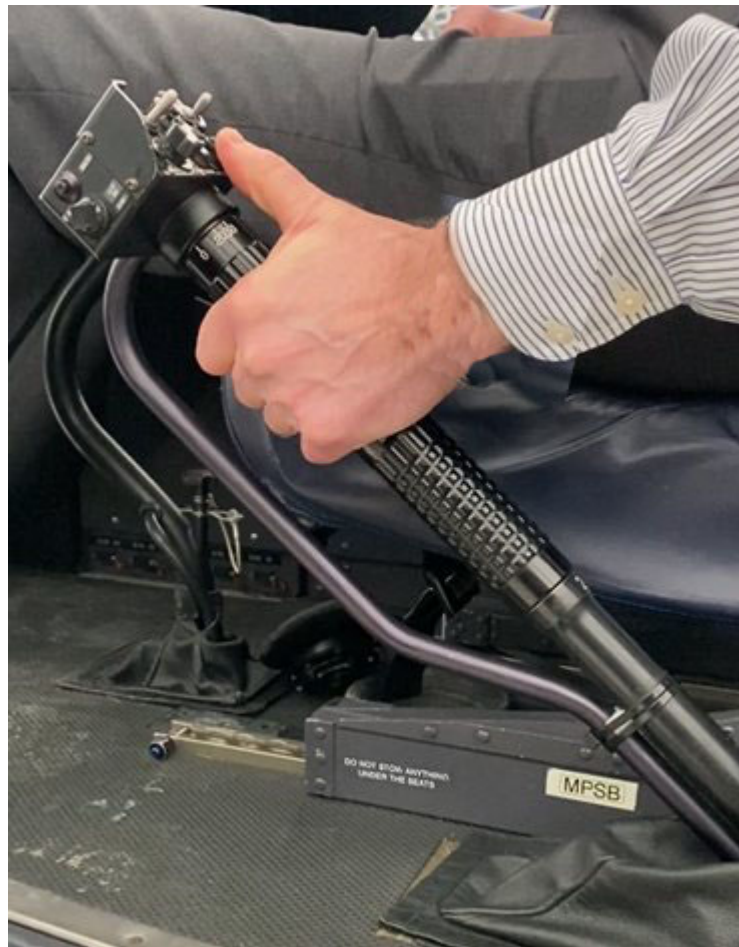
**Figure 13**

intermediate throttle setting, rather than IDLE, the encountered problems might not have occurred. The subsequent inadvertent deselection of FLIGHT on Engine No 2 probably resulted from the commander's hand accidentally overlapping its throttle as he tightened and/or moved his grip on Engine No 1's throttle while manipulating it in response to the unfolding emergency. The investigation heard that inadvertent manipulation of the throttles during high stress/workload situations was an uncommon, but not unknown occurrence on this type of helicopter. The helicopter manufacturer undertook to review their handling guidance for pilots employing the one engine to IDLE technique for simulating engine failures during Cat A Clear Heliport takeoffs.

Pilot's hand overlapping both throttle twist grips
