Rail Accident Investigation Branch

Rail Accident Report

Derailment of a tram at Bulwell, Nottingham 12 June 2023

Report 02/2024
March 2024

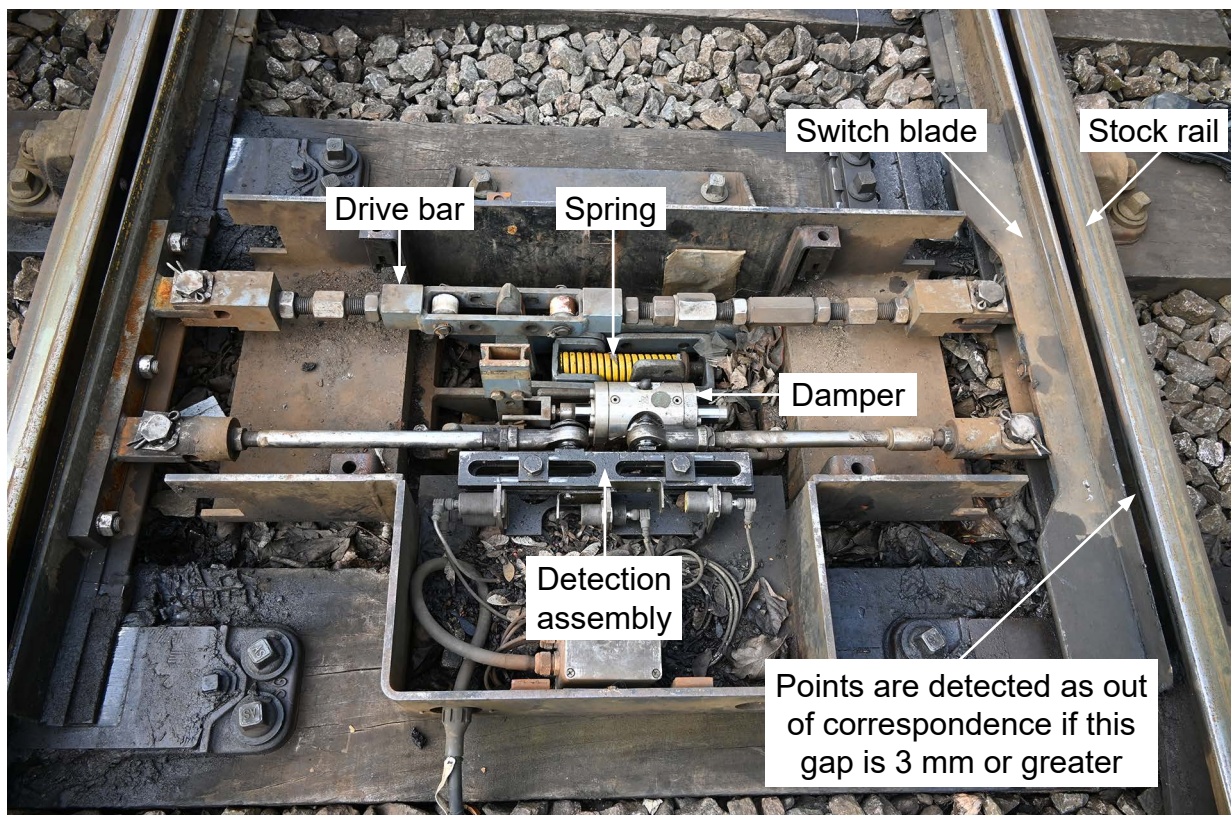
- 15 BUP3 points at Bulwell tram stop use a spring-loaded point mechanism to hold the points in the correct position. A feature of spring-loaded points is that a tram can travel through the points in a trailing direction, where two tracks converge into a single track, even if the points are not set in the correct position for that movement. When that happens, the tram's wheels push the points over to the opposite position as they pass and then, depending on the configuration of the mechanism, the points either stay in that opposite position or, as is the case with BUP3 points, spring back to their original position. If a tram travels through the points in a facing direction, where one track diverges into two, it will be routed in the direction the points lie at the time and there will be no positional change of the switch blades.

- 16 When operating correctly, the switch blades are held in position by a spring acting through a mechanical linkage to apply pressure on the desired switch blade (figure 5). If points fail to swing fully or to spring back, they can be operated manually using a metal bar which is available on all trams and carried by engineering technicians. To check that the points are set correctly, an independent detection system is installed in the points mechanism. In the case of points on the NET system, this is set to show as an 'out of correspondence' fault when the gap between the switch blade and the adjacent stock rail is 3 mm or more. If a set of points is detected as out of correspondence for more than 15 seconds, an alarm is raised on the SCADA system, triggering an audible alert in the control room. This alarm will sound until acknowledged by a network controller.

Figure 5: The internal mechanism of BUP3 points (held in the centre position), annotated to highlight important components.

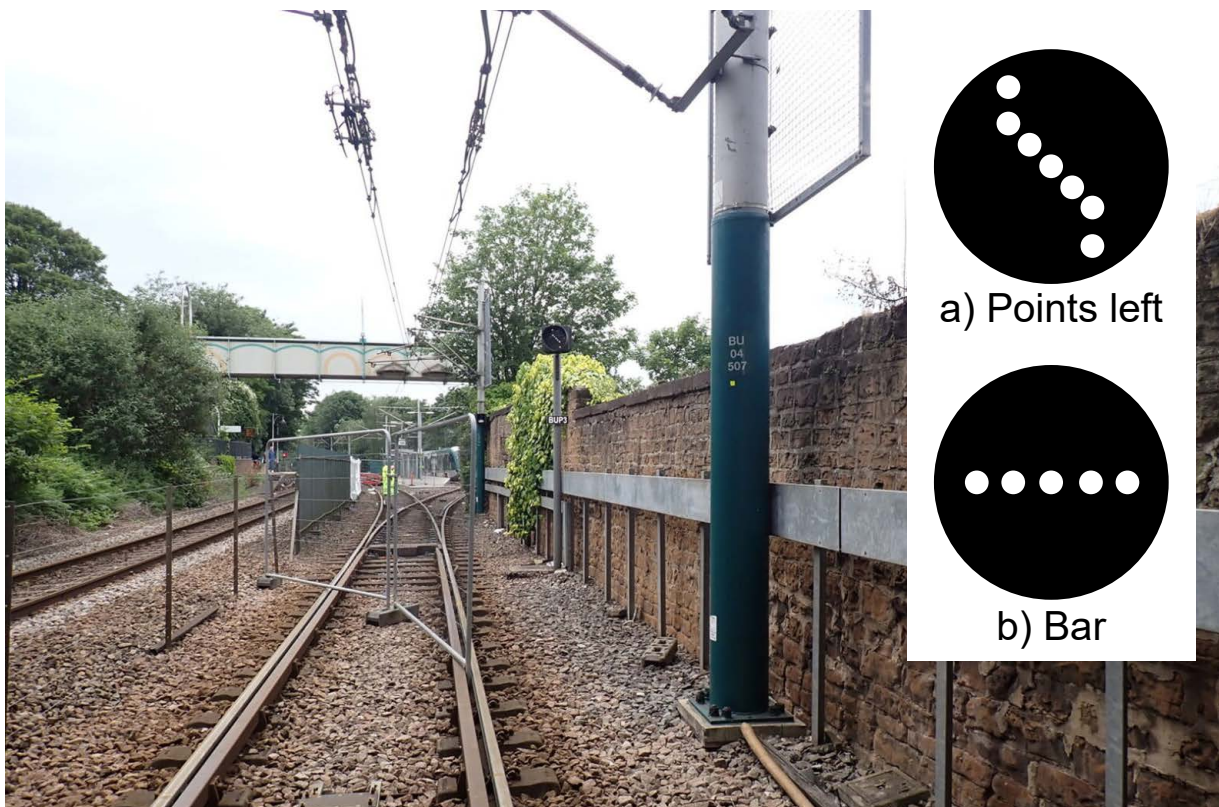
- 17 The detected position of the points is indicated to tram drivers using a lineside ‘facing point indicator’ (FPI). For BUP3 points, the FPI displays a ‘point left’ indication if the points are set correctly for a tram to enter the southbound platform, or a ‘bar’ indication for any other scenario (figure 6). If drivers observe a bar indication, they should not drive over the points. Instead, they should stop the tram, check the points (normally by getting out of the tram) and operate them manually to attempt to gain the correct indication.

Figure 6: The FPI alongside BUP3 points, and (inset) the two possible indications that the FPI can show to drivers: a) Points left and b) Bar.

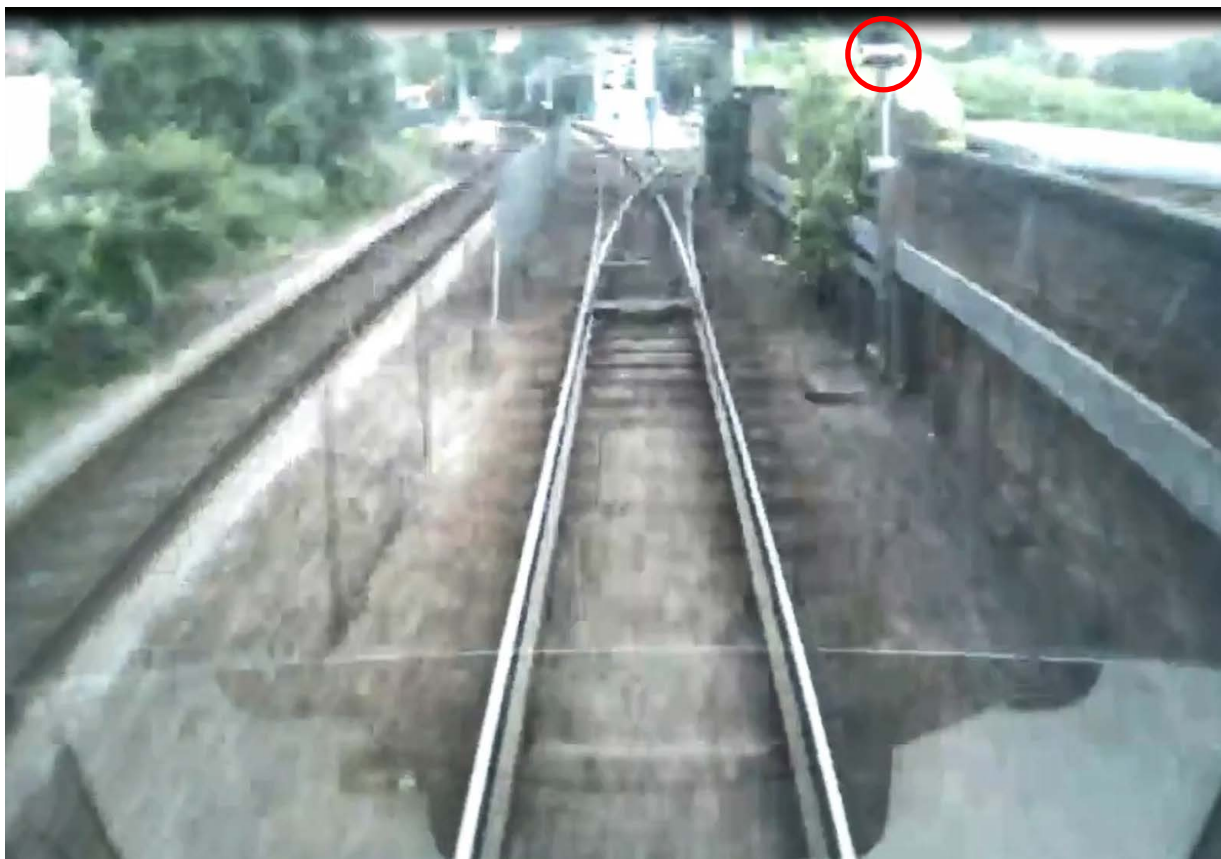
- 32 At 17:06:38 hrs, the driver applied the tram's normal service brake in preparation for stopping at Bulwell tram stop. Around nine seconds later, the tram passed under Highbury Road bridge, now travelling at 45 km/h (28 mph). The FPI is visible on the FFCCTV footage and is displaying a bar indication (paragraph 17 and figures 6 and 7).

- 33 Three seconds later, at 17:06:50 hrs, while travelling south at 41 km/h (25 mph), the tram reached BUP3 points. The points were still in the incorrect position following the northbound passage of tram 222 at 17:04 hrs. The points directed the first bogie along right-hand route, towards the northbound platform and the front module of the tram lurched in the same direction.

Figure 7: Still image captured from the FFCCTV footage on tram 232, showing the FPI displaying a bar indication (circled in red). (Image courtesy of Nottingham Trams Ltd).

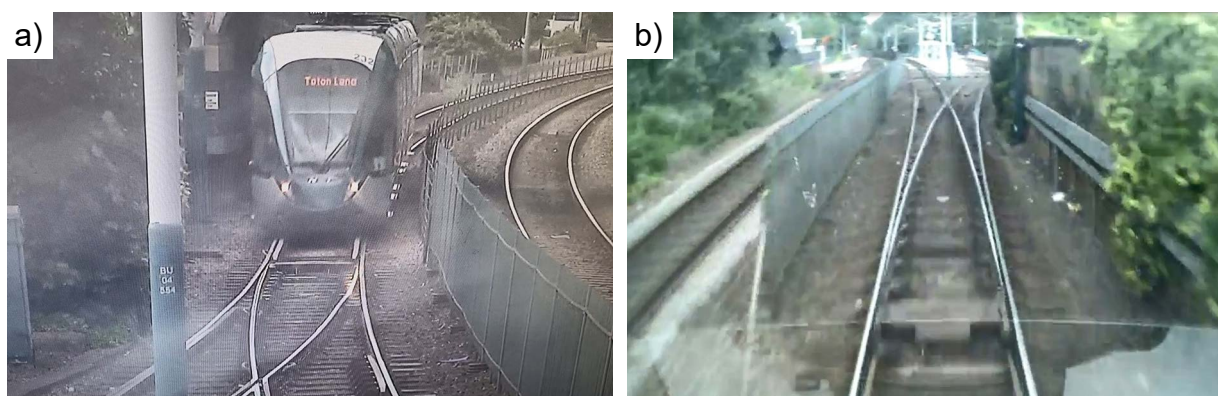
44 CCTV footage from Bulwell tram stop and from tram 232 shows that the points were in an intermediate position as tram 232 approached them (figure 8). Data recorded on the SCADA system confirms that the points were detected as 'out of correspondence'.

Figure 8: Still images from CCTV on a) Bulwell tram stop and b) tram 232 showing the state of BUP3 points immediately before tram 232 travelled over them. (Images courtesy of Nottingham Trams Ltd).

45 Track marks and CCTV show that upon reaching the points the first bogie was incorrectly directed to the right, towards the northbound platform. The points then reset to the correct position, probably due to the forces imparted by the passage of the first bogie. This directed the second bogie to the left, towards the southbound platform. As the distance between the two tracks increased, the second bogie became derailed by being dragged off the southbound track (paragraph 34).

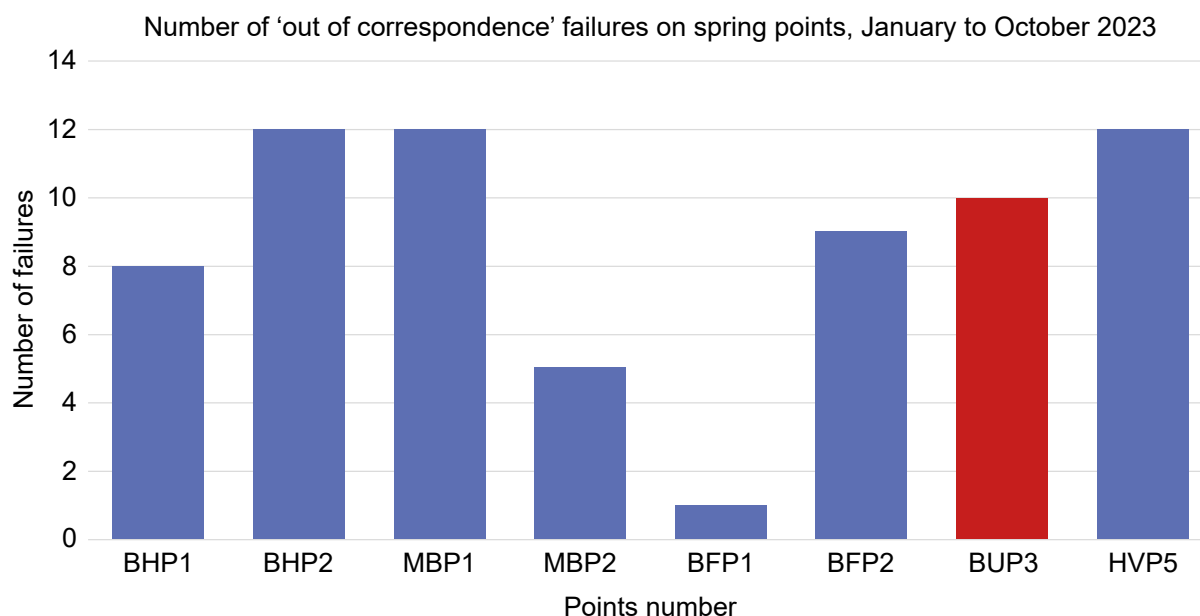
- 53 NTL supplied RAIB with a download from its asset management system relating to the spring-loaded points on the NET system between January and October 2023. This data showed that BUP3 points were recorded as being out of correspondence on 10 occasions, a similar number of times to comparable sets of points elsewhere on the system (figure 9).

- 54 Points may fail to swing correctly for a variety of reasons, and figure 9 shows that such failures of points are not uncommon on the NET system. In these circumstances, it is intended that safety is assured by the drivers of trams observing the bar indication on the FPI and stopping on the approach to the points. The number of points failures that a tramway considers acceptable can vary based on the criticality of those points to running an effective service, the potential delays and disruption, and what other control measures are in place should they fail. For these reasons, a failure of a set of sprung points to swing correctly is generally seen as a reliability issue.

Figure 9: Chart showing the number of recorded out of correspondence failures on BUP3 points (highlighted in red) and other sets of points used in a similar manner.
