**Serious Incident**

<b>Aircraft Type and Registration:</b>	Beech 400A, N709EL
<b>No &amp; Type of Engines:</b>	2 Pratt & Whitney Canada JT15D turbofan engines
<b>Year of Manufacture:</b>	1992 (Serial no: RK-52)
<b>Date &amp; Time (UTC):</b>	7 October 2022 at 1100 hrs
<b>Location:</b>	Newquay Airport, Cornwall
<b>Type of Flight:</b>	Private
<b>Persons on Board:</b>	Crew – 2                      Passengers – 1
<b>Injuries:</b>	Crew – None                      Passengers – None
<b>Nature of Damage:</b>	Damage to mainwheel tyres
<b>Commander's Licence:</b>	Airline Transport Pilot's Licence
<b>Commander's Age:</b>	40 years
<b>Commander's Flying Experience:</b>	5,263 hours (of which 2,692 were on type) Last 90 days – 150 hours (of which 30 on type) Last 28 days – 47 hours (of which 4 on type)
<b>Information Source:</b>	AAIB Field Investigation

**Synopsis**

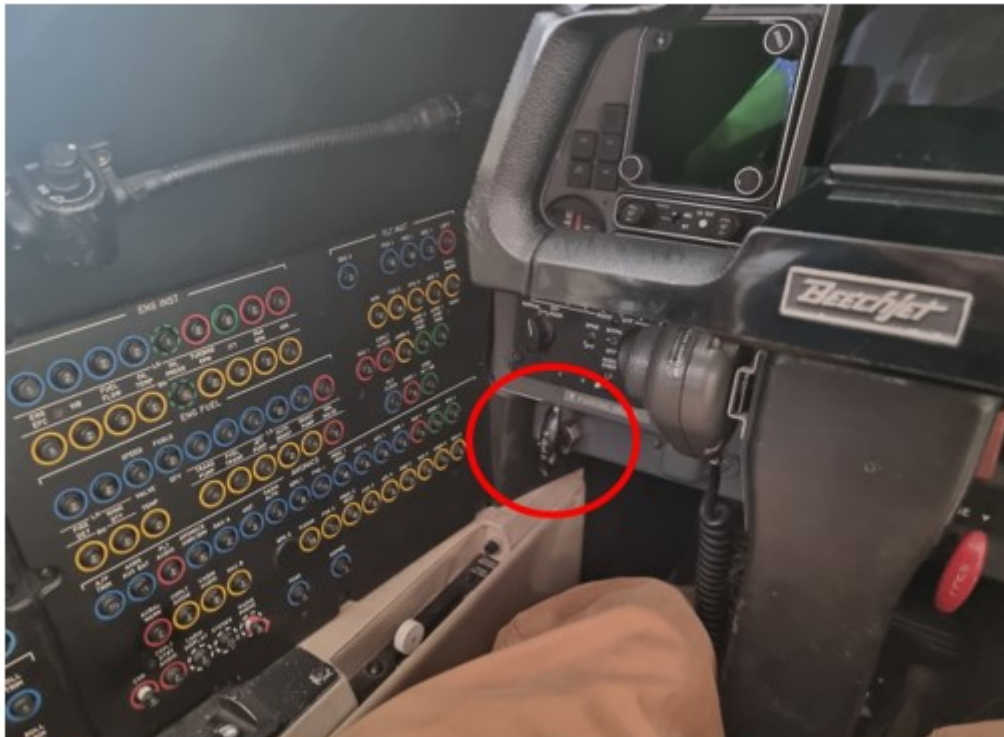
**Figure 2**

The parking brake handle is located on the lower left side of the instrument panel (Figure 2). The parking brake is set by pulling the handle fully out and depressing the toe brakes. The hydraulic brake pressure applied by the toe brakes is then locked in the system when the toe brakes are released. Accordingly, the pressure applied when the parking brake is set is not a fixed value but varies depending on the instantaneous pressure applied at the toe brakes when the parking brake handle is pulled. Pilots can therefore set an intermediate (partial) pressure between zero and the maximum achievable brake pressure. The parking brake is released by pushing the handle in, which releases the brake pressure.

Parking brake handle location

The parking brake handle is located just to the left of the commander's left leg and so it is unlikely that the co-pilot, in the right seat, will detect if it has been left in the ON position. The travel from ON to OFF was only 21 mm, on this aircraft, so there was only a small visual difference between a handle that has only been partially pushed in and one that is fully in. There was also no 'release parking brake' item on the 'Before Takeoff' checklist, which could have served as a reminder to help prevent taking off with the parking brake applied.

It is recommended that Textron Aviation Inc. amend the checklists for the Beech 400 series of aircraft to include a 'release parking brake' item in the 'Before Takeoff' checklist.

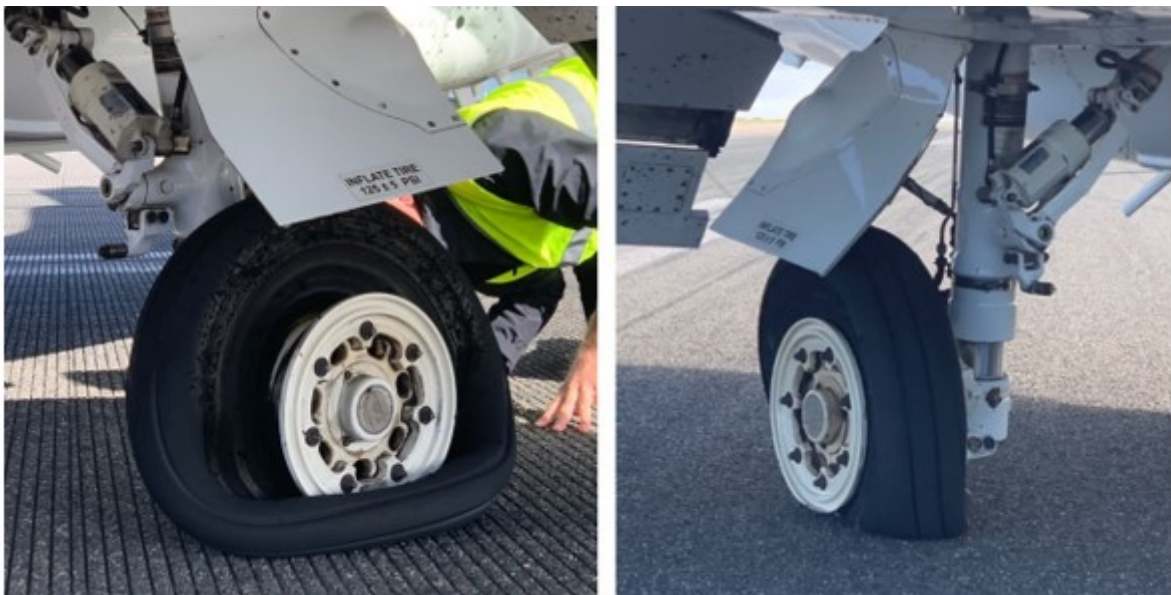
**Figure 3**

The rapid deceleration on touchdown was caused by either the tyres having already deflated due to the fuse plugs having melted, or the brakes being seized, or a combination of both. This was the result of the brakes having been heated during the takeoff run because the parking brake had been left on with partial pressure applied.

Both mainwheel tyres were intact but had partially separated from their wheel rims (Figure 3). The fuse plugs on both mainwheels were found to have melted, and both brake units had seized.

Left and right mainwheel tyres after the incident landing
