Annual Safety Review 2023

CIAA Foreword

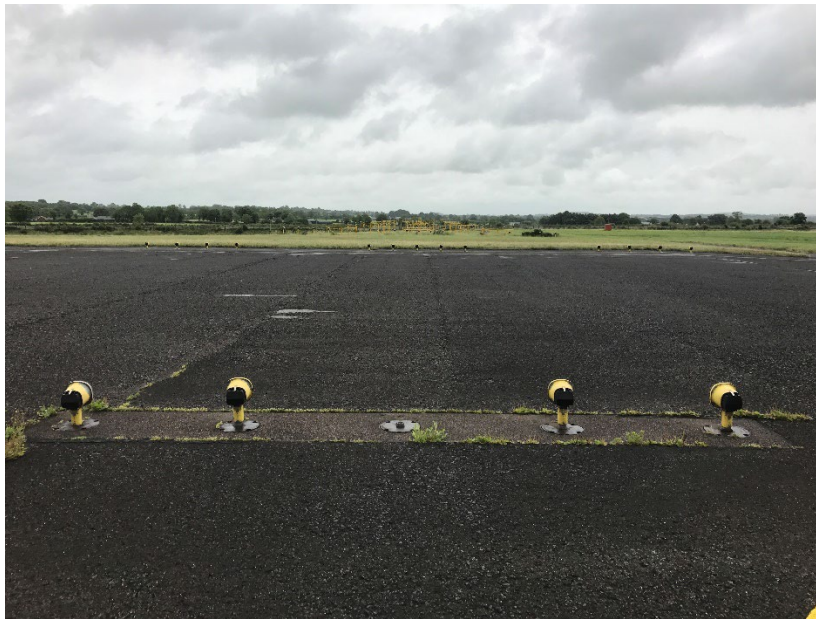
36 cm tall and 29 m beyond the end of the takeoff runway. Figure 3 contains an image of the damage which at first sight does not convey the seriousness of the event.

Damage to supplementary runway light 29 m from the end of the runway

There was no damage to the aircraft, which continued its flight to Corfu, Greece without further incident. However, it was only the benign nature of the runway clearway and terrain elevation beyond, and the lack of obstacles in the climb-out path which allowed the aircraft to climb away without further collision after it struck the runway light. Had an engine failed at a critical moment during the takeoff, the consequences could have been catastrophic.

The AAIB made six Safety Recommendations, which resulted in significant safety action.

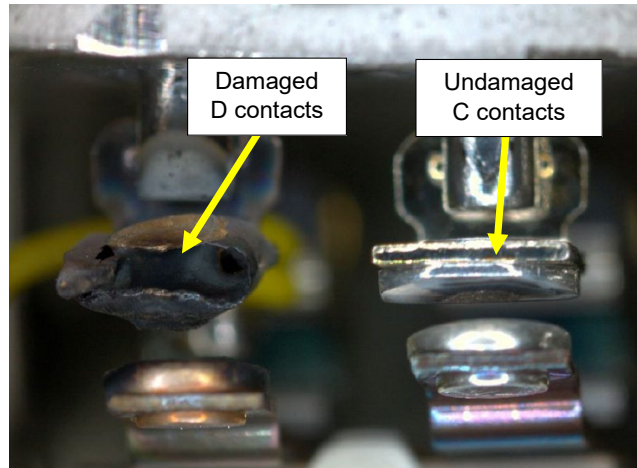
In the climb, after departing Farnborough Airport, D-AAAY had an uncommanded⁸ flap movement above the maximum flap extension speed during which the flaps moved to their fully extended position. The aircraft returned to Farnborough with the flaps extended where it landed without further incident. An uncommanded and unarrested flap movement requires the flaps to move without movement of the flap lever and then for a failure in the flap arrest system to stop this movement. The flap surfaces are moved by two drive motors that are commanded by the sequencing of four extend and retract relays. These four relays also form part of the system to arrest an uncommanded flap movement.

Damaged D contact (left) and undamaged C contact (right)

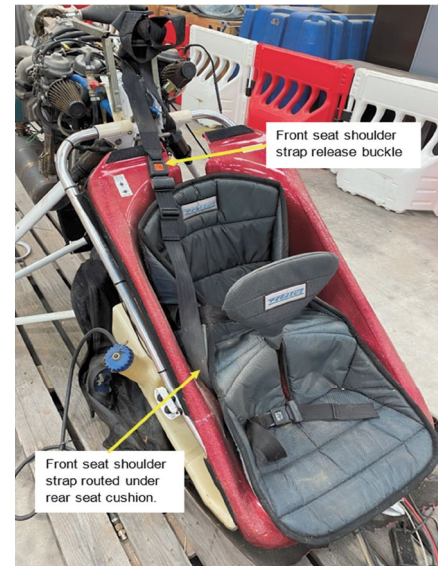
It is likely that the pilot started the engine with the hand throttle open and did not free the base bar, reduce the rpm or stop the engine before the aircraft became airborne. The pilot might have survived if he had been wearing his shoulder (diagonal) harness and his helmet had been designed to protect him from rotational head injuries.

Front seat diagonal shoulder strap positioned as found at the accident site

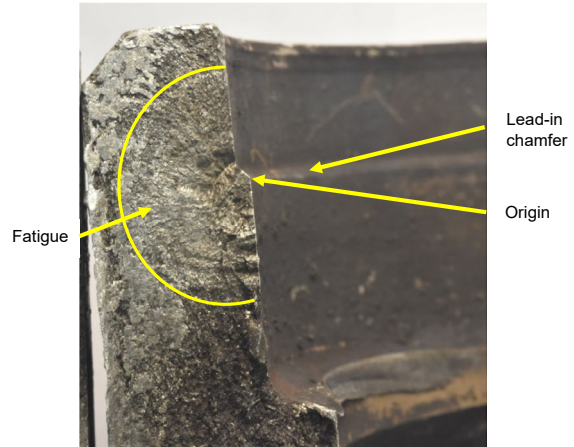
The fatigue crack originated from a corrosion pit in the wheel hub. Following this occurrence, the wheel manufacturer developed an ultrasonic inspection technique to identify cracks in this location on the hub and the operator has incorporated the new inspection into their maintenance programme.

Radial fracture surface with area of fatigue highlighted (reproduced with permission)

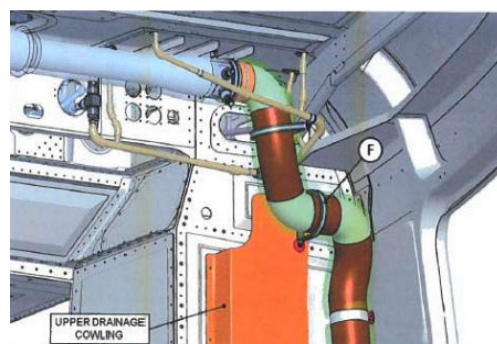
A heating duct failed in flight releasing fragments of duct insulation material into the cabin and cockpit, causing respiratory irritation to the occupants. The aircraft landed safely. Similar heating duct failures had previously occurred in several of the operator's other AW189 aircraft and were investigated by the AAIB (AAIB Bulletin 4/2022 report AAIB-27128 refers). As a result of those failures the aircraft manufacturer had published a Service Bulletin (SB) to inspect and modify the installation of the heating duct and this had been embodied on G-MCGV.

Heating duct on AW189 showing flexible sections in brown and rigid sections in green (Circle 'F' indicates a securing 'P-clamp')

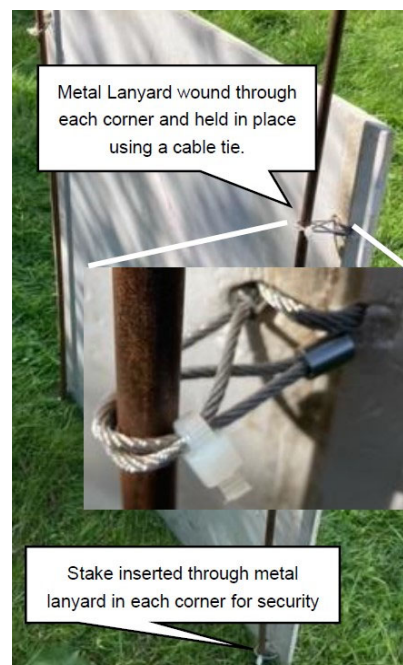
New method of securing the sign (Image used with permission)

- The operator took immediate action on the day to increase the distance between the landing helicopter and the passenger area.
- The operator issued a flying staff instruction that required the sign to be secured with two cable ties on each corner and ordered metal lanyards to secure the sign in future.
- The flying staff instruction also required the ground team leader to check the safety of the site before the first flight of the day and before each start of the helicopter engine.

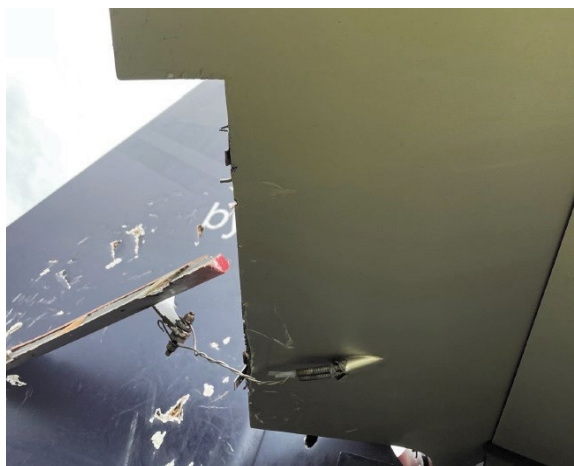
The elevator trim tab had detached due to a combination of the wrong hinge type being fitted (with only one third of the glue bonding area compared to the type of hinge that should have been fitted) and insufficient glue having been applied. Other aircraft with cracked hinge tabs were found which indicated that insufficient glue had also been applied between the hinges and the tab structure.

G-ZXEL lower side of right elevator showing trim tab detached at the hinge points but still connected via the control cables

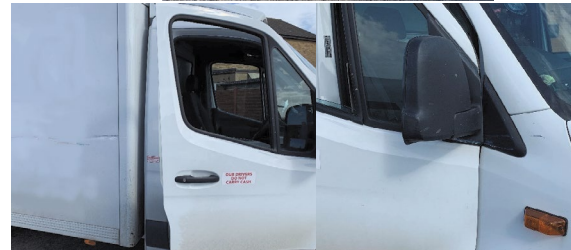
Damage to the aircraft wingtip (top) and to the vehicle panel side panel (left) and below the wing mirror (right). (Images used with permission)
