# Near miss with a track worker near Fishguard, Pembrokeshire, 4 January 2024

## Summary of the incident

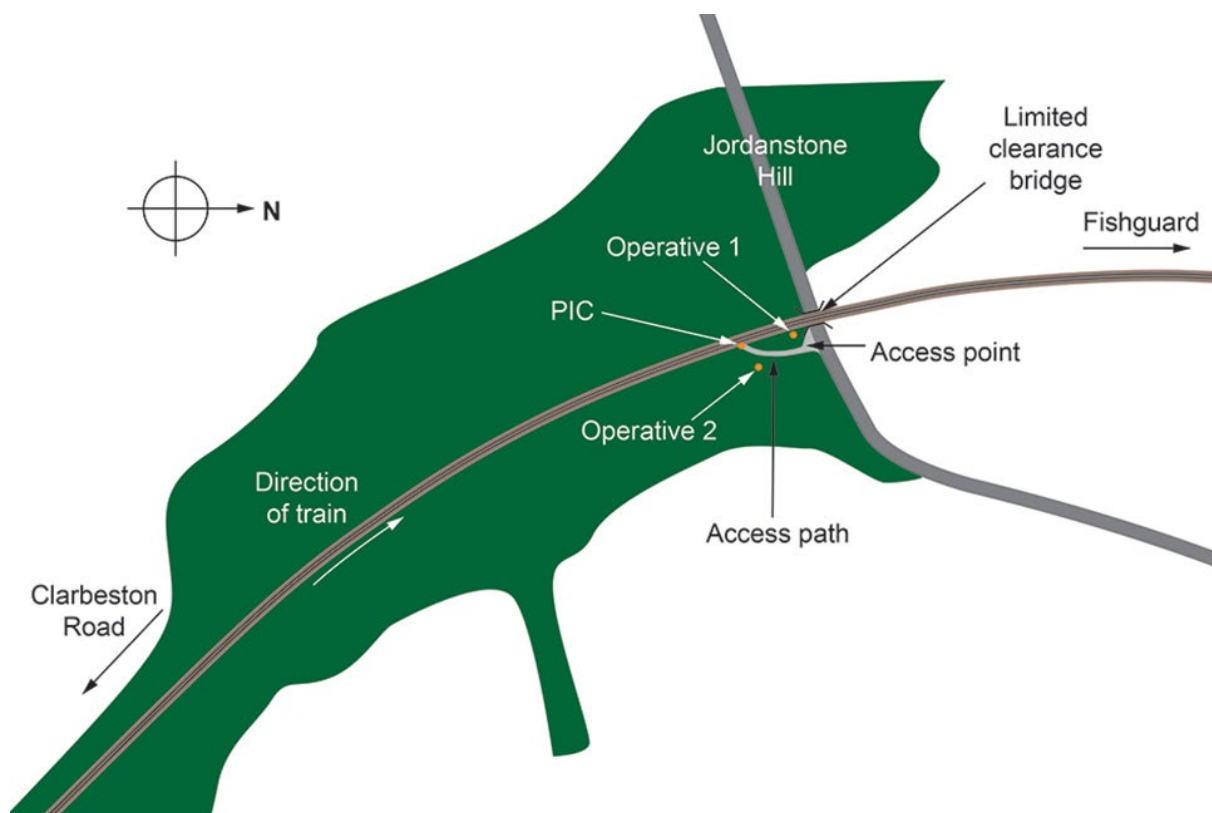
The railway at the site of work is a single track, bi-directional line, that runs between Clarbeston Road Junction and Fishguard Harbour station. The track is on a tight curve with vegetation further restricting the view for train drivers of the line ahead. An access point allows staff to enter the eastern side of the track. This takes the form of a roadside gate, situated next to a bridge that carries the railway over the road. From this access gate a grass path rises roughly parallel to the track, with railings on either side. At the top, the path and railings turn to face the track and lead into the cess (the area immediately alongside the track).

**Simplified diagram showing the location of the access point and the three track workers.**

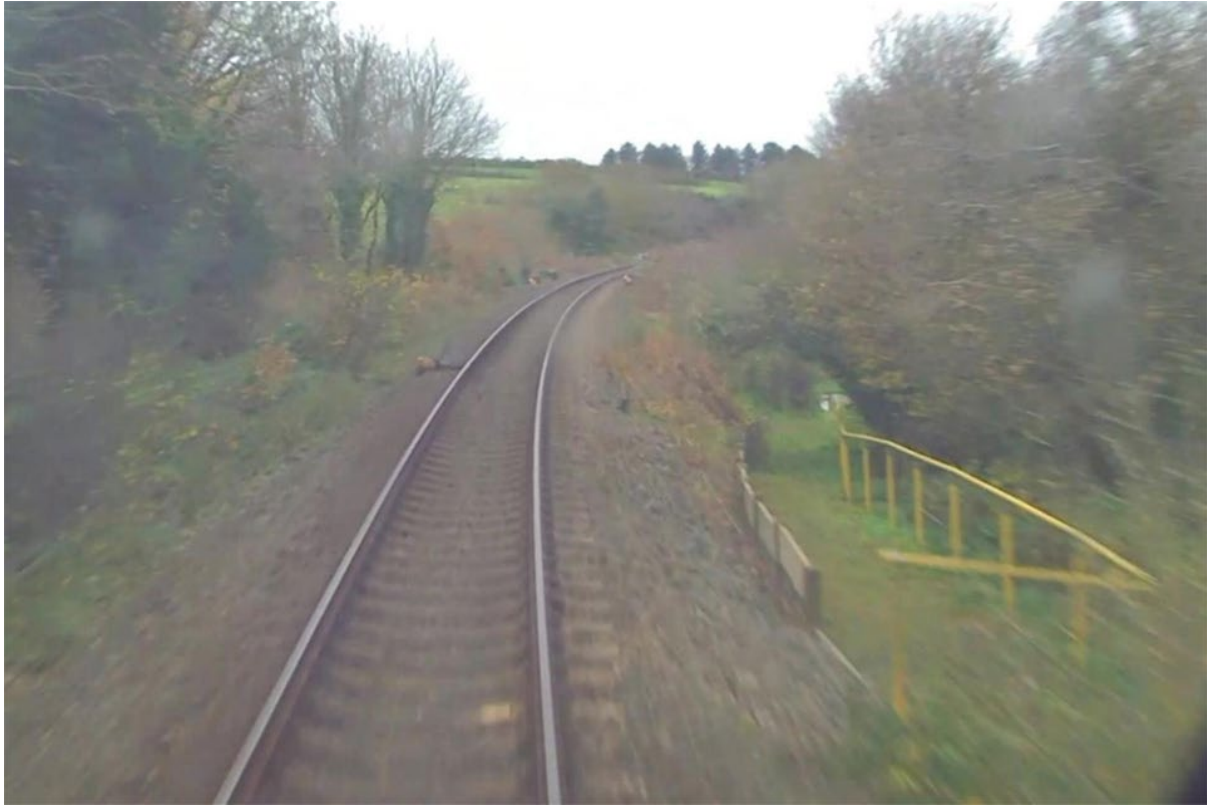
The railway passes over the bridge around 60 metres north of this access point. The track over the bridge is classed as 'limited clearance', meaning that staff do not have a position of safety throughout the length of the structure.

**Image from forward-facing CCTV taken from a different train, showing the access point in the foreground and the bridge in the background (courtesy of Network Rail).**
