Serious Incident

Aircraft Type and Registration:	Denney Kitfox MK2, G-BUKP	
No & Type of Engines:	1 Rotax 582 piston engine	
Year of Manufacture:	1992 (Serial no: PFA 172-12301)	
Date & Time (UTC):	3 September 2023 at 1300 hrs	
Location:	Near Old Buckenham Airfield, Norwich	
Type of Flight:	Private	
Persons on Board:	Crew – 1	Passengers – None
Injuries:	Crew – None	Passengers – N/A
Nature of Damage:	None	
Commander's Licence:	National Private Pilot's Licence	
Commander's Age:	55 years	
Commander's Flying Experience:	99 hours (of which 28 were on type) Last 90 days – 11 hours Last 28 days – 7 hours	
Information Source:	Aircraft Accident Report Form submitted by the pilot and further AAIB enquiries

Synopsis

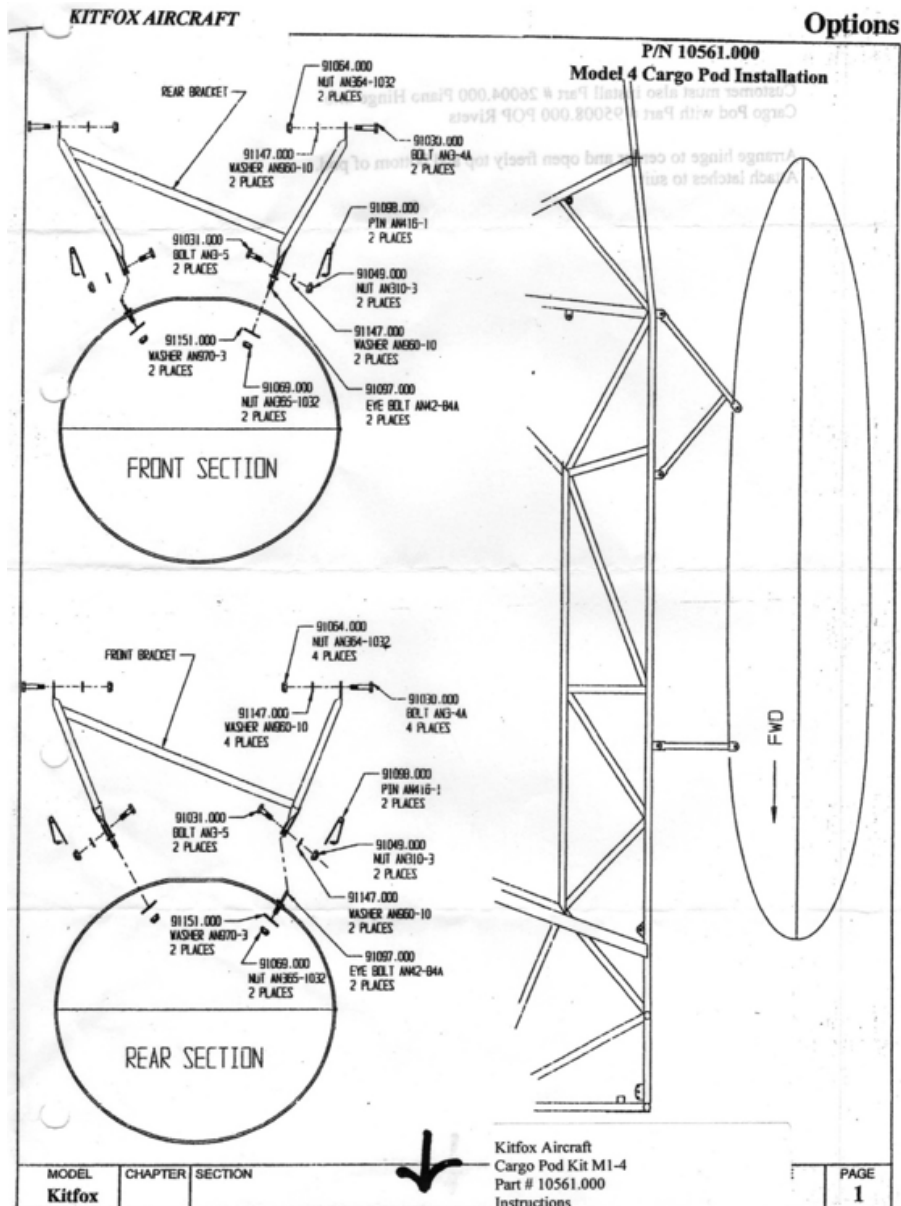
Figure 1

The underslung cargo pod is an optional modification supplied by the manufacturer (Figure 1). G-BUKP's cargo pod was supplied to the aircraft builder with the aircraft kit and had been passed on with the aircraft to subsequent owners.

The LAA has not accepted the cargo pod as a factory standard option for use in the UK, although it can be approved by modification application. This is due to concerns about how the pod and luggage is secured and not fuel consumption. G-BUKP had not been approved to use this modification.

Illustration of the underslung cargo pod

The cargo pod was not an approved factory standard option for use in the UK. To obtain approval, the aircraft owner was required to apply to the LAA for a modification but had not done so. Owners of LAA aircraft should note that only options listed in the 'standard options' section of the aircraft *Type Acceptance Data Sheet (TADS)* can be fitted without a modification application. The TADS that was current when the aircraft was rebuilt did not explicitly preclude use of the cargo pod or any other modification that was not in the 'standard options' list. This may have contributed to the misunderstanding. The next issue of the TADS was clearer but was published after the aircraft was rebuilt. The LAA has modified the TADS for this aircraft type to make it clearer that the underslung cargo pod has not been approved.
