Accident

Aircraft Type and Registration:	Flylight Nine, G-CMRF	
No & Type of Engines:	1 Polini 303 piston engine	
Year of Manufacture:	2023 (Serial no: DA275)	
Date & Time (UTC):	17 November 2023 at 1405 hrs	
Location:	Darley Moor Airfield, Derbyshire	
Type of Flight:	Private	
Persons on Board:	Crew – 1	Passengers – None
Injuries:	Crew – None	Passengers – N/A
Nature of Damage:	Significant damage to right wing and propeller.	
Commander's Licence:	National Private Pilot's Licence	
Commander's Age:	70 years	
Commander's Flying Experience:	545 hours (of which 457 were on type) Last 90 days – 44 hours Last 28 days – 13 hours	
Information Source:	Aircraft Accident Report Form submitted by the pilot and further enquiries by AAIB.

Synopsis

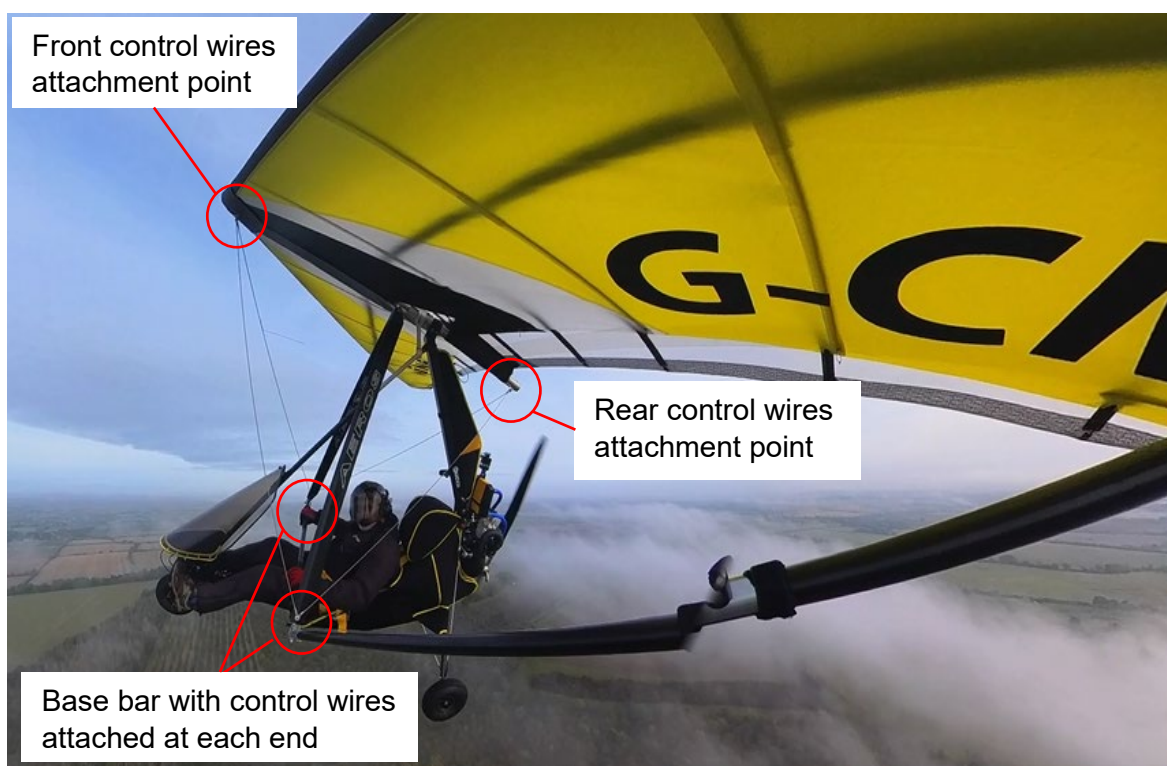
Figure 1

Image from an onboard camera showing base bar cables attached.

Examination of the keel tube after the landing found that the bolt and nyloc nut² securing the rear control wires to the keel tube were missing. As the aircraft was a new product, cameras had been fitted to record the flight. Video footage showed the moment where the rear control wires slackened indicating that they had detached from the keel tube.

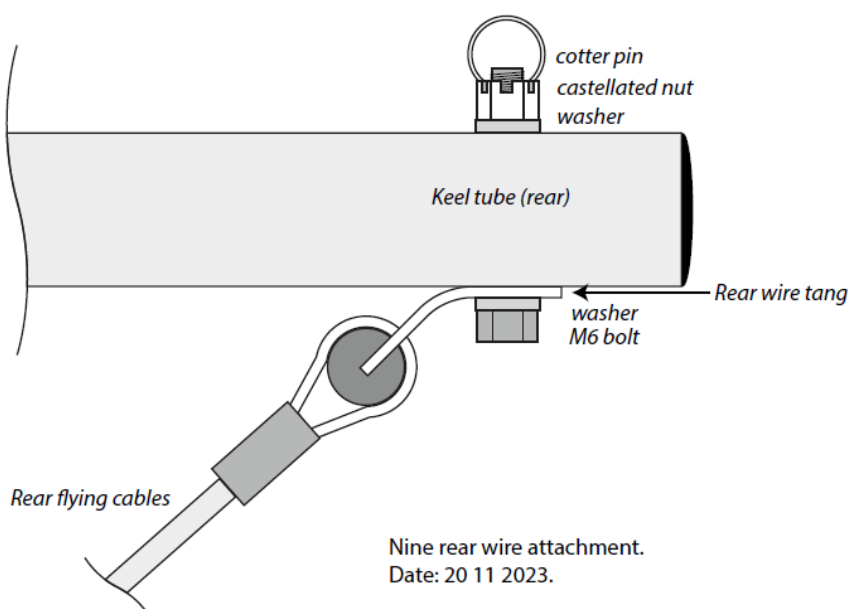
Figure 2

Pictures of the aircraft that were taken soon after construction was completed showed that the bolt, which was fitted to the underside of the keel tube, was secured by the nyloc nut on top of the tube but there was only one thread visible protruding from the nut³. The nut and bolt must have been present during the pilot's pre-flight inspection because the rear cables would not have been connected and it would have been immediately noticeable that the wires were slack. Moreover, the pilot would not have been able to use the base bar to adjust the angle of the wing during taxi, takeoff and flight. Figure 1 shows the rear cables still connected between the base bar and the keel during the accident flight. It was likely that the nut vibrated loose and, as a result, the bolt fell out due to vibration and gravity.

Diagram showing replacement castellated nut and cotter pin.

The manufacturer has replaced the bolt with a longer variant and the nyloc nut with a castellated nut and cotter pin, (Figure 2). They updated the design documents for the aircraft to reflect this change and added the requirement for pilots to specifically check this fitting during their walk-round check in the Pilot's Operating Manual.
