AAIB Bulletin

4/2024

Aircraft Type and Registration:	ATR 72-212A 600, EI-GPN	
No & Type of Engines:	2 Pratt & Whitney PW127 turboprop engines	
Year of Manufacture:	2015	
Date & Time (UTC):	19 September 2022 at 1100 hrs	
Location:	Belfast City Airport	
Type of Flight:	Commercial Air Transport	
Persons on Board:	Crew – 4	Passengers – 32
Injuries:	Crew – None	Passengers – None
Nature of Damage:	None	
Commander's Licence:	Airline Transport Pilot's Licence	
Commander's Age:	40 years	
Commander's Flying Experience:	3,900 hours (of which 3,200 were on type) Last 90 days – 164 hours Last 28 days – 50 hours	
Information Source:	AAIB Field Investigation

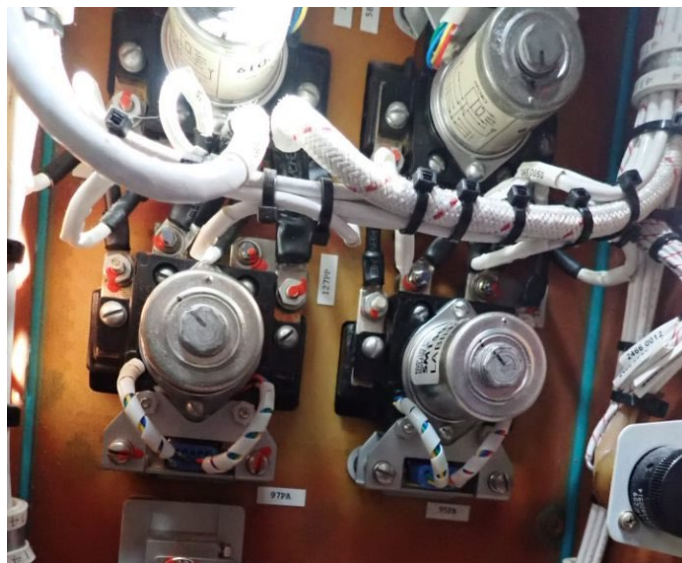
Figure 9

The 95PA contactor as fitted to EI-GPN

the TRU was selected OFF, the systems returned to normal. With the aid of the aircraft circuit diagrams and the assistance of the operator's line engineer, a malfunction of the 95PA contactor was identified as the most likely cause. System functional checks carried out on the aircraft confirmed this was the case. The 95PA contactor was replaced and further testing of the systems and operation of the TRU corroborated this. The aircraft was released back to the operator and placed back into service; there has been no recurrence of the malfunction.

The contactor was disassembled and it was found that the contact surfaces on the contact plate and on the A1/A2 contacts showed evidence of arcing and poor connection. Further examination found that the pin had slipped 0.0196 inches out of the plunger hole. A pull-out test was also carried out and the pin moved with a force of 18 lbs. The minimum pull-out force should have been 80-100 lbs.

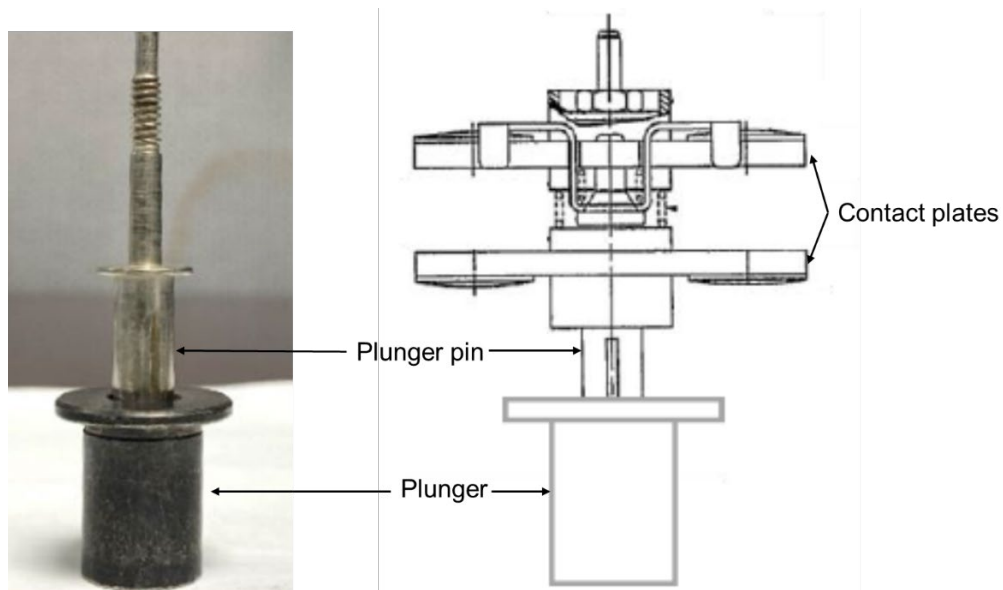
Figure 11

The plunger assembly consist of two parts; the plunger and plunger pin. The plunger pin is held in a hole drilled in the plunger by a form of interference¹⁸ fit. (Figure 11). During manufacture the minimum force required to insert the pin into the hole is 70 lbs. When correctly assembled, the force required to withdraw the pin, known as the pull-out force, is 80-100 lbs.

Plunger and pin assembly

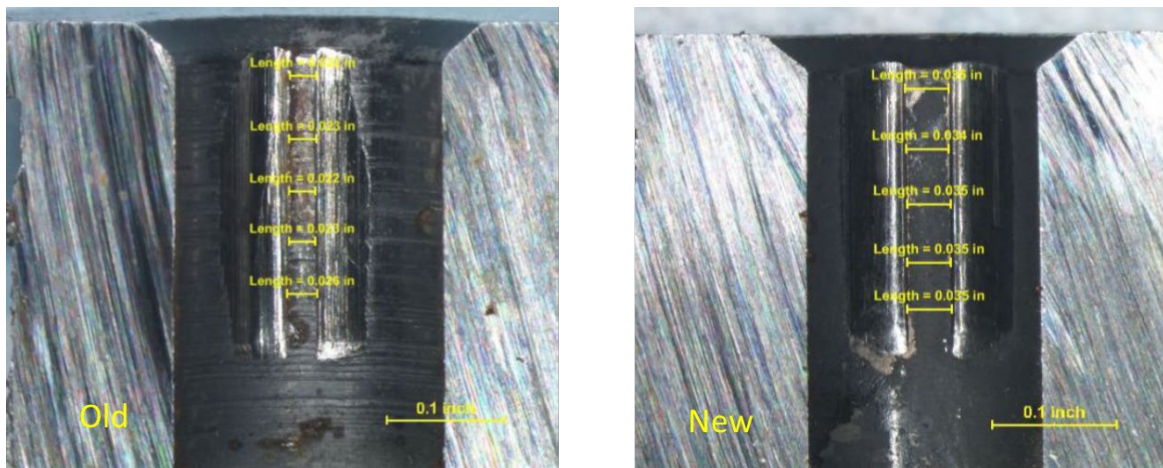
Example plungers taken from older and newer assemblies were sectioned and measured. This found the dimensions of some of the older pin groove indentation marks left in the bore of the plunger were less than those marks in newer plungers. Figure 12 shows the difference in the dimension with a mean of 0.0245 inches in the older plunger and a mean 0.0319 inches in the newer plunger.

Plunger bore dimensions of the grooves left by the pin

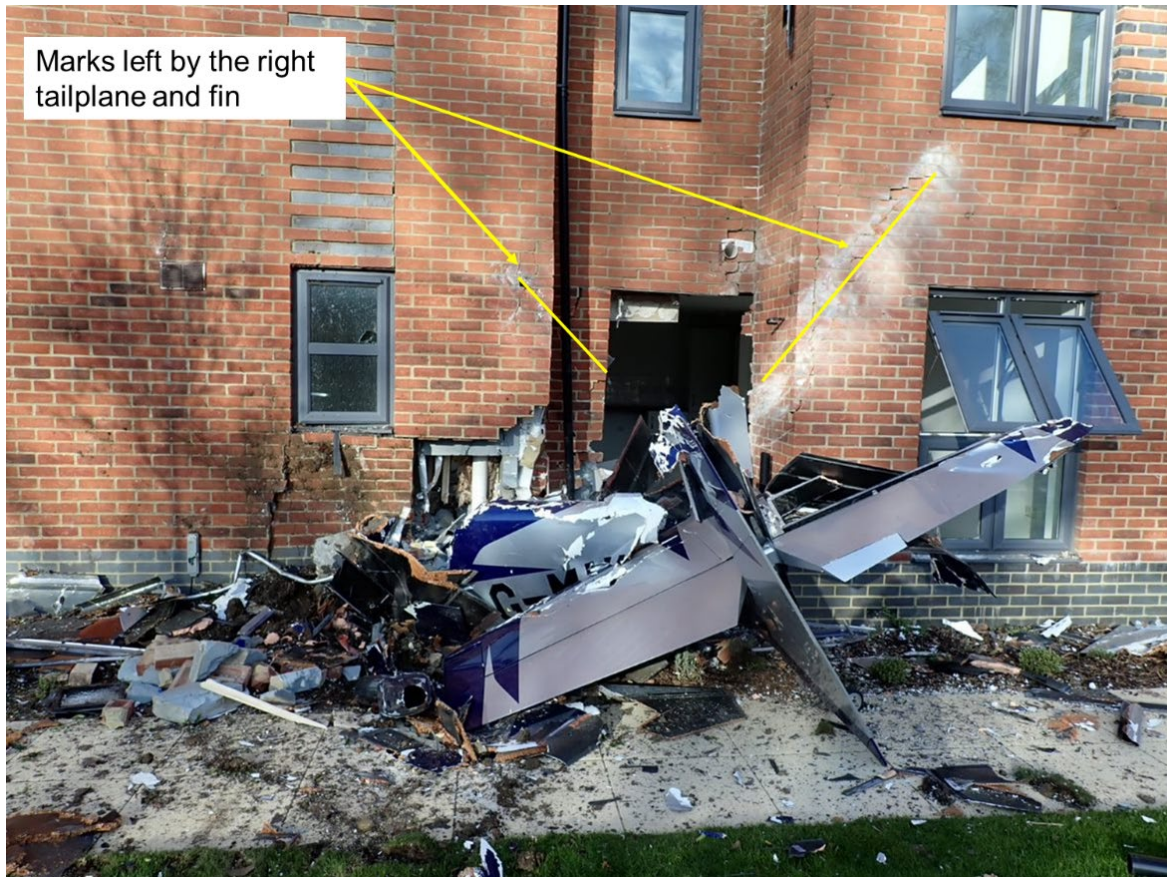
Figure 1

The aircraft hit the ground approximately 1 m from an unoccupied newly built block of flats. Marks on the ground and on the building show the aircraft was at a shallow angle at impact with enough energy to continue to penetrate the building. The engine embedded itself into the foundations of the building and was lodged beneath the ground floor concrete beams. The outer walls and a window of two adjacent flats had collapsed inwards. The aircraft had disintegrated to the extent that the only recognisable parts were the tailplane and fin. Marks on the brickwork left by the leading edges of the tailplane and fin indicated the trajectory of the aircraft at impact (Figure 1).

Accident site showing marks on the walls made by the fin and tailplane

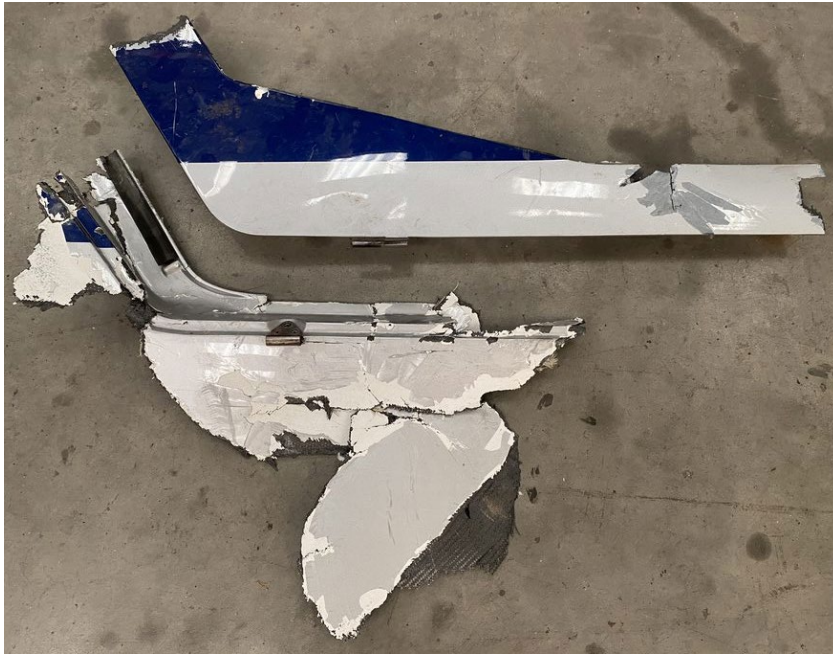
Figure 2

Right rear section of canopy frame and hinge

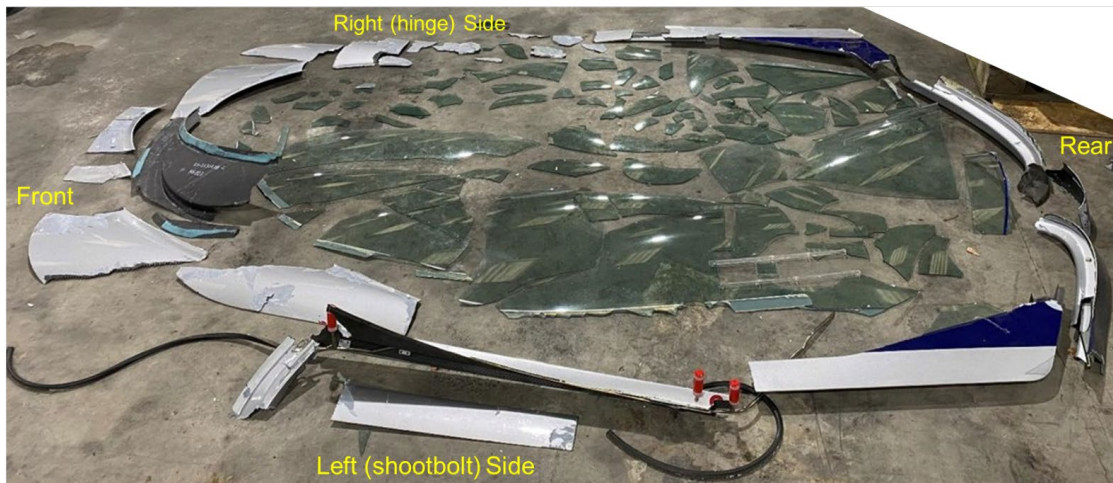
Figure 9

All the canopy parts were laid out and despite the extensive fragmentation showed that the left side of the canopy had fragmented into generally larger parts than the right (Figure 9).

Canopy remains

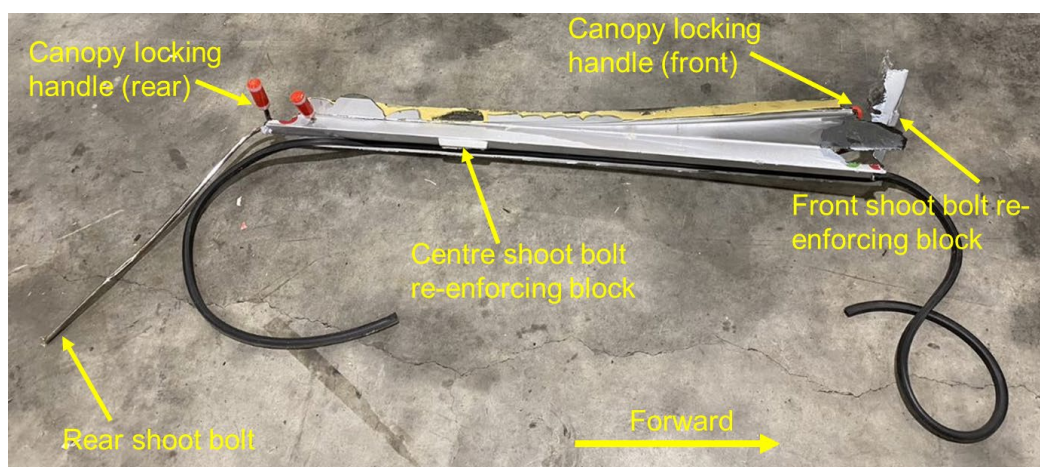
Figure 10

The left side of the canopy frame was severely damaged and distorted, but the shoot bolts, linkage tube and its handles were present. Despite the extensive damage the linkage tube and shoot bolts were being held in the closed and locked position by the spring (Figure 10). This part of the canopy had landed in a ploughed field. There was no evidence of soil or organic matter on any part of this structure indicating that the damage had occurred prior to it hitting the ground.

Left side canopy frame

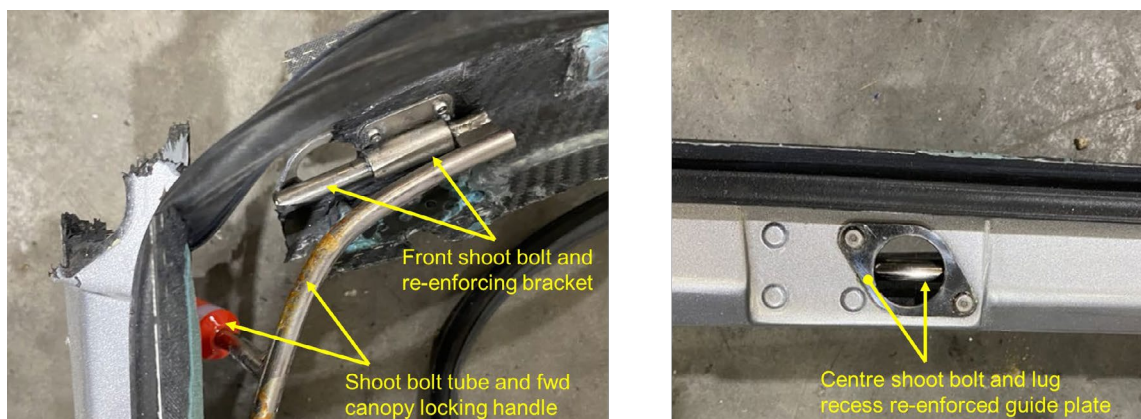
Figure 11

The front shoot bolt tube showed evidence of having been forced away from the fuselage mounted lug and roller. The centre shoot bolt assembly and surrounding canopy frame was undamaged with the shoot bolt in its locked position (Figure 11).

Front and centre shoot bolt assemblies

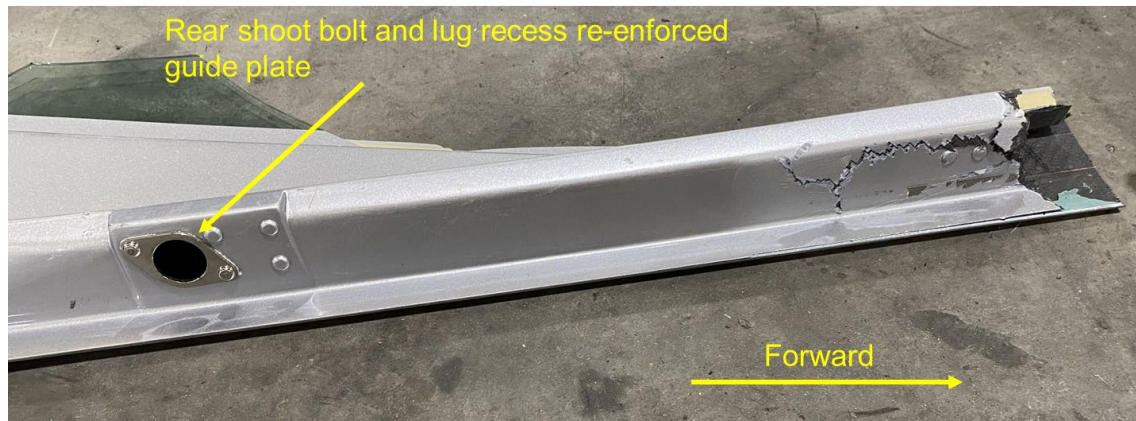
Figure 12

The rear shoot bolt was of a slightly different design to the two other shoot bolts as it was fitted into the end of the linkage tube on to which they were all attached. The canopy frame surrounding the rear shoot bolt had become detached. However, its re-enforcing plate and bracket were undamaged (Figure 12).

Left side rear canopy frame section

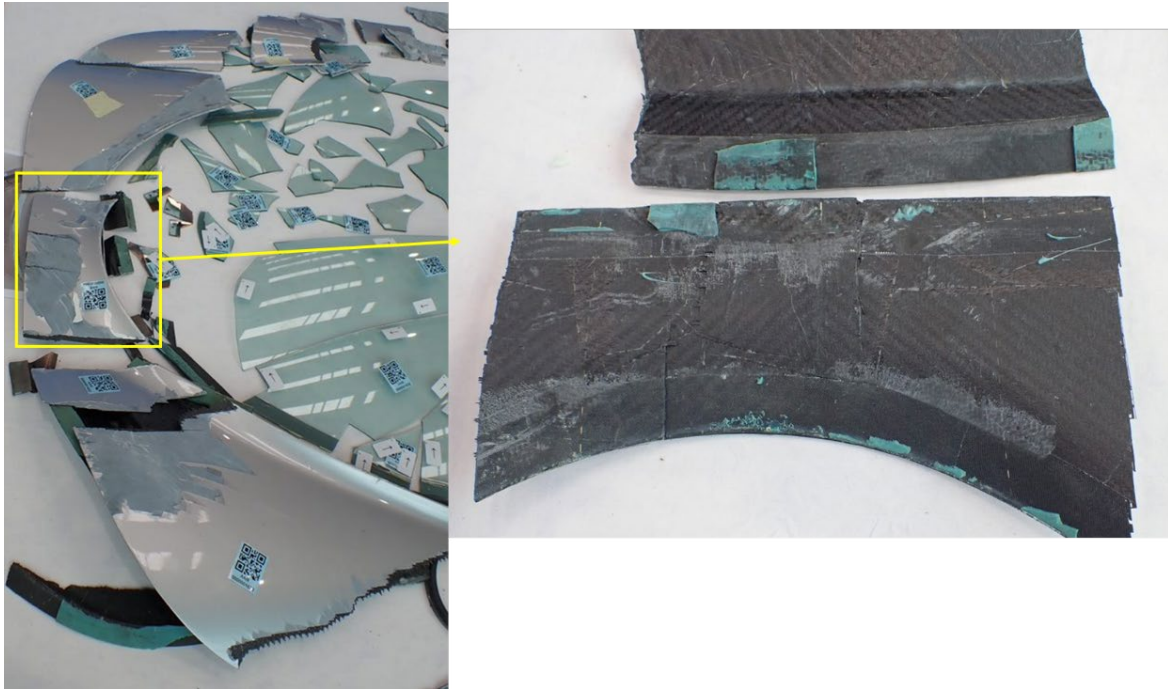
Figure 14
Canopy front section

Examination of the canopy frame parts revealed significant differences in the way the front area of the frame had broken up compared to the rear. The front parts had broken into small pieces (Figure 14). The outer skin had separated from the inner 'U' channel from the front lug to the front hinge.

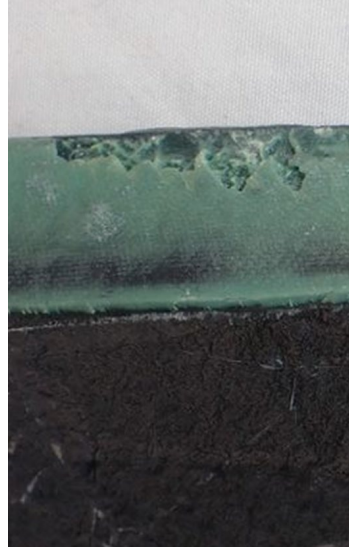
Figure 15

One small section of the front canopy frame had a small area of bond which showed an apparent 'crystalline' feature and to be very thinly spread into the peel ply surface (Figure 15).

Epoxy bond 'crystalline' feature

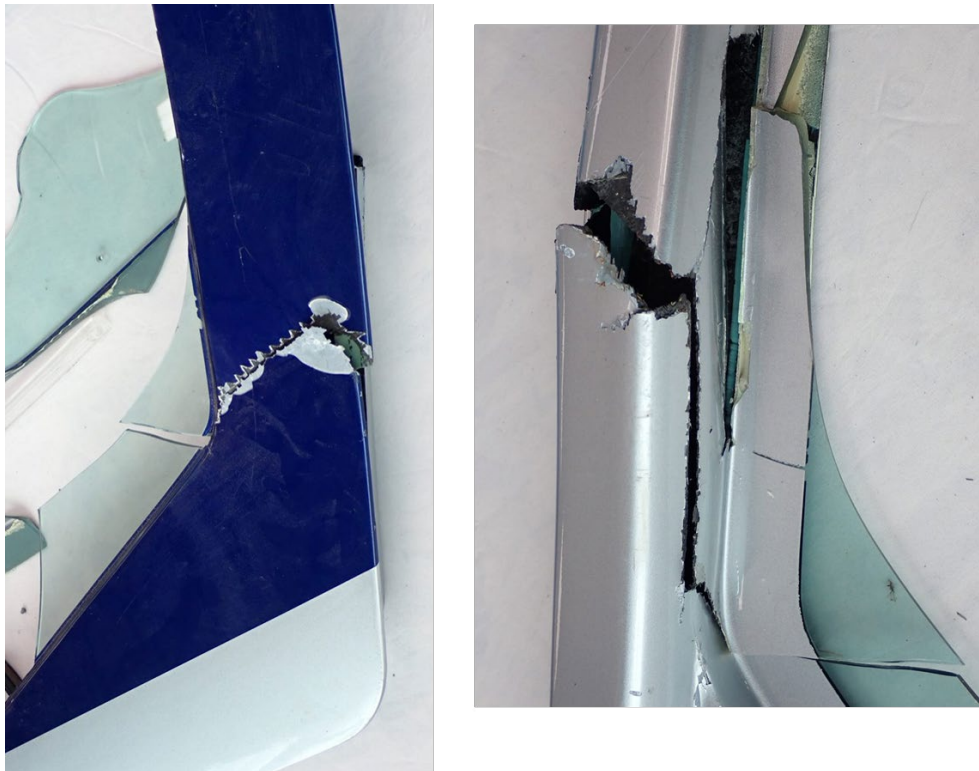
Figure 16

Parts of the rear canopy frame had breaks through the inner and outer skin. Other than small areas either side of the breaks, the remains of the inner and outer skin were still bonded together (Figure 16).

Part of the rear left side corner of the canopy frame

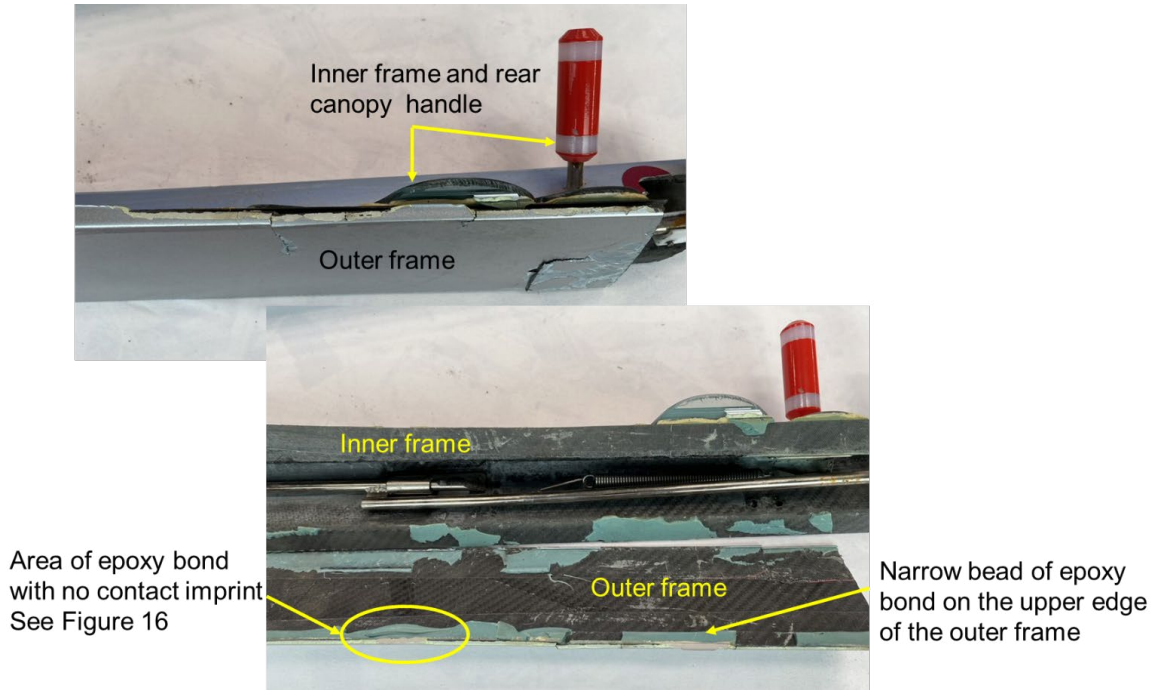
Figure 17
Canopy inner and outer frames left side

One area of the outer frame covering the shoot bolt mechanism had not been attached to the left channel of the canopy frame (Figure 17). The bead of bond material at the top of this piece of the structure was inconsistent and narrow and had not been fully applied over the peel ply area. In one small area, about 50 mm in length, it had not made contact with the inner frame at all (Figure 18).

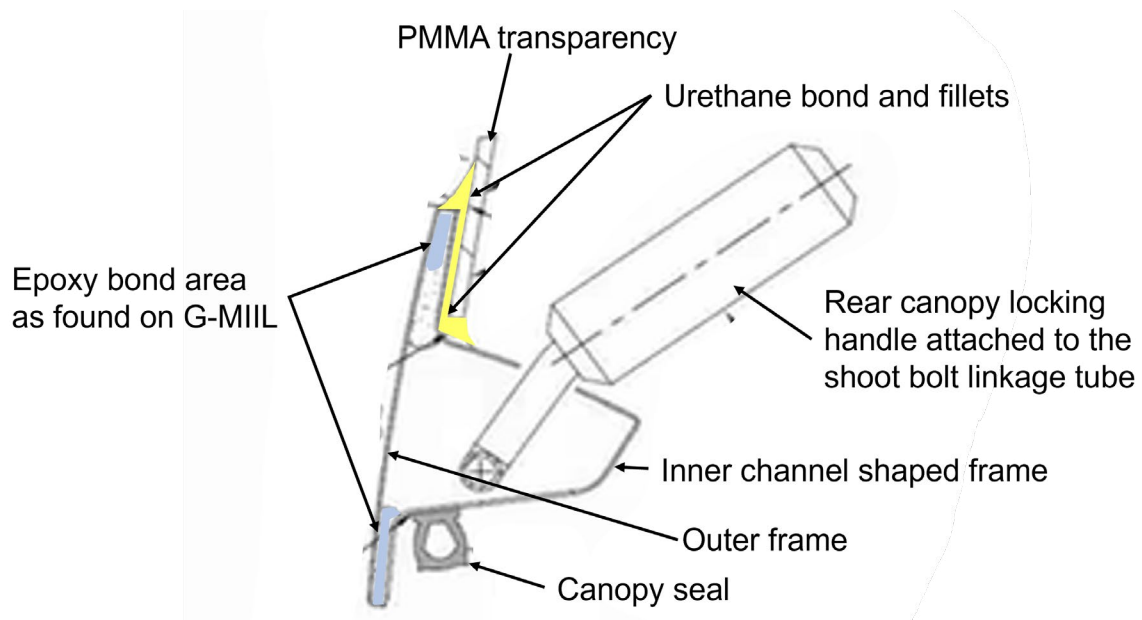
Figure 20

Epoxy bond area between the inner and outer canopy frames as found on G-MIIL

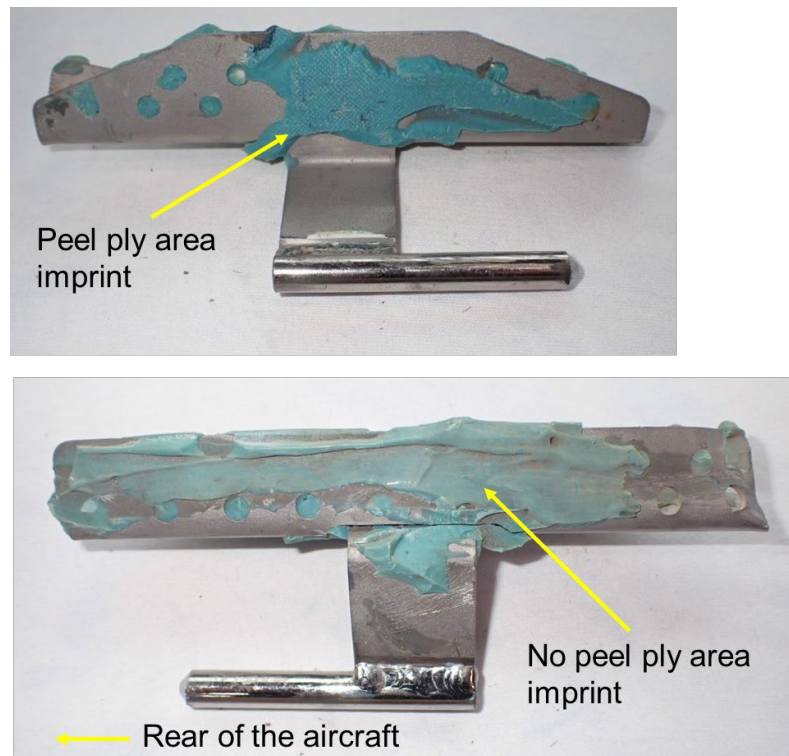
Figure 21

Imprints left in the epoxy bond present on the surface of the hinge that was found completely detached, appears only to have been in contact with a peel ply surface on one of its faces. The other face showed only partial contact with a large area of the epoxy bond showing no peel ply area imprint (Figure 21).

Both sides of unidentified canopy hinge showing the extent of the epoxy bond in contact with the peel ply area

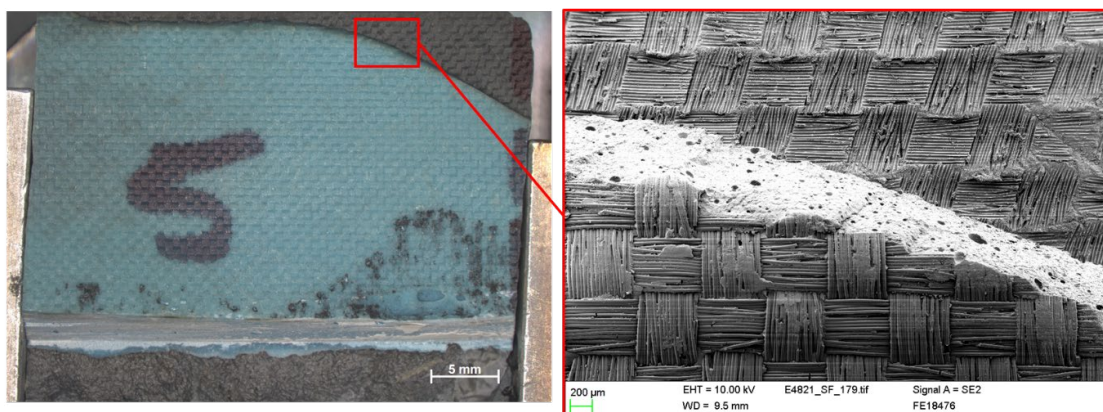
It was found that the surfaces on several sites were relatively clean with little matrix or resin present, showing an adhesive⁴ failure at the interface. There was also significant porosity in some of the adhesive layer, which may be indicative of a problem with the bonding method. Figure 22 shows an example of this phenomena on one of the sample pieces. Numerous other pieces showed similar characteristics with apparent adhesion failure. There did not appear to be any areas which exhibited cohesion⁵ failure.

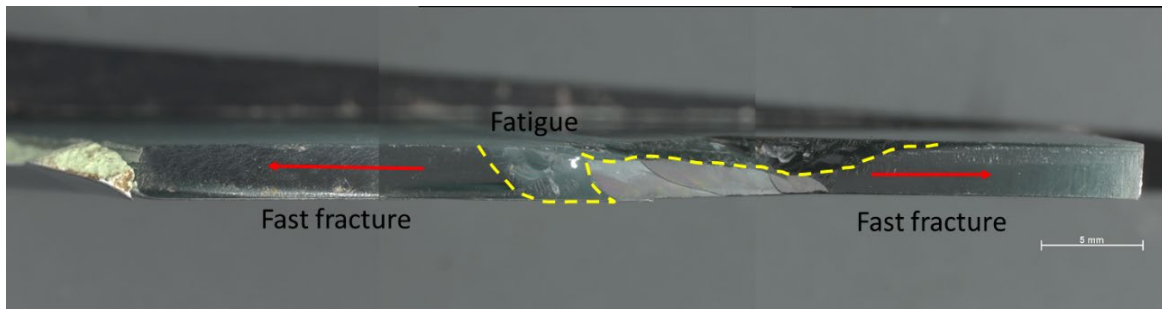
Parts of the transparency were also examined using the same method, particularly the edges where they had been bonded onto the canopy frame. Clear evidence of fatigue initiation was found. This resulted in crack initiation followed by fast, unstable crack propagation extending into the material. Figure 23 shows an example of this and Figure 24 shows its location.

Evidence of fatigue and crack initiation

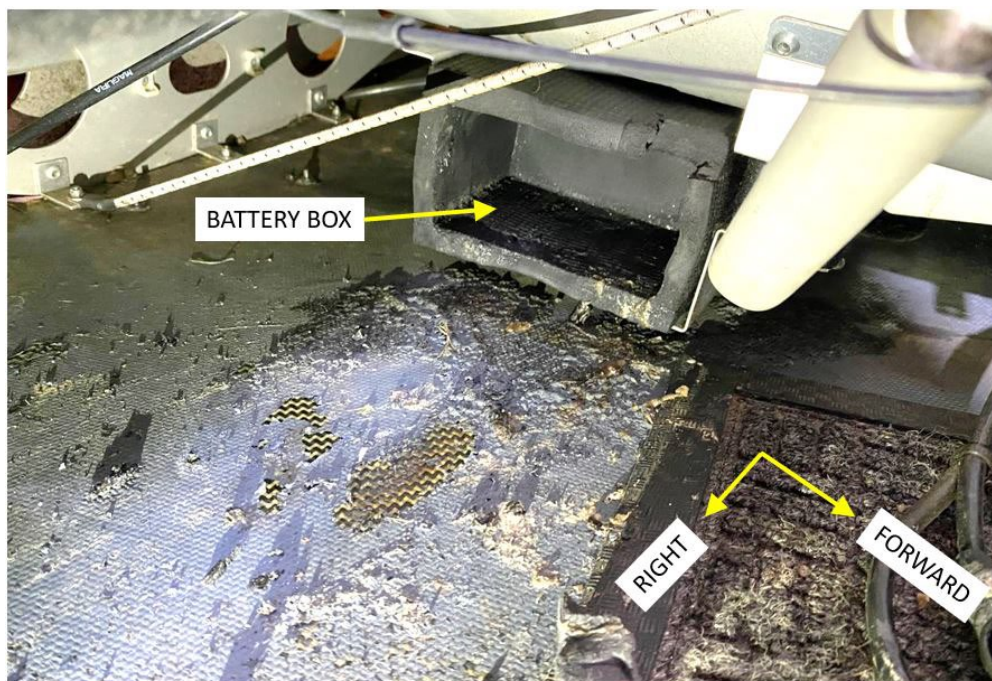
Figure 3

The damage to the aircraft was limited to charring and scorching of the composite cabin floor around the battery box (Figure 3).

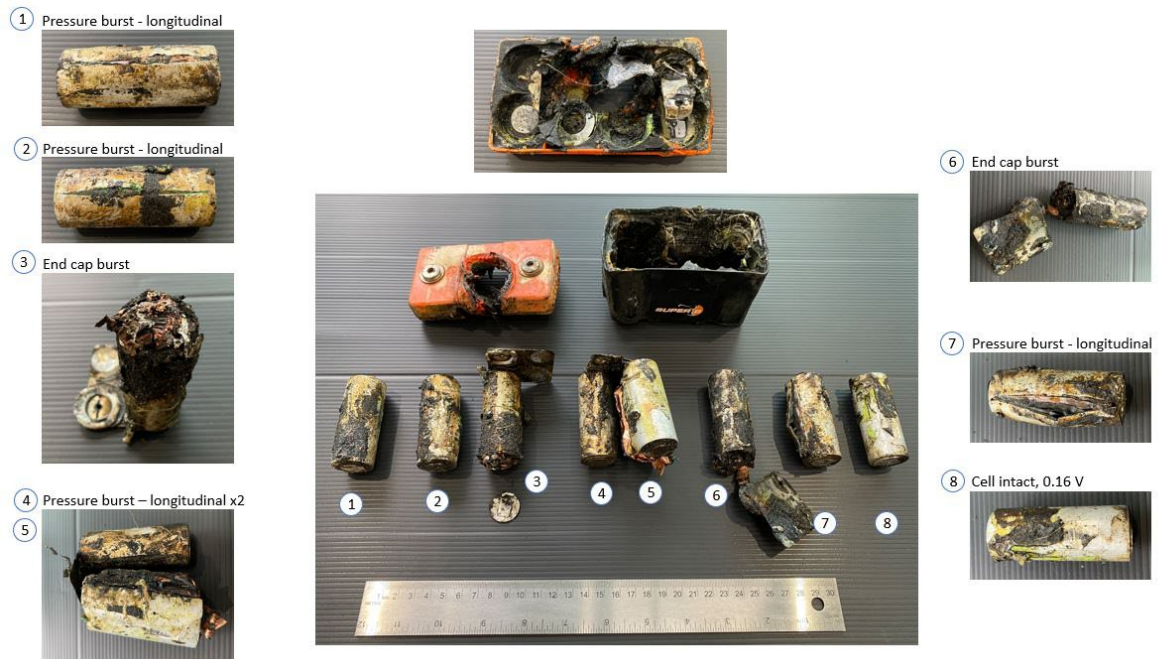
Figure 4
Damaged parts of the battery

The battery's external plastic case had melted and was penetrated between the battery terminals, indicating that the final stage of the thermal runaway was located close to this position. Seven of the cells had burst, due to excessive internal pressure, and one cell was intact and still retained a low voltage level of 0.16 V. The manufacturer stated that it was not possible to identify a cause for the battery thermal runaway due to the damaged state of the battery parts.

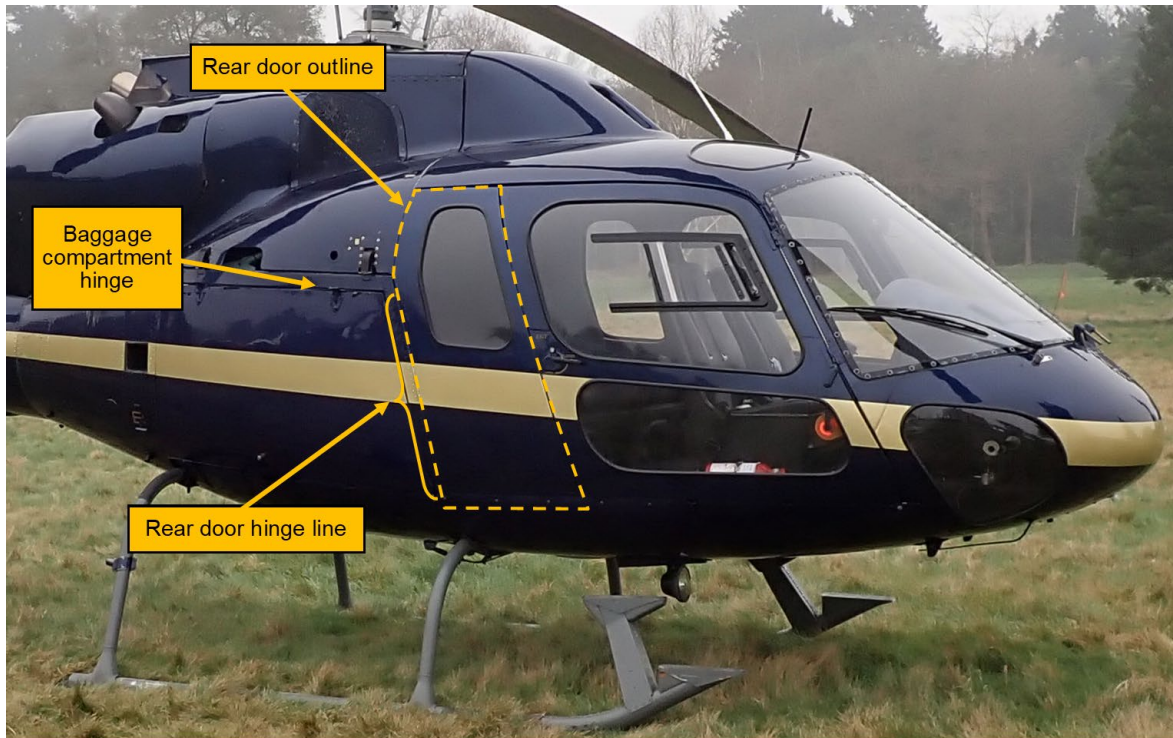
Figure 1

After shutting the helicopter down the pilot saw there was minor skin damage on the rear door and that its window was cracked. The crack was contained, with no loose fragments, and appeared to have been caused by the window striking the baggage compartment hinge (Figure 1) when the door swung backwards as it opened.
