Accident

Aircraft Type and Registration:	AW109SP, G-RAYN	
No & Type of Engines:	2 Pratt & Whitney Canada PW207C turboshaft engines	
Year of Manufacture:	2019 (Serial no: 22401)	
Date & Time (UTC):	1 November 2022 at 1726 hrs	
Location:	Nantclwyd Lodge, near Llanellidan, Denbighshire	
Type of Flight:	Non-commercial operation	
Persons on Board:	Crew - 1	Passengers - 5
Injuries:	Crew - None	Passengers - 1 (Serious) 4 (Minor)
Nature of Damage:	Helicopter destroyed	
Commander's Licence:	Commercial Pilot's Licence (Helicopters)	
Commander's Age:	47 years	
Commander's Flying Experience:	3,815 hours (of which 1,565 were on type) Last 90 days - 81 hours Last 28 days - 24 hours	
Information Source:	AAIB Field Investigation

Synopsis

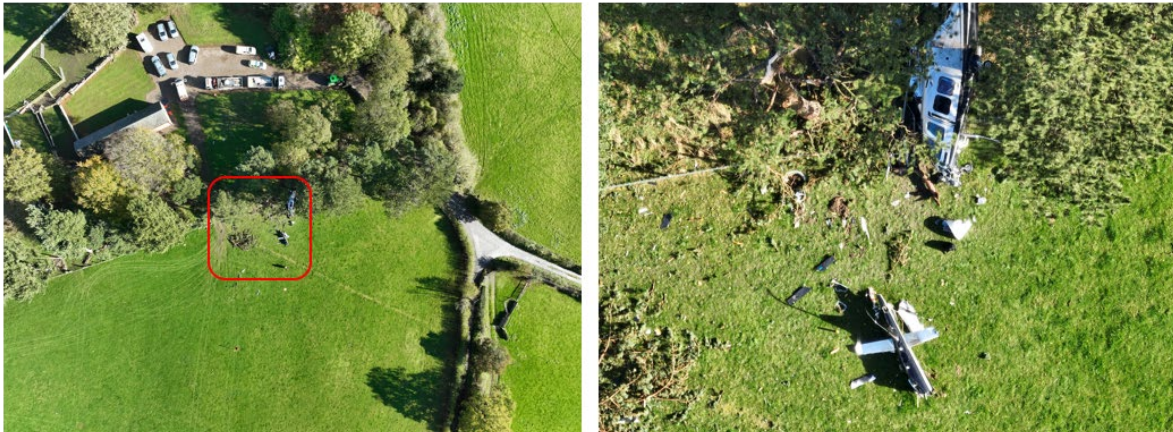
Figure 2

The helicopter came to rest at the base of a tree approximately 30 m from the shooting lodge. The main fuselage of the helicopter was intact but the tail boom had separated and been thrown forward of the point of ground impact (Figure 2).

Overhead view of G-RAYN accident site

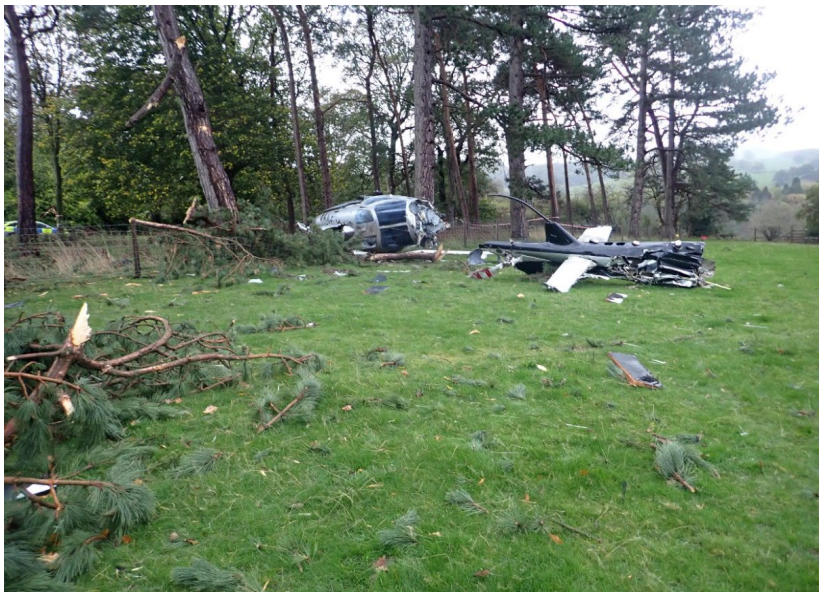
Figure 3

There was a large amount of debris spread around the surrounding area, mainly consisting of fragments from the rotor blades and branches from the trees. A detailed GNSS plot was taken of the main components of wreckage, impact marks and debris. There was no evidence of fuel leaks and there was no post-crash fire. There were clear impact marks near the top of the trunk of the tree adjacent to the helicopter wreckage and a significant swathe of branches had been cut from the top of this tree and landed adjacent to the main fuselage (Figure 3).

Ground view of main accident site

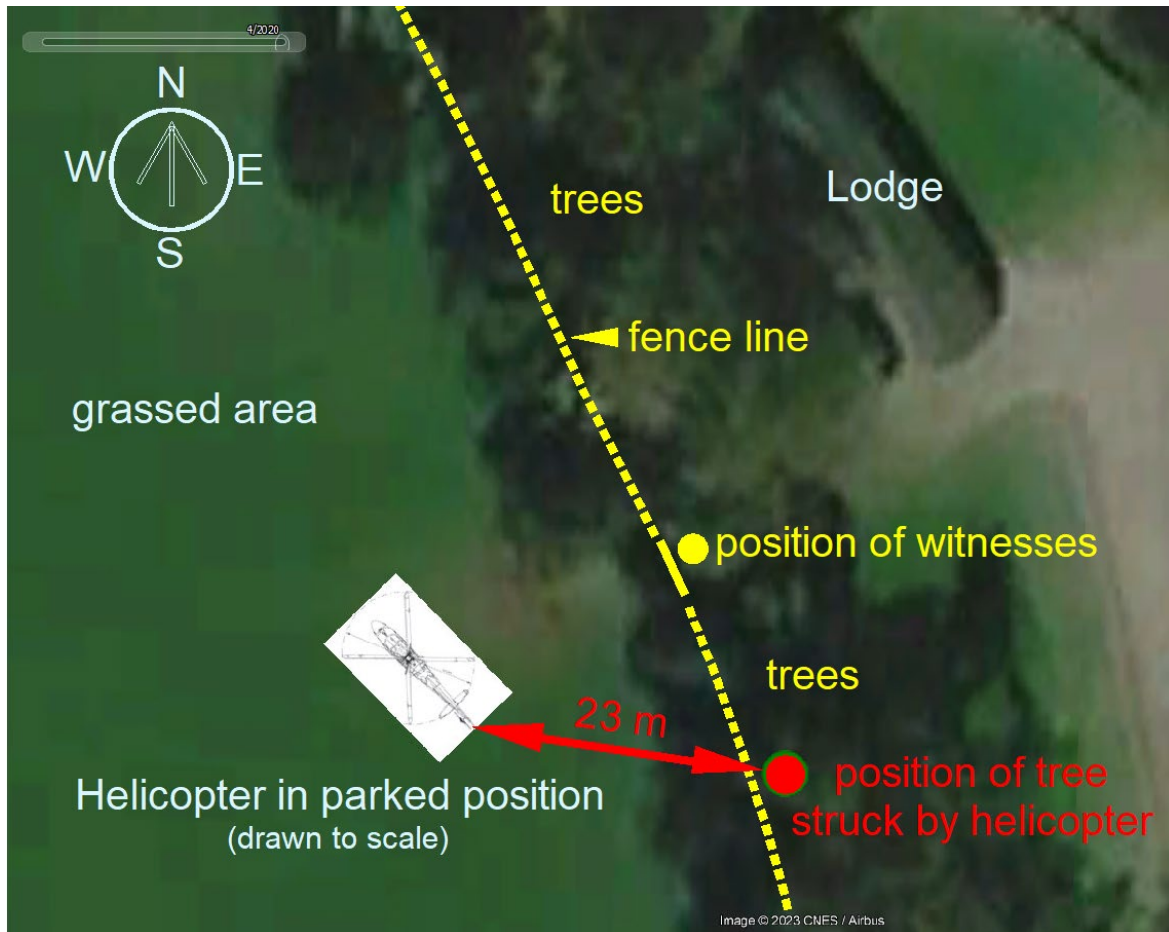
Figure 6

Position of helicopter prior to takeoff
(©2023 Bluesky, Infoterra Ltd & COWI A/S, CNES / Airbus, Getmapping plc, Maxar Technologies)

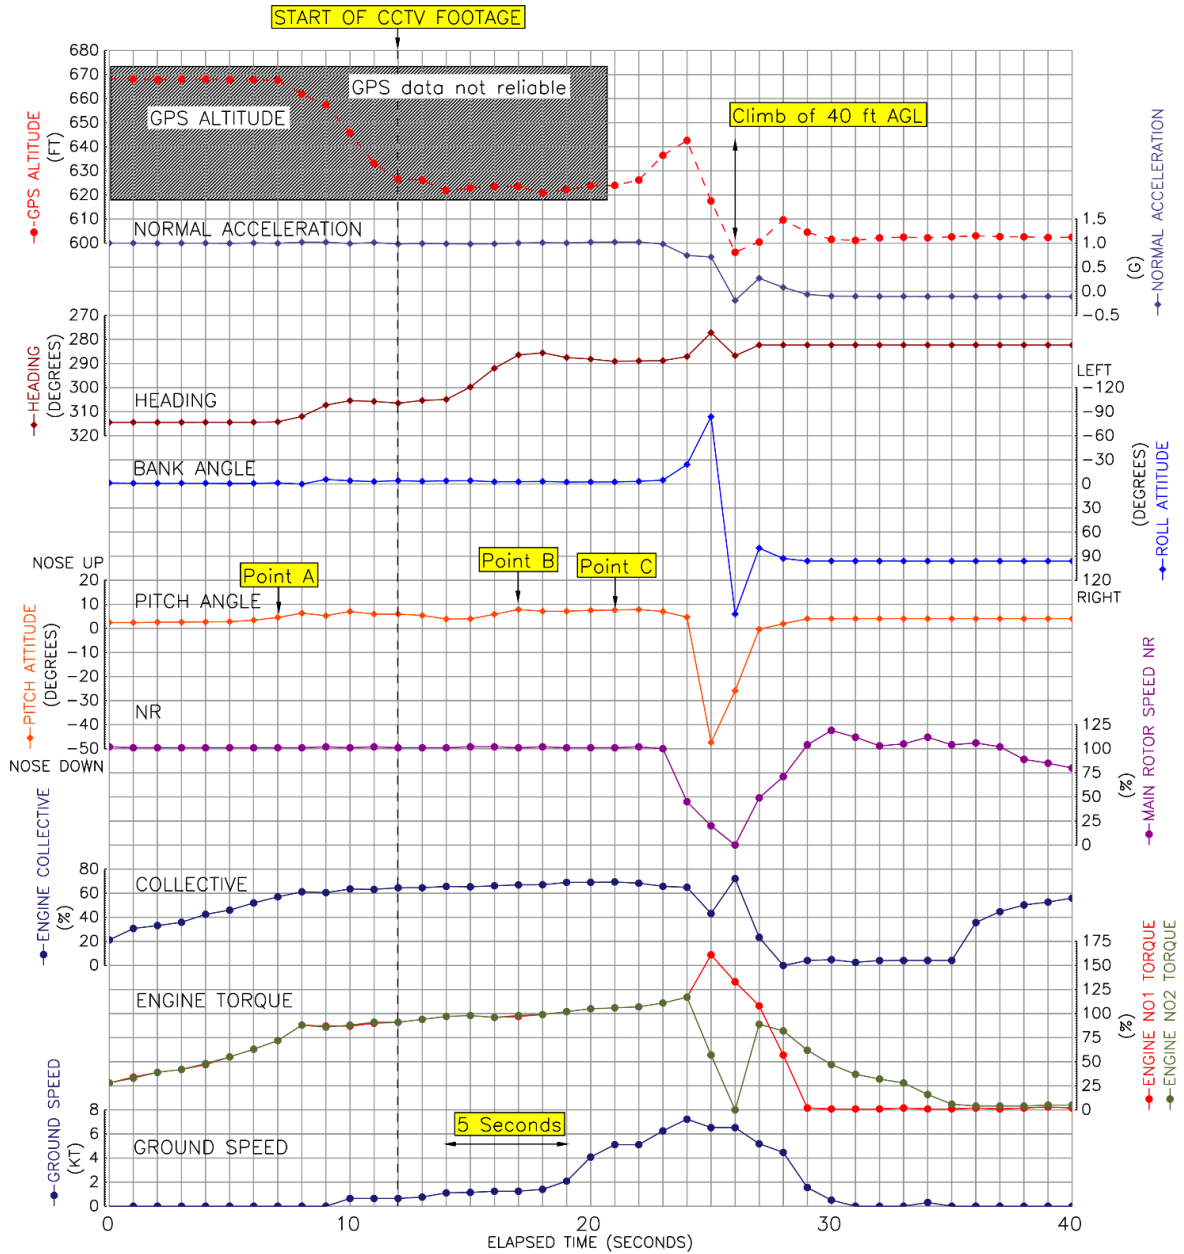
Figure 7

Flight data during the accident

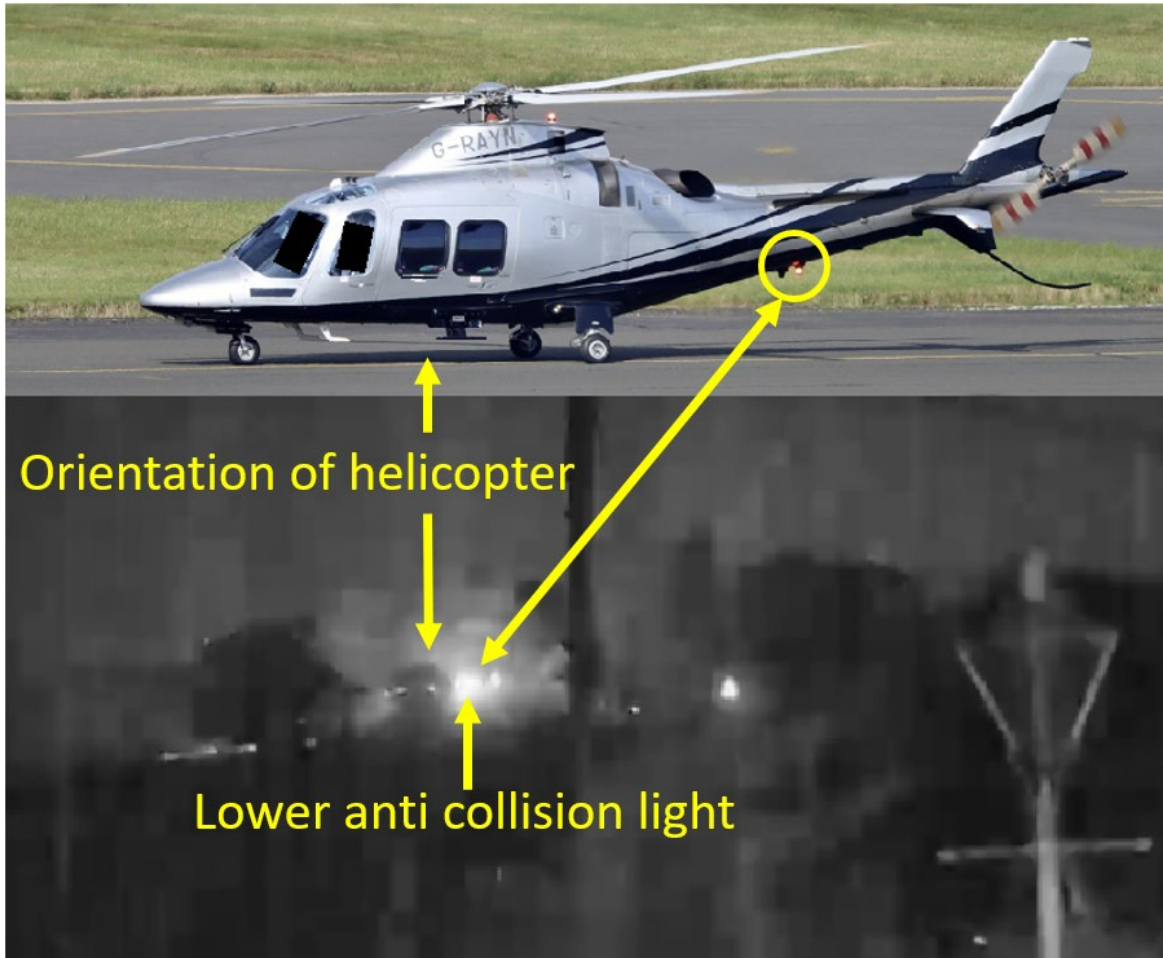
Figure 8

CCTV image as the helicopter started to climb

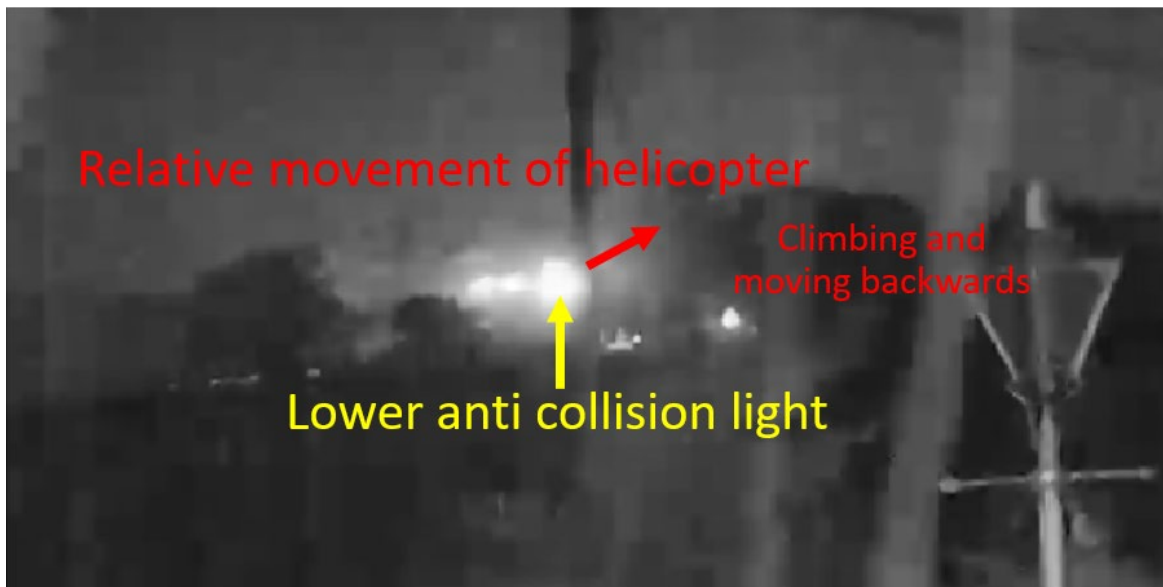
Figure 9

Image of helicopter shortly before striking trees

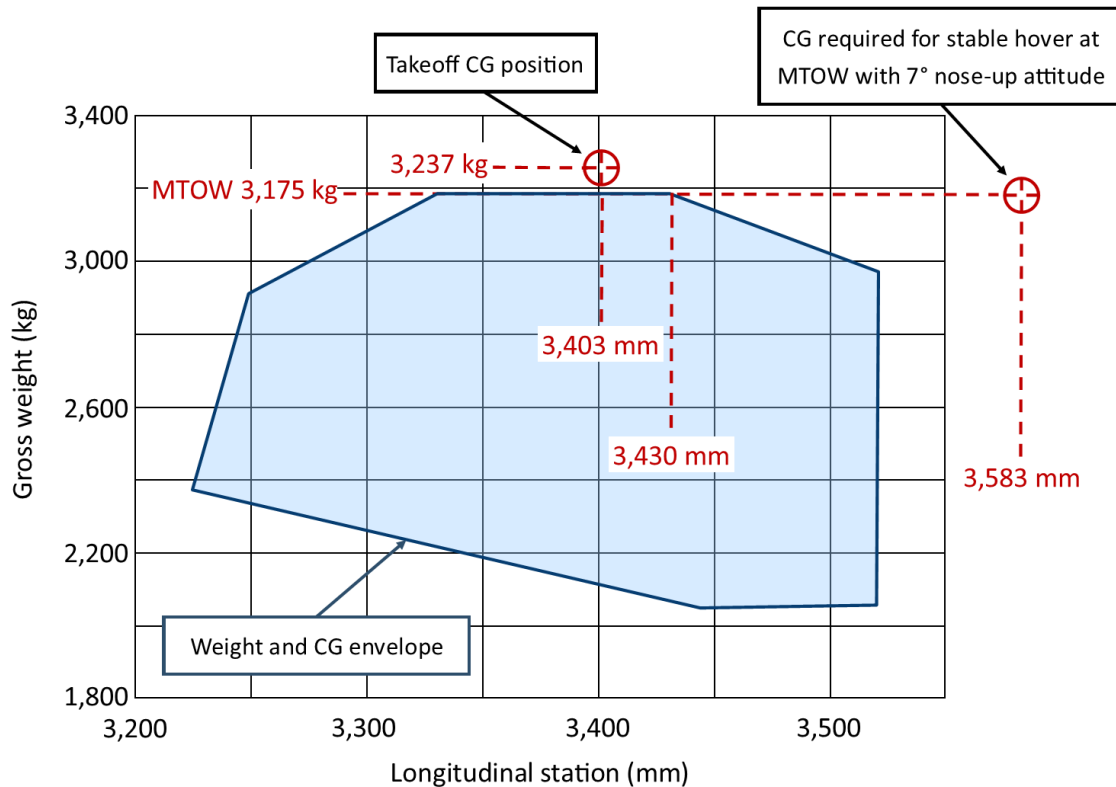
Figure 11

Weight and longitudinal CG envelope for G-RAYN

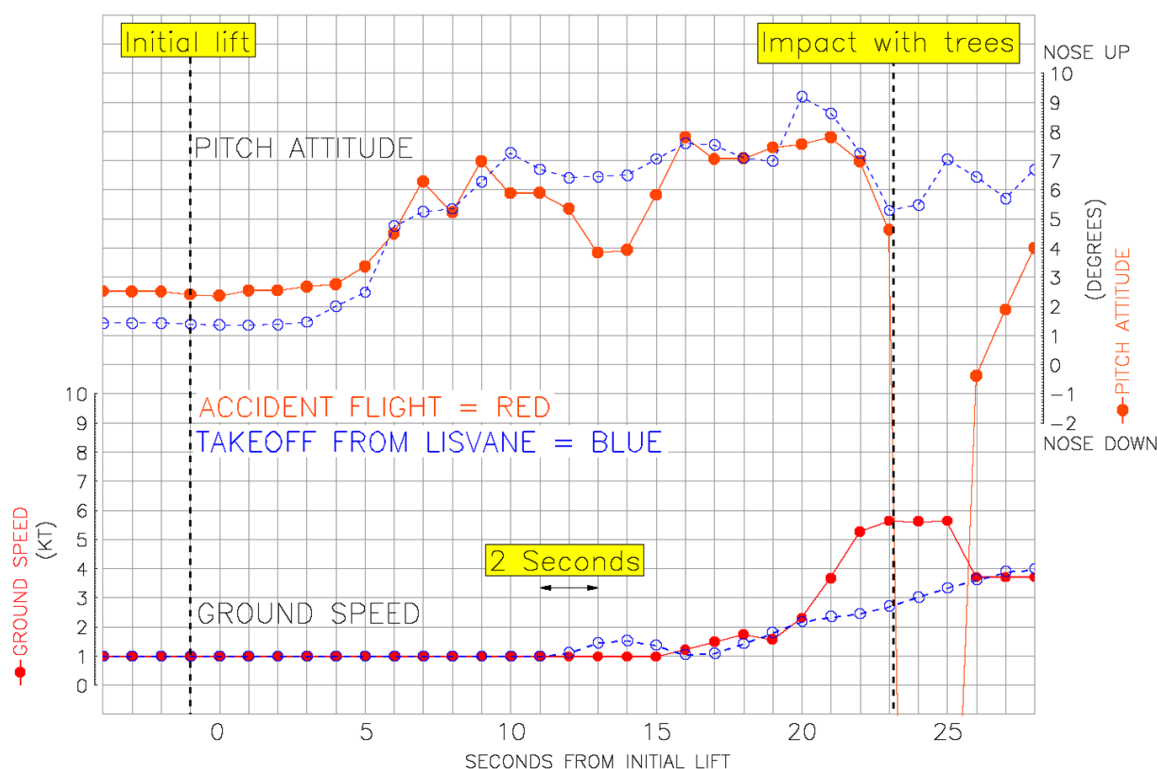
Figure 14

A comparison between the recorded pitch attitudes and groundspeeds during the Category A back-up departure flown from Lisvane that morning and the attempted vertical departure on the accident flight is shown below (Figure 14). Other than the temporary reduction in pitch attitude as the pilot turned into wind at LEA2²⁹ the pitch attitude profiles are broadly similar. The takeoff from Lisvane was a crosswind departure, whereas the helicopter was experiencing a headwind as it climbed from LEA2, this could explain the difference in rearward ground speed acceleration rates observed beyond the 20 second point on the Figure 15 chart.

Comparison of Lisvane (blue) and accident flight (red) Category A departures

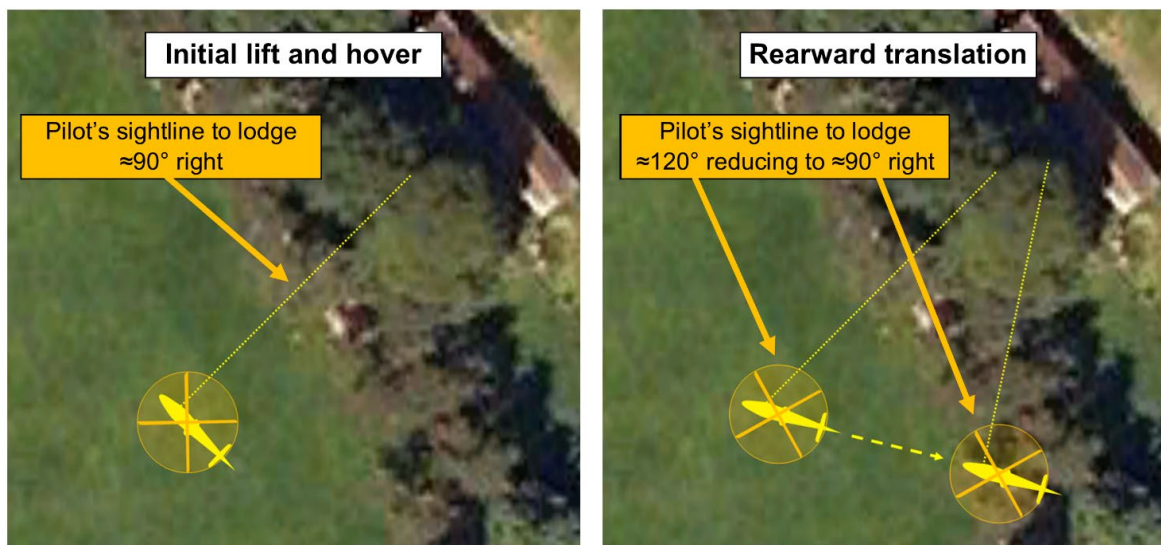
Figure 21

As the helicopter lifted into the hover, the lodge's windows would have been in the helicopter's approximate 3 o'clock position, in line with the pilot's shoulders. Having turned into wind, the chosen lateral markers would have become more difficult to see, the pilot needing to look back over his shoulder to see the lights, approximately 30° behind his shoulder line (Figure 21). The lights' change in relative position would have made it harder to discriminate between real and apparent drift, degrading their usefulness as markers. As the helicopter translated rearwards the lights would have appeared to move closer to their original orientation in the pilot's 3 o'clock position.

Representation of pilot's sightline to lodge windows during departure
(image © 2023 Getmapping plc)
