# Train damaged by collision with an object at Highdyke, Lincolnshire, 19 December 2023

## Summary of the accident

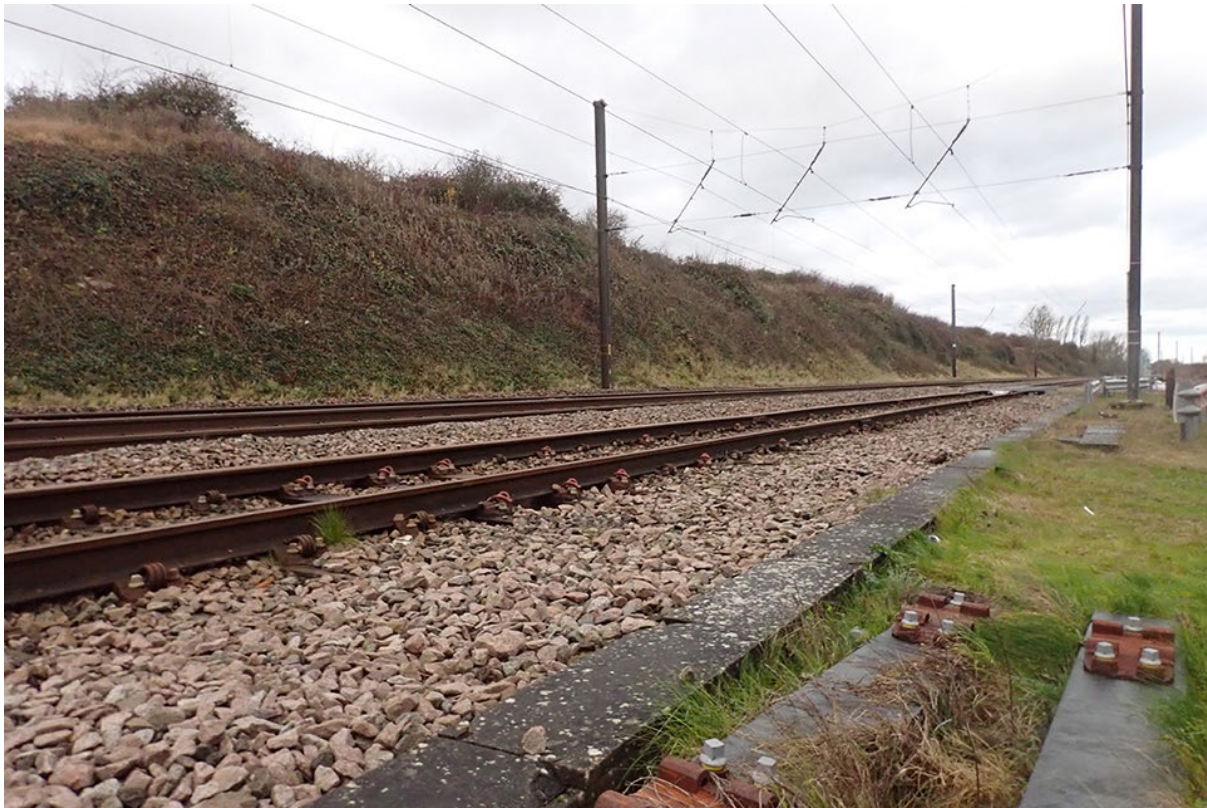
**Road-rail vehicle access point at Ponton Yard near Highdyke, looking north towards Grantham.**

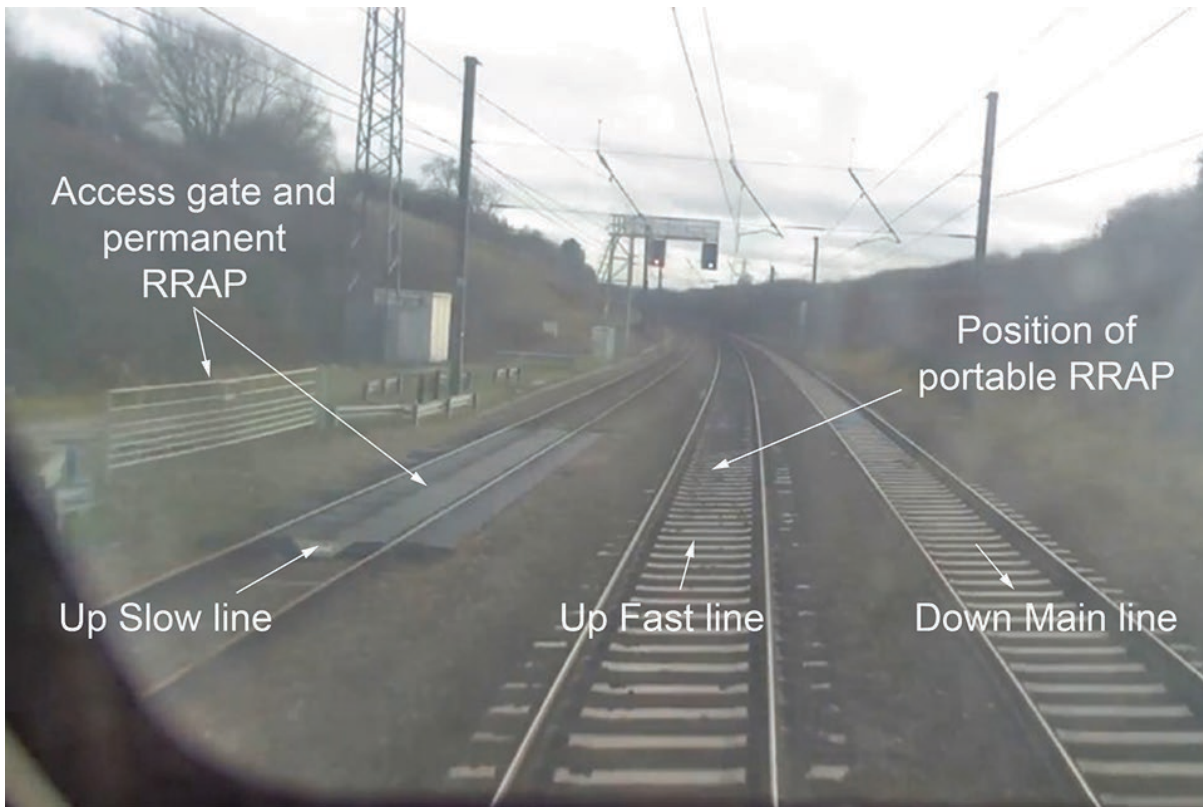
**Image captured of Ponton Yard access point from a train travelling south on the Up Fast line. From left to right can be seen the access gate, the permanent road-rail access point on the Up Slow line, the Up Fast line and the Down Main line. (Image courtesy of Network Rail.)**

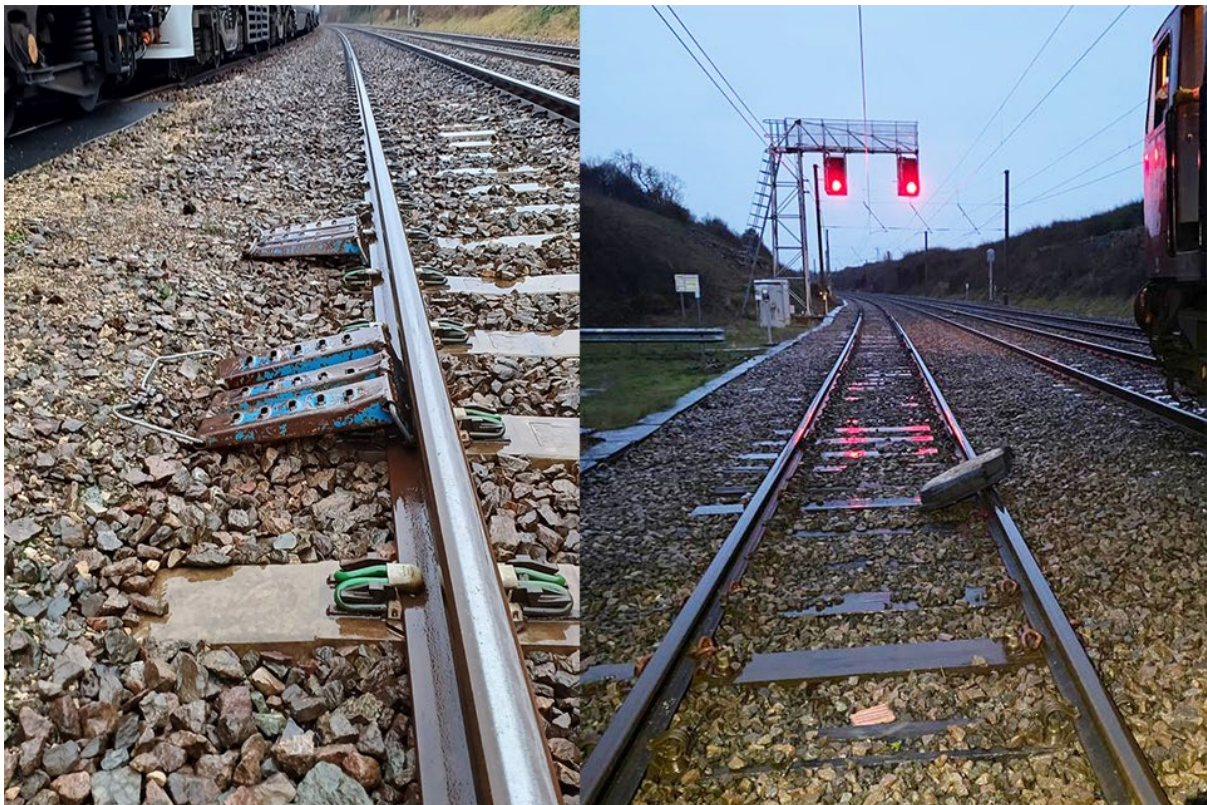
The accident occurred because a portable RRAP was unintentionally left on the track after a possession was given up, following routine inspection and maintenance of overhead line equipment (OHLE). The passage of the train disturbed light-weight parts of the portable RRAP which resulted in multiple damaging impacts to the train's underside.

**Remains of the portable RRAP found on track. Still in situ metal ramps (left). Displaced foam ramp (right). (Images courtesy of Network Rail.)**

The high-density foam ramps damaged multiple underfloor panels along the length of the train during the collision. This included removing sections of drive motor casing, and dislodging a gearbox temperature sensor on the locomotive that was at the rear of the train. This latter damage triggered emergency braking on the train, bringing it to a halt. Train 1Y00 was subsequently recovered using a standby locomotive. The passengers were detrained at Grantham, before train 1Y00 was taken to Leeds Neville Hill depot.
