SAFETY FLYER TO PLEASURE CRAFT USERS

Loss of control of the powerboat *Awesome* near Little Thatch Island, British Virgin Islands on 2 October 2022, resulting in two fatalities

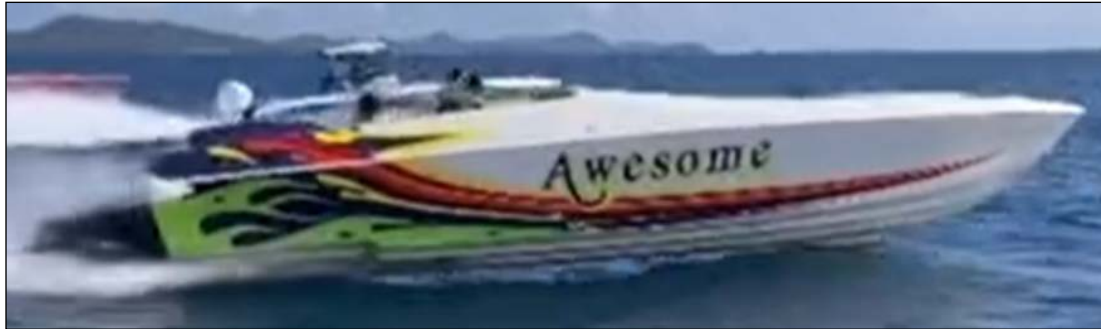
Awesome

Image courtesy of *Awesome's* owner
