# ACCIDENT REPORT

REPORT NO 2/2024

## Loss of control of the powerboat *Awesome* near Little Thatch Island, British Virgin Islands on 2 October 2022, resulting in two fatalities

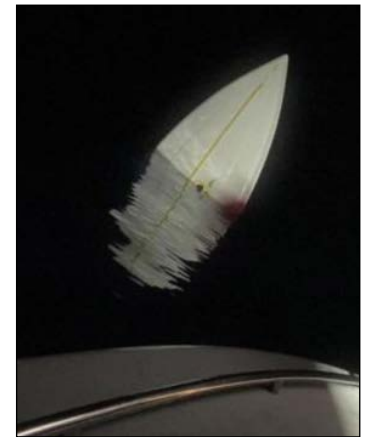
**Figure 4:** Awesome partially sunk, bow up

*Awesome* was travelling at about half speed as the two boats headed towards Steele Point (**Figure 3**) in the dark. At 1903, as *Awesome* entered the cut between Little Thatch Island and Frenchman's Cay, it turned very sharply to starboard, inducing a lateral slide, and tripped<sup>1</sup> to port violently, resulting in the ejection of ten of the eleven occupants. *Awesome* then reared up into a vertical position, with its bow in the air, landed back in the water on its transom, and then started to sink. The air trapped in the forward cabin briefly held the boat afloat vertically (**Figure 4**).

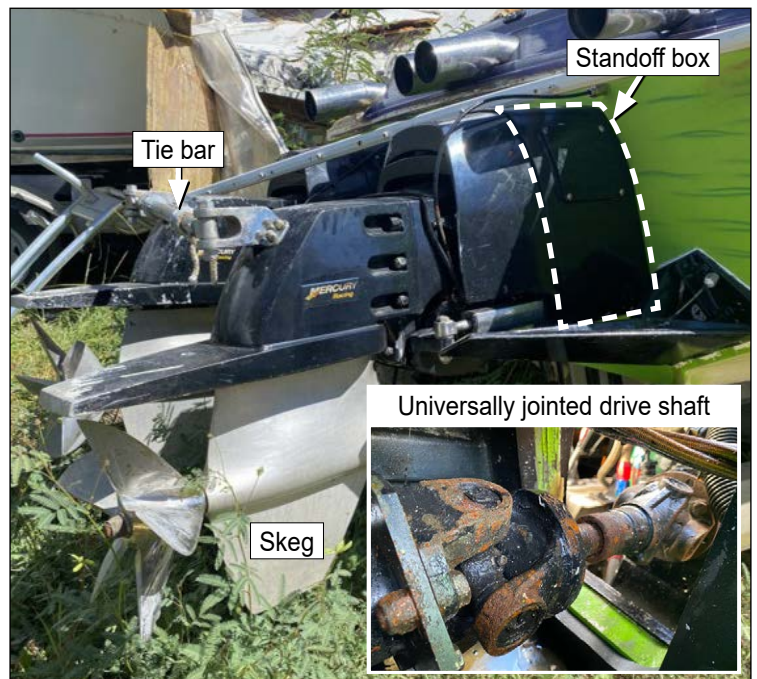
**Figure 5:** The Mercury Racing M6 stern drive units and (inset) universally jointed drive shaft

The Royal Virgin Islands Police Force engaged a local surveyor to inspect *Awesome* post-recovery and before the MAIB investigators attended. The surveyor found the port drive shaft from the stern drive to the gearbox lying in the bottom of the boat. On further inspection it was evident that a yoke on the aftmost universal joint had failed. The surveyor also noted that a hydraulic pressure hose near to the failed drive shaft had been severed.

being recovered. Both drive shafts were examined by MAIB investigators who found that there was no evidence of the universal joints having been regularly greased.

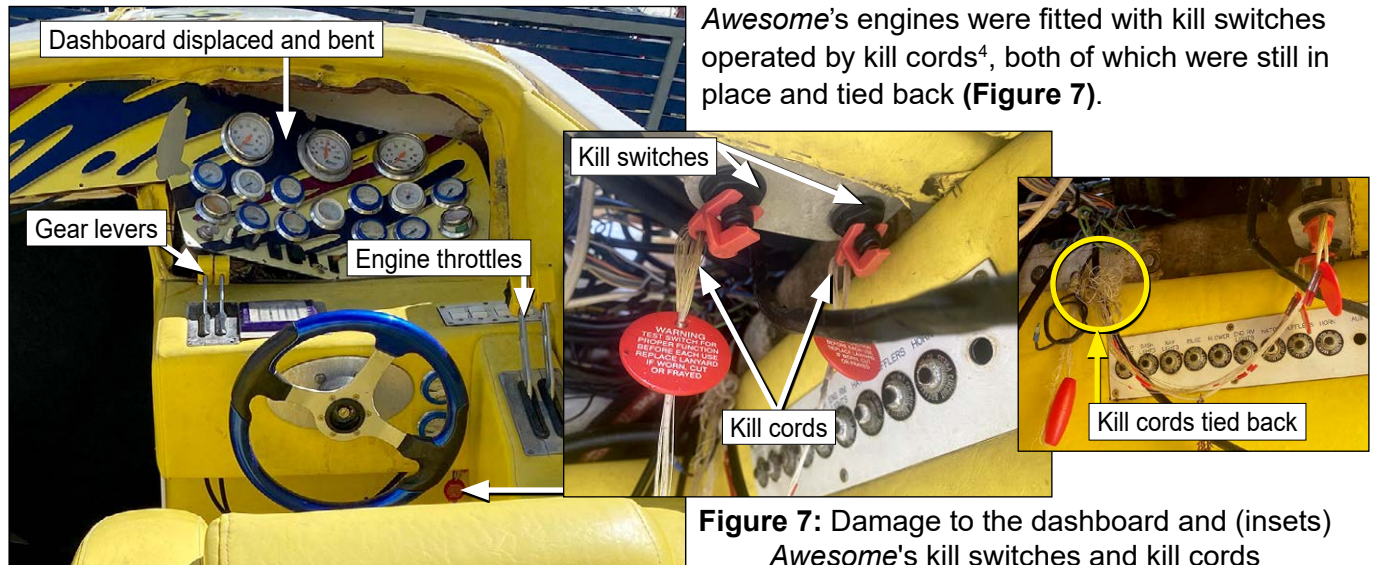
**Figure 7:** Damage to the dashboard and (insets) *Awesome's* kill switches and kill cords

Damage was noted to the dashboard in front of the driving position (**Figure 7**) and to the rear section of the port side of *Awesome's* hull. The engine cover was also missing. Some of the hull damage was known to have occurred during the wreck recovery operation. There was no damage to the bottom of the hull or to the propellers.

*Awesome's* engines were fitted with kill switches operated by kill cords<sup>4</sup>, both of which were still in place and tied back (**Figure 7**).

*Awesome's* engines were equipped with kill switches, operated by kill cords that should have been clipped to the driver when the boat's engines were running. However, the kill cords were found to be still in place and tied back, indicating that they were not being used as intended. Had the kill cords been worn, the accident sequence might have been shorter and with a less serious outcome.

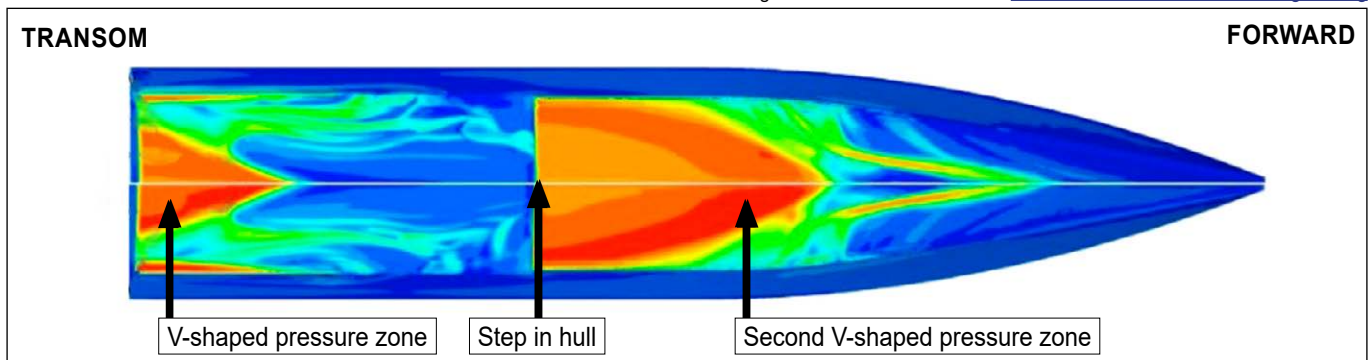
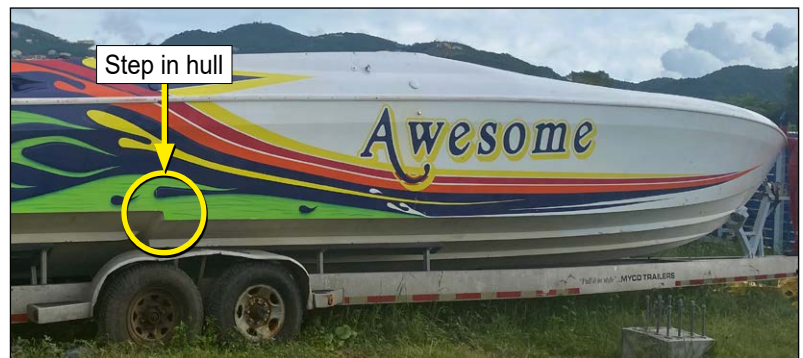
**Figure 9:** Pressure zone on a stepped planing hull and step in *Awesome's* hull

*Awesome's* hull was of an older design; modern stepped hulls are designed with the step further forward or with multiple steps to break up the pressure zones.

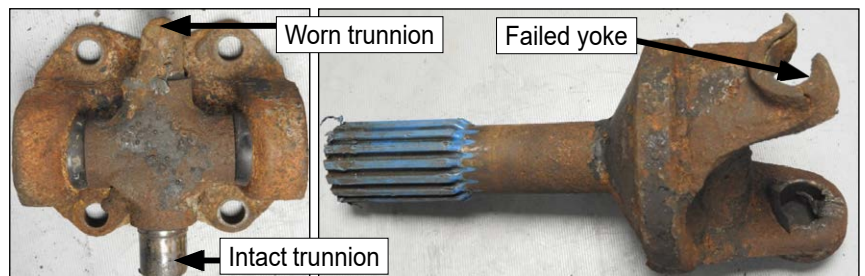
**Figure 10:** Failed port drive shaft universal joint

*Examination of the trunnions, bearings and bearing cups has shown evidence of over loading, overheating and corrosion of the bearings. Small amounts of old grease were found in the bearing housings, but all the bearing caps showed signs of burning and the trunnions showed signs of brinelling (bruising) due to a lack of lubrication. One of the oilways that carries grease to the bearings in the failed drive shaft universal joint was partly blocked with old hard grease.*

*The failure was a sudden event, with no evidence of fatigue. A lack of lubrication caused a trunnion bearing to seize, leading to heavy wear of the trunnion and yoke, this is likely to have occurred over a prolonged period of time. The wear to the yoke reduced its cross-sectional area to a point where it could no longer transmit the level torque applied and suddenly failed. Examination of the remaining trunnions, bearings and bearing cups has shown evidence of over loading, overheating and corrosion of the bearings. It is considered that the failure of the bearings is the most likely cause of the incident.*

When inspected, all the universal joint trunnions showed signs of overheating, wear and corrosion to varying degrees. As number three trunnion on the port drive shaft started to wear and the running clearance within the bearing housing increased, there would be a cyclic impact loading with the trunnion hitting the bearings with every rotation of the shaft. With further use, the bearing would have disintegrated, and the trunnion would have then impacted on the cast steel yoke of the joint. This repeated impact led to plastic deformation of the trunnion and the degradation of the cast steel yoke, gradually reducing its cross-sectional area. On the day of the accident the cross-sectional area of the yoke had reduced to a level where it could no longer transmit the torque applied by the engine and it failed due to brittle fracture (**Figure 10**). With the yoke no longer holding the trunnion in place, the opposite trunnion was released from its bearing and the two halves of the universal joint violently separated while rotating at around 1500 revolutions per minute. The end of the drive shaft, still attached to the gearbox, was free to flail around and impacted the steering hydraulic hose located nearby, severing it.

- The drive shaft coupling failed because it had become worn over a significant period of time due to a lack of routine lubrication.
- *Awesome* forcibly ejected ten of the eleven occupants because the hull lost its grip on the water when it veered sharply to starboard at high speed, which induced a lateral slide that arrested abruptly as the keel gripped the water triggering a violent roll.

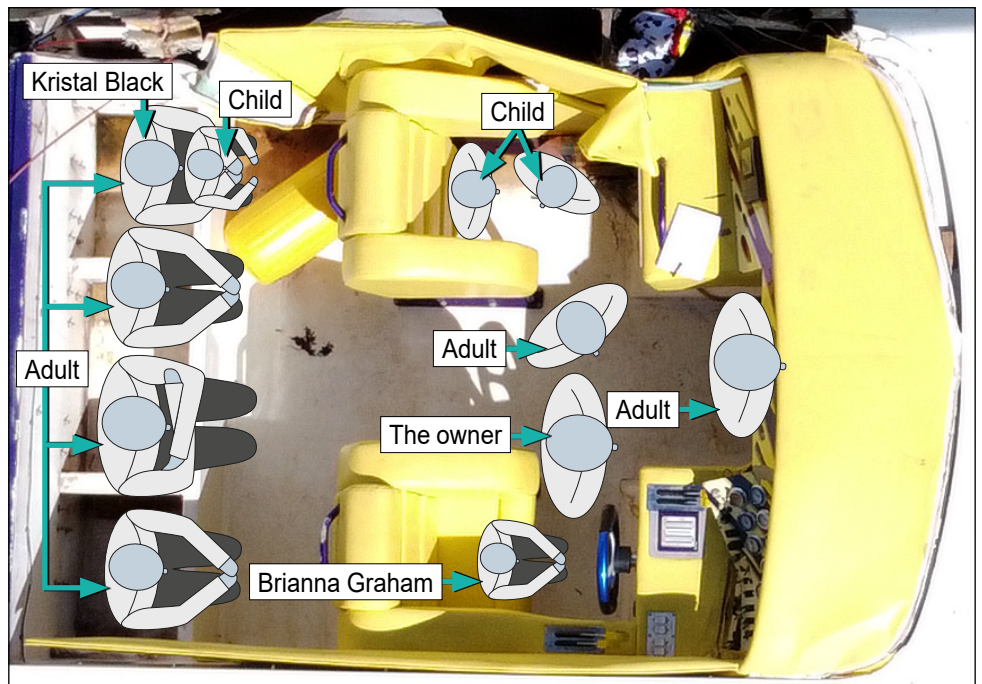
**Figure 11:** Position of *Awesome's* occupants (post-salvage representation)

*Awesome* had dedicated seating for five people in the cockpit area but at the time of the accident it was travelling with eleven people on board (**Figure 11**). There were four adults seated across the three rear seats, two children occupying the port side front seat area, and three adults were standing. Few, if any, were able to access dedicated handholds or benefit from the restraining nature of the seating. Kristal was holding her young son on her lap and this would have significantly compromised her ability to hold on or brace herself. It is likely that Kristal Black impacted the handle on the back of the port side front seat with sufficient force to knock her unconscious during the accident. When her body was found by the divers, her fingernails were intact and her arms and legs were not bruised, suggesting she was unconscious when she ended up in the cabin and had made no attempt to escape before she drowned.

As Brianna was sitting in *Awesome's* driving seat, it is likely that her head impacted the dashboard during the accident, causing the subdural haemorrhage. It is probable that the impact rendered Brianna unconscious and this, coupled with the fact that she was not wearing a PFD, contributed to her drowning.
