## Accident

<b>Aircraft Type and Registration:</b>	1) Ventus-2CT, G-KADS 2) E1 Antares, G-CLXG
<b>No &amp; Type of Engines:</b>	1) 1 Solo Kleinmotoren GmbH 2350 piston engine 2) 1 Lange Flugzeugbau EA 42 electric engine
<b>Year of Manufacture:</b>	1) 2012 (Serial no: 231) 2) 2019 (Serial no: 89E58)
<b>Date &amp; Time (UTC):</b>	17 August 2023 at 1356 hrs
<b>Location:</b>	Melton Mowbray, Leicestershire
<b>Type of Flight:</b>	1) Private 2) Private
<b>Persons on Board:</b>	1) Crew - 1                      Passengers - None 2) Crew - 1                      Passengers - None
<b>Injuries:</b>	1) Crew - 1 (Fatal)          Passengers - N/A 2) Crew - None                Passengers - N/A
<b>Nature of Damage:</b>	1) Aircraft destroyed 2) Damage to right wing and wingtip missing
<b>Commander's Licence:</b>	1) Sailplane Pilot's Licence 2) Sailplane Pilot's Licence
<b>Commander's Age:</b>	1) 67 years 2) 78 years
<b>Commander's Flying Experience:</b>	1) 2,760 hours (of which 458 were on type) Last 90 days - 138 hours Last 28 days - 82 hours 2) Approx 2,500 hours (of which 188 were on type) Last 90 days - 18 hours Last 28 days - 6 hours

<b>Information Source:</b>	AAIB Field Investigation

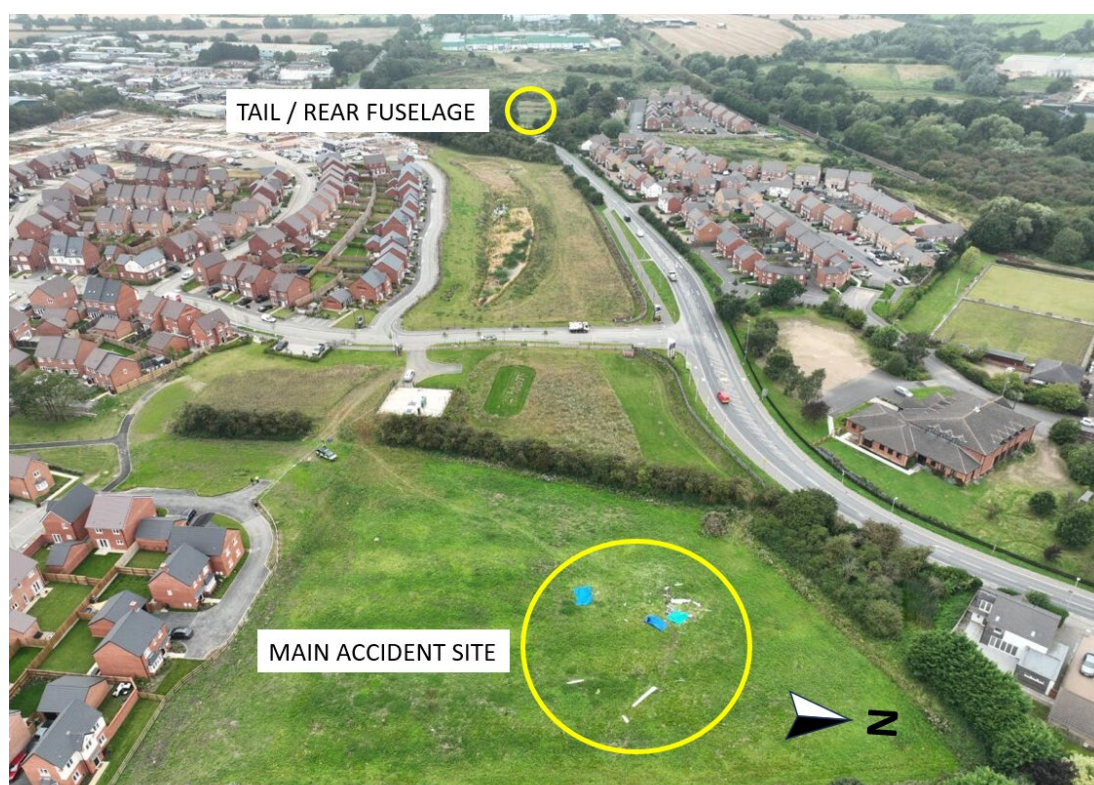
**Figure 2**  
G-KADS accident site

The glider, minus the tail and a section of the rear fuselage, struck the ground in a grass field beside a housing estate on the southwest edge of Melton Mowbray (Figure 2). The rear fuselage and tail fell to the ground 450 m to the east of the main accident site, in an open area of vegetation.

The glider struck the ground at high speed in a nose-down, left wing low attitude. The impact was not survivable, and the glider was destroyed. Examination of the wreckage identified that the airbrakes were open at impact, although it was not possible to determine whether they had opened in flight due to the collision impact on the airbrake mechanism, or by pilot action. The landing gear was up. Deformation of the canopy latching mechanism showed that the canopy was latched closed at impact. The pilot's four-point seat harness was fastened, and his parachute had not been used, with the ripcord present in an undeployed condition. The glider's fuel tank was found punctured with no fuel present, and no fire had occurred.

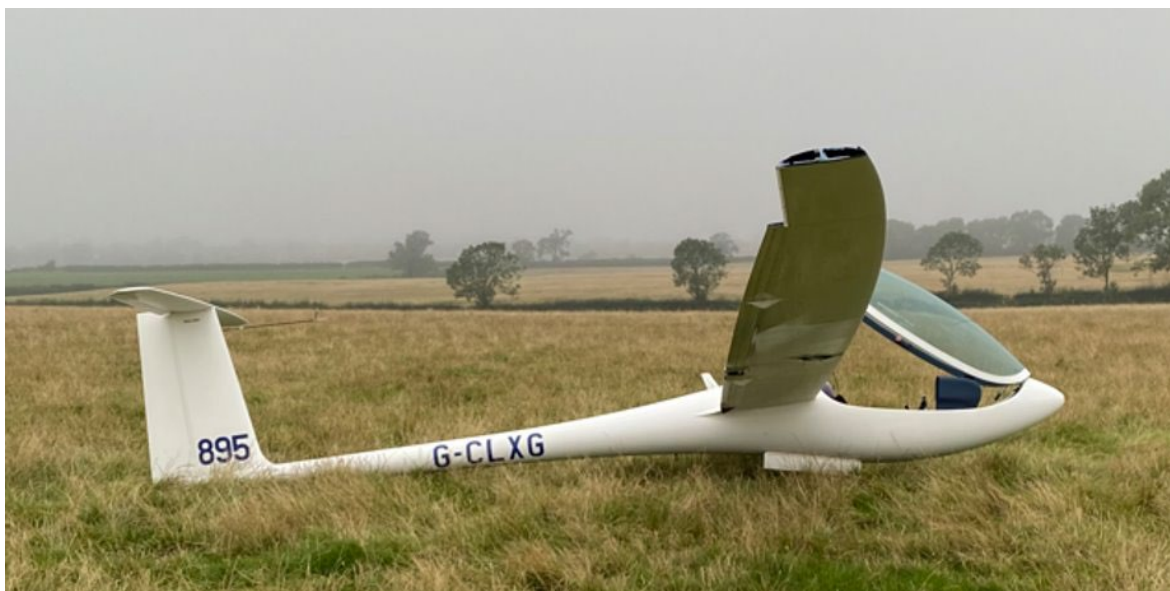
**Figure 3**

G-CLXG landed in a grass field 1.4 nm southeast of the G-KADS accident site. The glider was mostly intact apart from the right winglet and outermost section of right flaperon which were missing and not subsequently recovered (Figure 3).

G-CLXG after the field landing

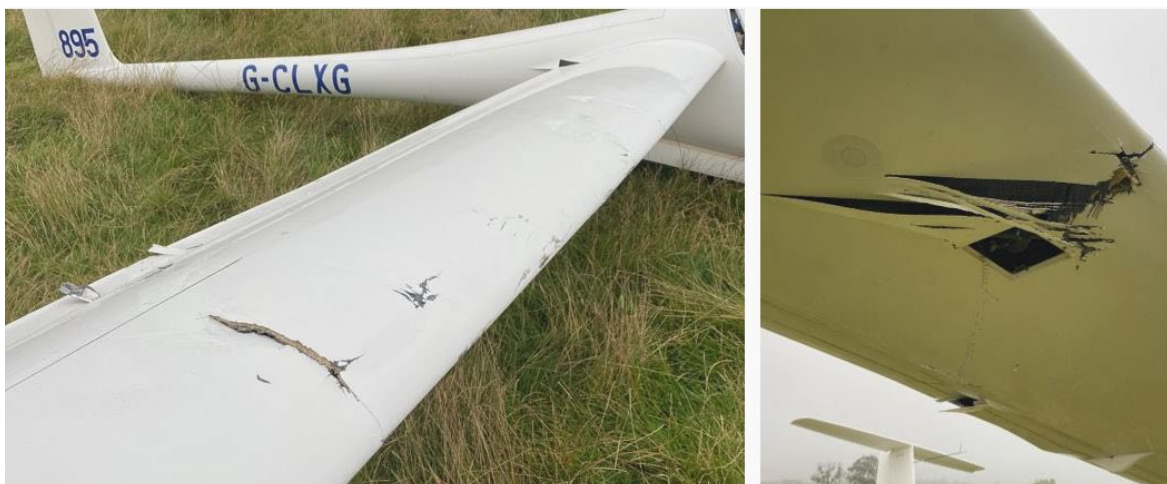
**Figure 4**

G-CLXG's right wing was damaged between 1.6 m and 3.5 m outboard from the wing root due to the impact with G-KADS' rear fuselage. The upper and lower wing skins were torn and delaminated, and the flaperon control surface at the trailing edge had split open due to rearward deflection of the wing (Figure 4). The right flaperon moved in response to movement of the control column through the flaperon inboard and outboard drive arms, which were undamaged. The battery compartment access panel in the lower wing skin was missing, the battery pack was not damaged and the powerplant battery management system did not indicate that any faults were present.

Damage to G-CLXG's right wing

The outer right wingtip, adjacent to the missing winglet and flaperon section, was damaged with paint cracking at the leading edge and large areas of delamination of the lower wing skin from the foam core material. There were no witness marks present on these damaged areas indicating that this damage had not been caused by direct contact with G-KADS during the collision but was due to the wing's structural response when the collision occurred.

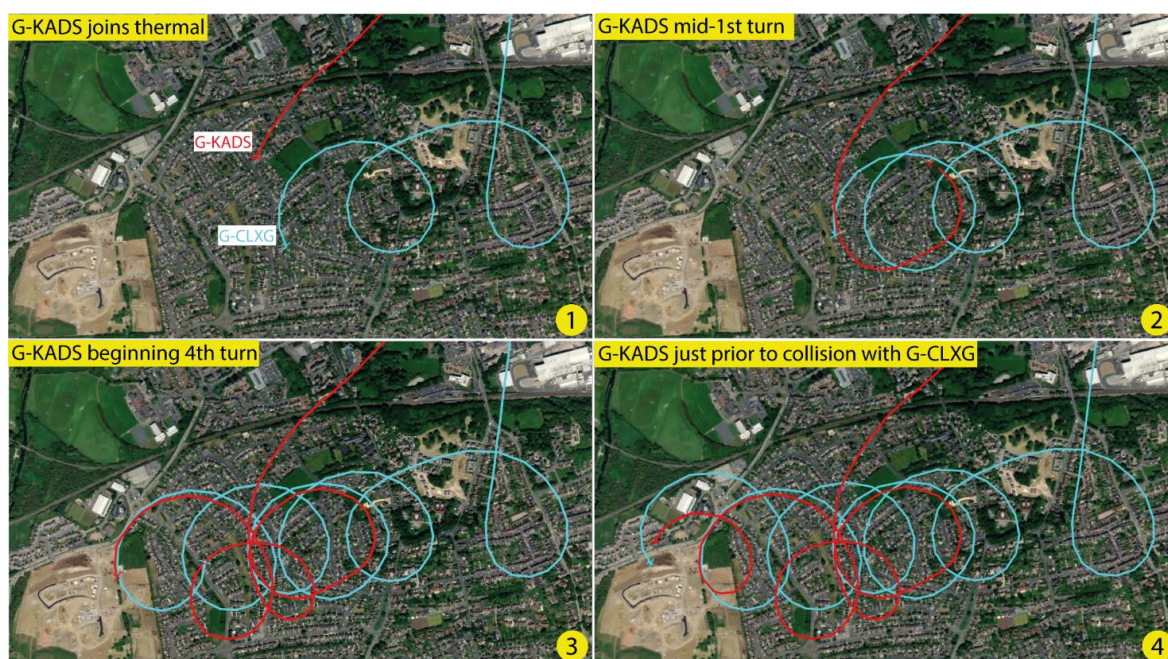
**Figure 5**

Flightpaths of G-KADS and G-CLXG in a thermal prior to the collision  
© 2022 SeeYou software by Naviter

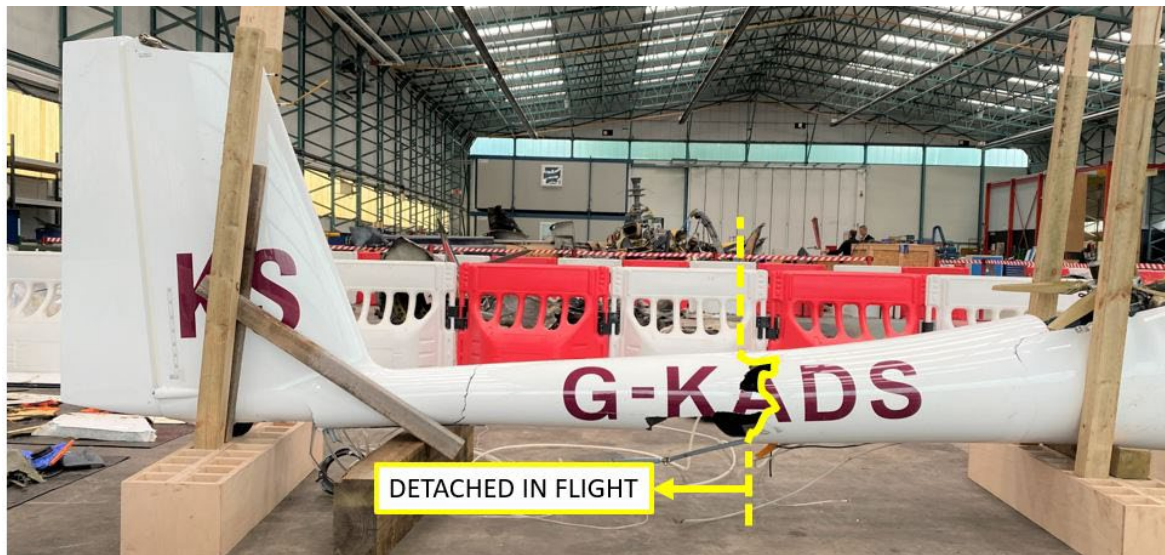
**Figure 6**

The recovered parts of G-KADS' fuselage were reassembled (Figure 6). This showed that G-CLXG's right wing had struck the fuselage from below, in an upwards direction. The rudder cables, fin ballast tank dump cable and elevator pushrod had failed in overload and the pitot-static system tubes were severed.

Detached section of G-KADS' rear fuselage and fin

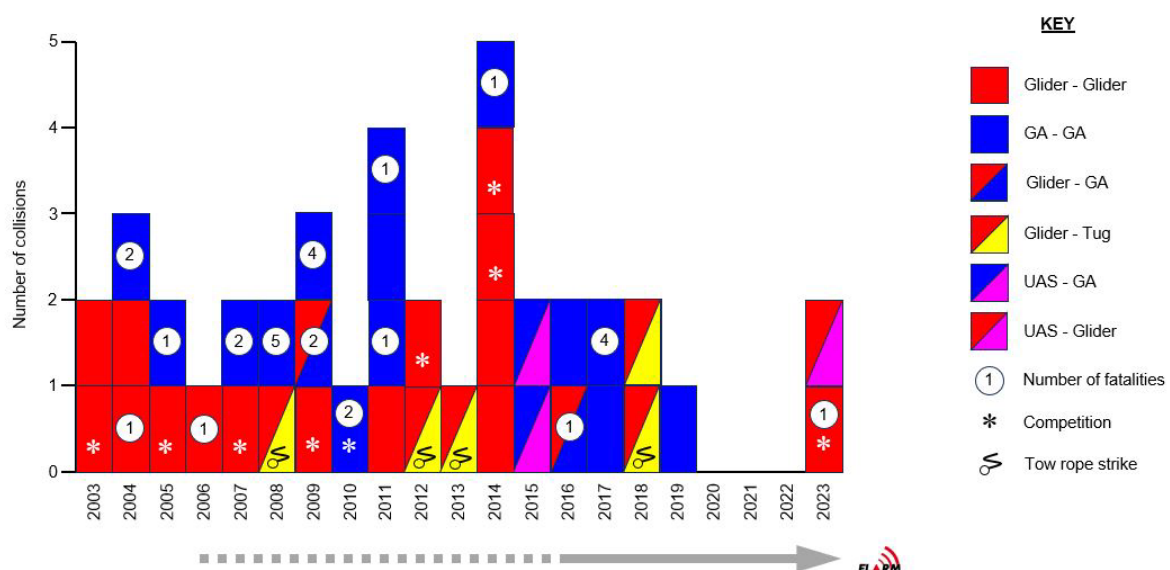
**Figure 7**

Chart of UK midair collision events, 2003-2023

There were 15 collisions between gliders in the period, three of which involved a fatality. Eight collisions occurred between gliders participating in a competition. Of the 30 gliders involved, 18 landed safely and 12 crashed. Ten pilots were able to parachute to safety following a collision. Analysis of flight recorder files showed that, in 2022, gliding competitions accounted for 8.5% of all glider hours flown in the UK.
