Near miss near Nottingham station, 1 January 2024

Summary of the incident

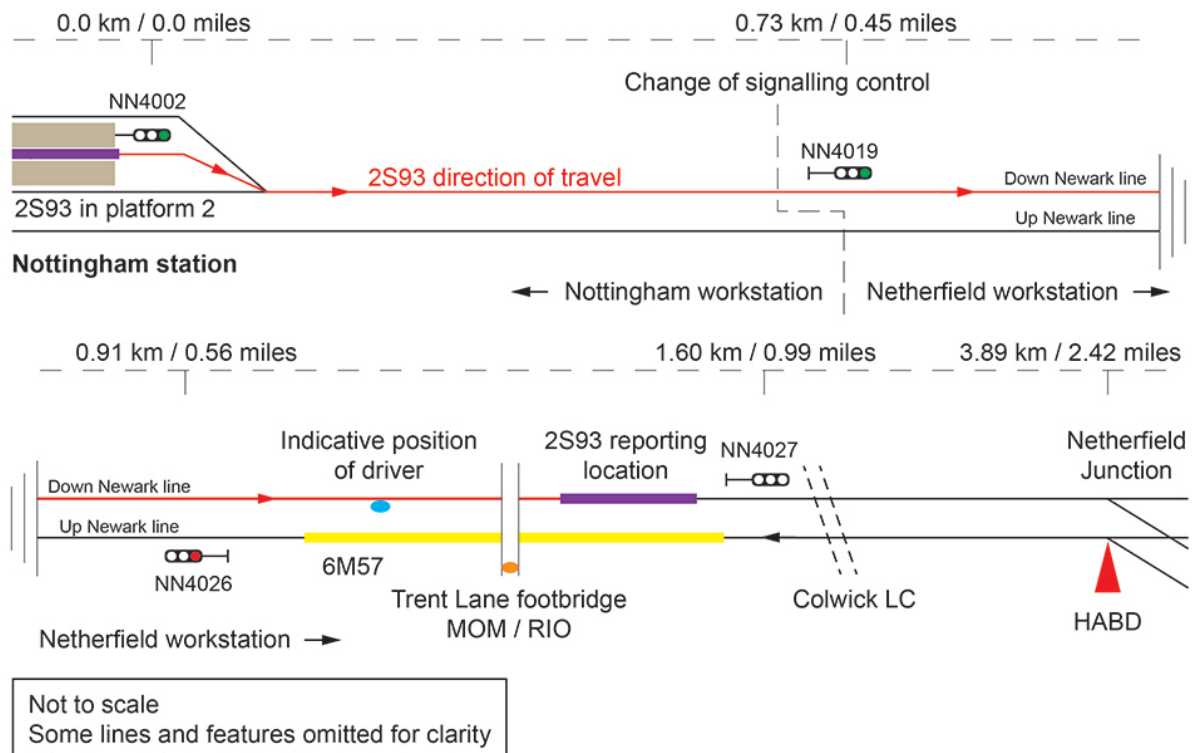
Diagram showing location of stopped train 6M57, and the route taken by train 2S93 once it departed from Nottingham. Also shown are the approximate location of the change of control between workstations and the location of HABD. Distances shown are relative between areas of interest.
