9. Wrong side failures of signalling

Purpose of this summary

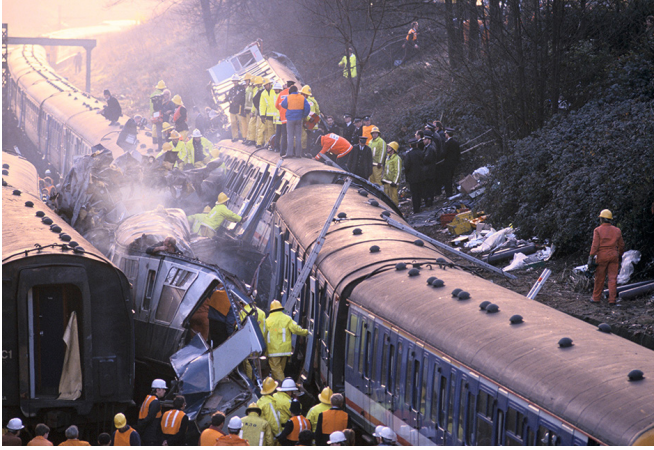
The tragic accident at Clapham Junction in 1988 occurred when a train driver received a proceed aspect at a signal which should have been at danger. This resulted in a collision with a preceding train which should have been protected by the signal. The incorrect proceed aspect was shown because inadequate working practices during a resignalling project had resulted in a loose, uninsulated redundant wire remaining close to, and eventually coming into contact with, other circuitry. As a result of this accident, 35 people lost their lives and the subsequent [public inquiry](#) led to major changes being made to signalling design, installation and testing processes. These processes remain in place today.

Aftermath of the 1988 accident at Clapham Junction (Christopher Pillitz / Alamy Stock Photo).

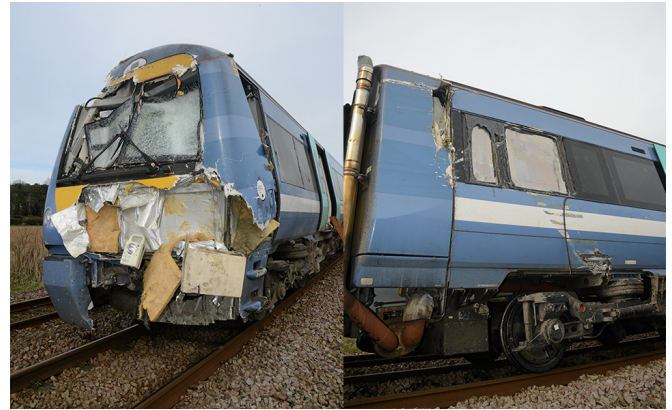
During its investigation into a collision at Hockham Road level crossing ([report 04/2017](#)), RAIB found that Network Rail had not come to a clear understanding with the manufacturer of a software-based level crossing warning system as to how the system met the required safety integrity level. After an internal review of the safety assurance documentation supplied as part of the procurement process, and having assessed the risks, Network Rail decided to decommission the system while improvements were made.

The level crossing system was intended to display green or red lights to road users to warn them when it was unsafe to cross. Decommissioning the warning system meant that users were required to telephone the signaller for permission to cross, and this was a factor which led to a collision between a tractor and train at the crossing in 2016.

Damage to the train involved in the collision at Hockham Road in 2016.

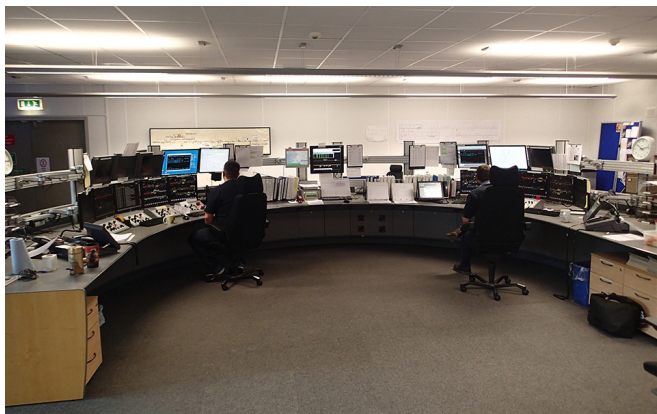
uploaded during an automated signalling computer restart, resulting in incorrectly displayed data being loaded for transmission. A suitable method of assuring that the correct data was provided to the display had not been clearly defined in the design documentation and the resulting software included a single point of failure which affected both the data upload and display functions.

As a result of this failure, on the morning of 20 October 2017, four trains travelled over the Cambrian Coast line in North Wales while temporary speed restriction data was not being sent to the trains by the signalling system. This included one train which approached a level crossing significantly exceeding the temporary speed restriction needed to give adequate warning time for level crossing users.

Operating floor at Cambrian line signalling control centre.

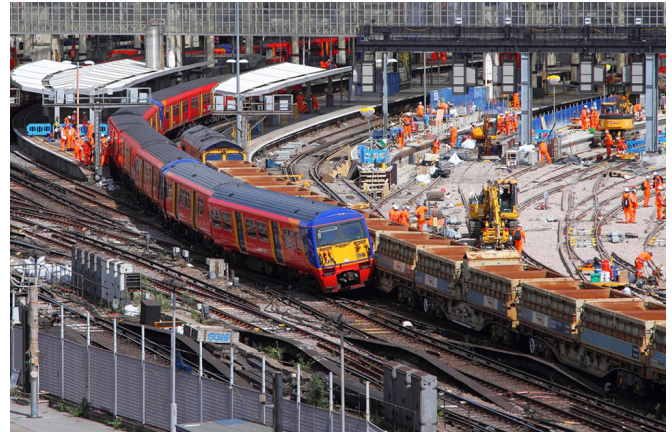
Uncontrolled wiring was added to enable testing of signalling equipment during a staged commissioning at London Waterloo ([RAIB report 19/2018](#)), without the safeguards required by Network Rail signalling works testing standards. This wiring was added to overcome a problem that was encountered while testing modifications to the signalling system. The problem arose because the test equipment design process had not allowed for alterations being made to the signalling system after the test equipment was designed. The uncontrolled wiring remained in place when the line was returned to service resulting in a passenger train being diverted away from its intended route by a set of points which were no longer interlocked by the signalling system in 2017. This resulted in a low-speed collision between the passenger train and a stationary engineering train.

Overview of the station an accident at Waterloo in 2017 (courtesy of Jamie Squibbs).

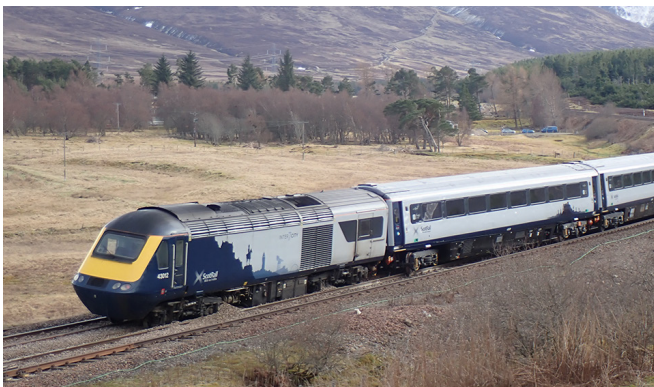
Derailed of a train at Dalwhinnie in 2021.

At Dalwhinnie ([RAIB report 10/2022](#)) in 2021, unwanted electrical connections were retained inside a point machine following its replacement nine months earlier. These connections were intended to allow the machine to be adapted for different operational environments.

The need to alter the internal wiring of the machine for its intended usage was not identified when the renewal work was planned, nor did the prescribed checks required as part of a like-for-like replacement process identify the wiring discrepancy. The last opportunity to identify the wiring error during testing before the points were handed back was not effective because it was interrupted and testing work was overlooked.
