## 8. The integrity of train braking systems

### Purpose of this summary

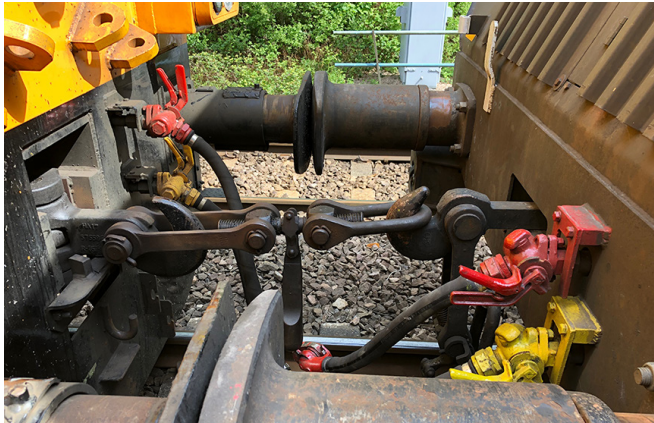
The need for brake continuity tests to be the final duty undertaken before departure was further demonstrated in the incident at Crofton West Junction in 2020 ([safety digest 06/2020](#)). In this incident, a freight train was prepared for departure, including a brake continuity test, during the evening before departure. However, after train preparation was completed, but before departure, a group of trainees and an instructor visited the sidings and used the train to practise train preparation procedures. This led to the brake pipe valves between the locomotive and the wagons being closed, rendering the air brakes on the wagons non-operational. This

Positions of brake pipe valves on locomotive involved in the SPADs at Crofton.

was not detected before the train moved off the next morning and a running brake test was not carried out in accordance with the railway Rule Book once the journey was underway. The closure of these valves and the absence of a test which could have identified that inadequate brake force was available meant that the driver was unable to stop the train when it encountered restrictive signal aspects. The train subsequently passed two signals at danger and crossed a junction which was being protected by one of the signals.
