7. The safe management of weather-related events which affect train operation

Purpose of this summary

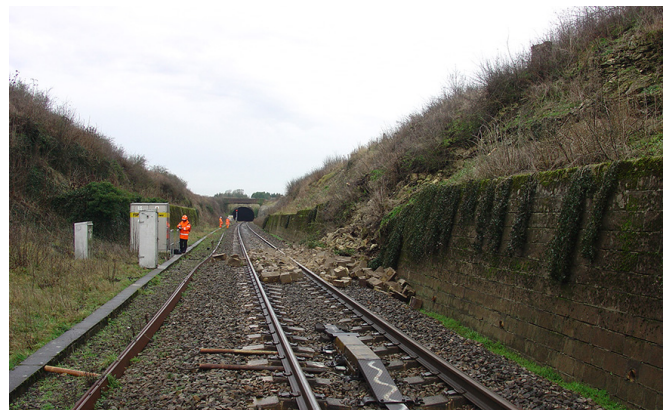
Collapsed wall following landslip at Kemble.

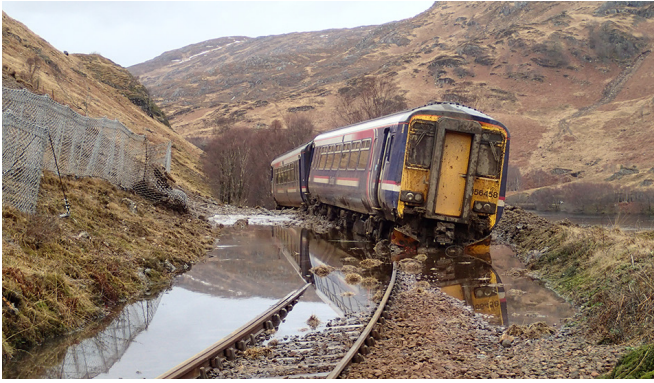
Derailed train following landslip at Loch Eilt.

Structural failures are often related to the effects of heavy rain, either by itself, as at Dryclough Junction in 2011 ([report 17/2011](#)) and Loch Eilt in 2018 ([report 10/2018](#)) or as the cause of floods as at Lamington in 2015 ([report 22/2016](#)) when larger than normal water flows create additional scour risk around the supports of bridges. Responding to these pressures may require the railway to work with owners of adjacent land to ensure that drains are adequate to deal with the flows of water, and to recognise when changes in

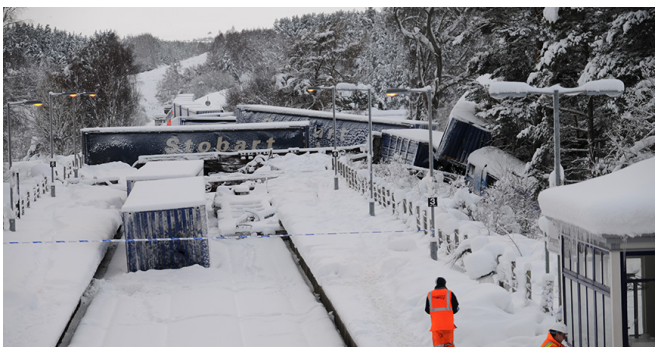
Wagons following derailment at Carrbridge.

Winter weather can bring particular hazards to the railway. While ice and snow are recognised as disruptive, it is possible for them to create significant safety risks. RAIB's investigations into an incident at Carstairs ([report 02/2011](#)) and an accident at Carrbridge ([report 03/2011](#)), which both occurred in Scotland during the winter of 2009-10, found that a build-up of snow on rail vehicles, occurring during a journey, could lead to impaired braking performance

affecting the trains' ability to stop safely. As well as changes to the operating rules to improve the effectiveness of brake tests carried out by train drivers, there was also a need for the extreme weather actions described above to include measures to deal with risks from wintry weather. Failure to implement a strategy for risk mitigation in wintry weather was also a factor in the accident in Summit tunnel, West Yorkshire, in 2010 ([report 16/2011](#)), when a train derailed after hitting a pile of ice which had fallen onto the track. When train operations are disrupted by adverse weather conditions, the situation needs to be properly managed. We have commented on this in [Summary of Learning number 4](#) covering the management of abnormal train operating events.

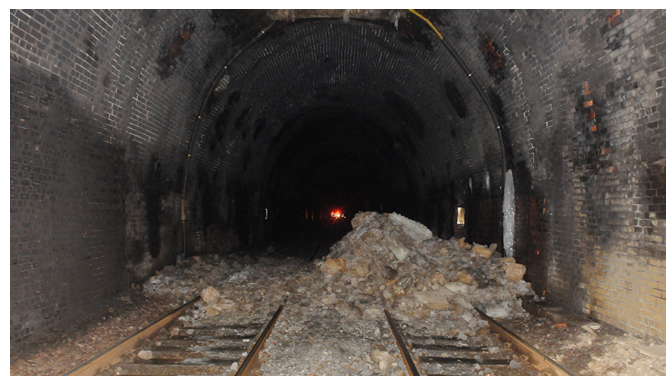
Ice found below a ventilation shaft after the derailment at Summit tunnel (courtesy of British Transport Police).

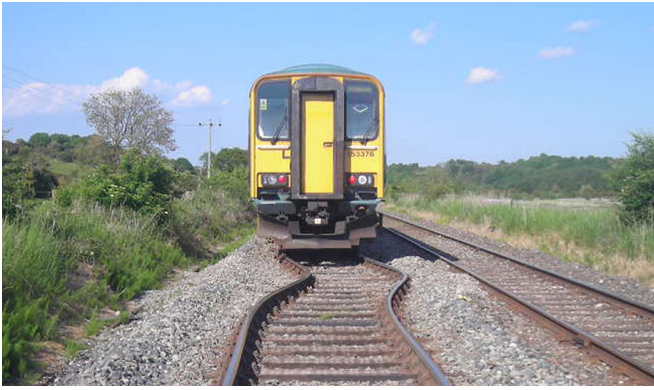
Severe track buckle at Cummersdale.

As the temperature rises and falls, rails expand and contract. Railway track is designed and constructed to cater for this, but in hot weather instability in the track support, and/or a restriction on the ability of rails to move longitudinally, can create conditions in which the track moves laterally (known as buckling), possibly immediately before or during the passage of a train. RAIB has investigated derailments caused by buckling, at Cummersdale, Cumbria in 2009 ([report 06/2010](#)) and at Langworth, Lincolnshire in

2015 ([report 11/2016](#)). These investigations highlighted the importance of good maintenance practice, and the need for clarity in the Rules relating to trains passing over sections of track where defects have been reported.
