5. Freight train derailments

Purpose of this summary

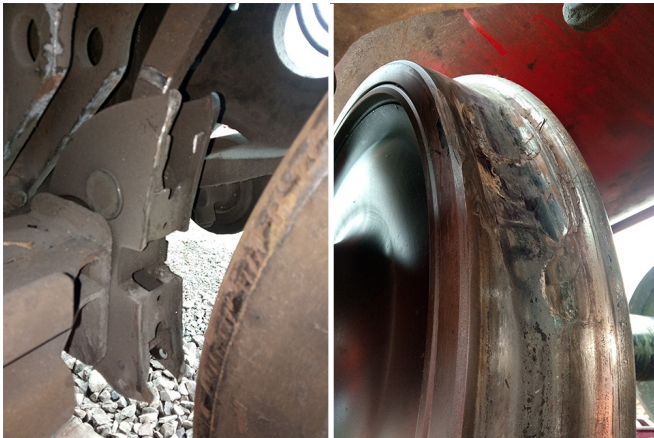
A poor standard of maintenance was also found in our investigation into an accident at Carpenters Road North Junction, London, in 2019 ([safety digest 07/2019](#)), when components of a wagon's braking system fell off during the journey, and got under the wagon's wheels and derailed it.

Missing components and damaged wheel treads following locking of a wagon brake mechanism.

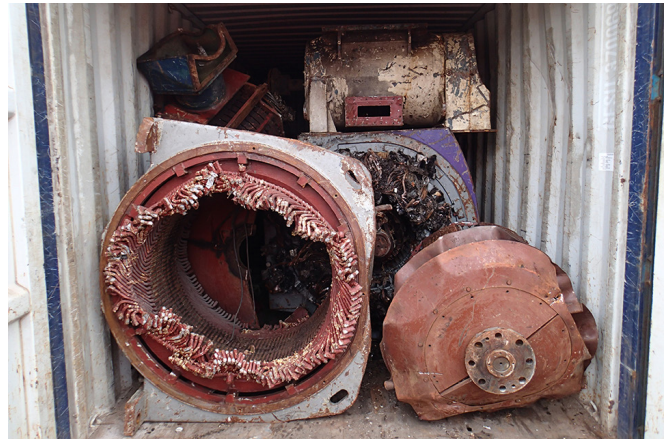
If the payload carried by a wagon, such as bulk material or discrete items, is not centred both laterally and longitudinally, there will be uneven distribution of weight through the wheels of the wagon. The resulting unequal forces between wheel and rail can lead to some wheels becoming sufficiently unloaded to the degree that, on curves, they can climb up and over the head of the rail, resulting in derailment of the vehicle. If an unevenly loaded wagon encounters track with a twist fault, conditions for derailment may be set up.

An example of asymmetric loading of heavy scrap electrical machinery.

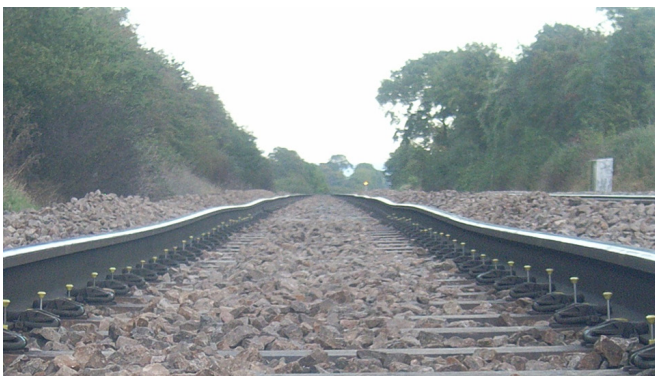
An example of poor track geometry which resulted in derailment of a freight train.

The geometry of the track, in terms of its vertical alignment ('top'), horizontal alignment ('line'), the change in relative height of the two rails ('twist'), and the distance between the rails ('gauge'), must be maintained to suitable standards to prevent derailments. Other factors, including rail wear and railhead condition, can also be among the causes of accidents. Many RAIB investigations have identified deficiencies in maintenance which have led to derailments, either on their own or in combination with vehicle defects.
