Accident

Aircraft Type and Registration:	VA-1X, G-EVTL	
No & Type of Engines:	8 Equipmake HTM-1900 electric motors	
Year of Manufacture:	2022 (Serial no: 1)	
Date & Time (UTC):	9 August 2023 at 0715 hrs	
Location:	Cotswold Airport (Kemble), Gloucestershire	
Type of Flight:	Experimental flight test	
Persons on Board:	Crew - None	Passengers - None
Injuries:	Crew - None	Passengers - N/A
Nature of Damage:	Damage to right wing, fuselage, landing gear and engine pylon	
Commander's Age:	60 years	
Commander's Flying Experience:	More than 4,300 hours (of which 3 were on type) Last 90 days - 6 hours Last 28 days - 0 hours	
Information Source:	AAIB Field Investigation

Synopsis

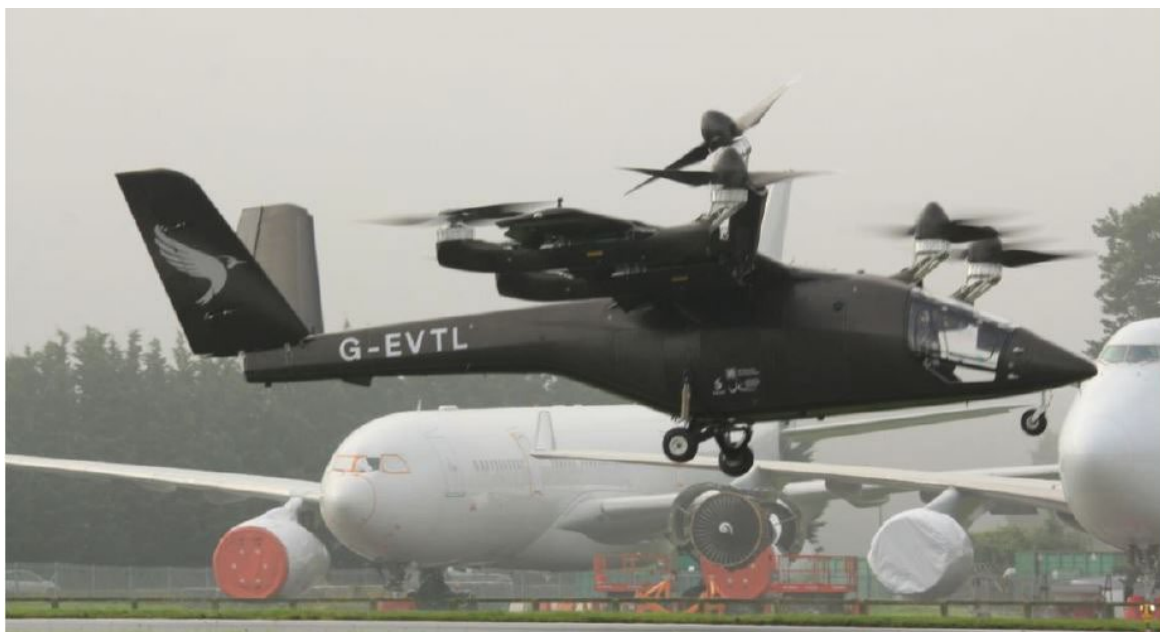
Figure 1

Pylon 3 failure following the release of a propeller blade from EPU3
(courtesy of manufacturer)

Pylon 3 had failed in overload due to high out-of-balance loads caused when the EPU3 propeller blade released, allowing the forward section of the pylon to initially rotate vertically upwards under residual propeller thrust. This movement damaged the wiring harnesses where pylon 3 was attached to the wing front spar, severing the CAN bus C1 and C2 wiring. Low voltage wires providing power and return feeds to the EPU3 inverter were open circuit within a connector, due to cable strain. Damage to the high voltage wiring consisted of phases U and W pulling out of their connectors at the EPU3 motor and phase V pulling out of its connector to the inverter, with electrical arcing damage between the cable and the connector body.

The failure of the adhesive bond between the EPU3 propeller blade sheath and spar allowed the sheath to translate radially outwards, increasing the bending load on the blade spar which caused the outer section of the spar to fracture and separate. The loss of the blade whilst the propeller was spinning at 1,200 rpm generated large out-of-balance forces, causing the structural failure of the forward section of pylon 3.

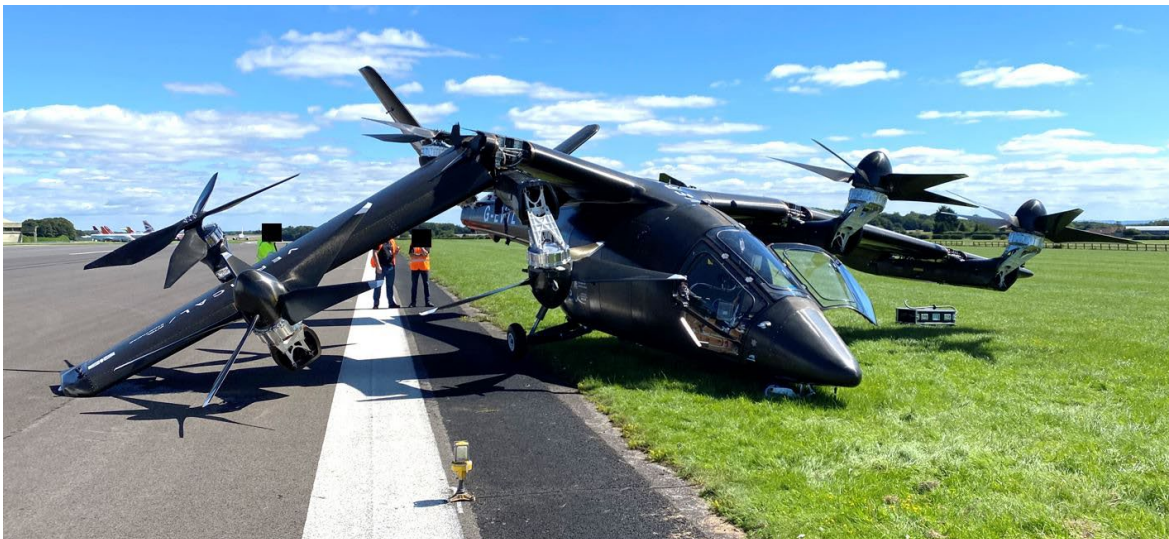
Figure 2

The aircraft hit the southern edge of Runway 26 in a level attitude with the right mainwheel on the paved runway surface and the left mainwheel and nosewheel on the grass. The right wing had broken at the inboard pylon but remained attached to the aircraft by wiring harnesses. Two propeller blades had detached from EPU3, with the blade sheath that separated in flight coming to rest 50 m from the aircraft, at its seven o'clock position. A section of blade spar that had also released came to rest close to where the sheath had landed. A second blade had detached during the ground impact as EPU3's propeller was still rotating when the aircraft touched down.

G-EVTL after the accident

The nose landing gear had collapsed and the left main landing gear oleo remained fully compressed. A number of skin-to-frame fasteners had pulled through the fuselage skin around the right main landing gear upper fitting. The right wing had failed in downward bending overload at the inboard pylon station.

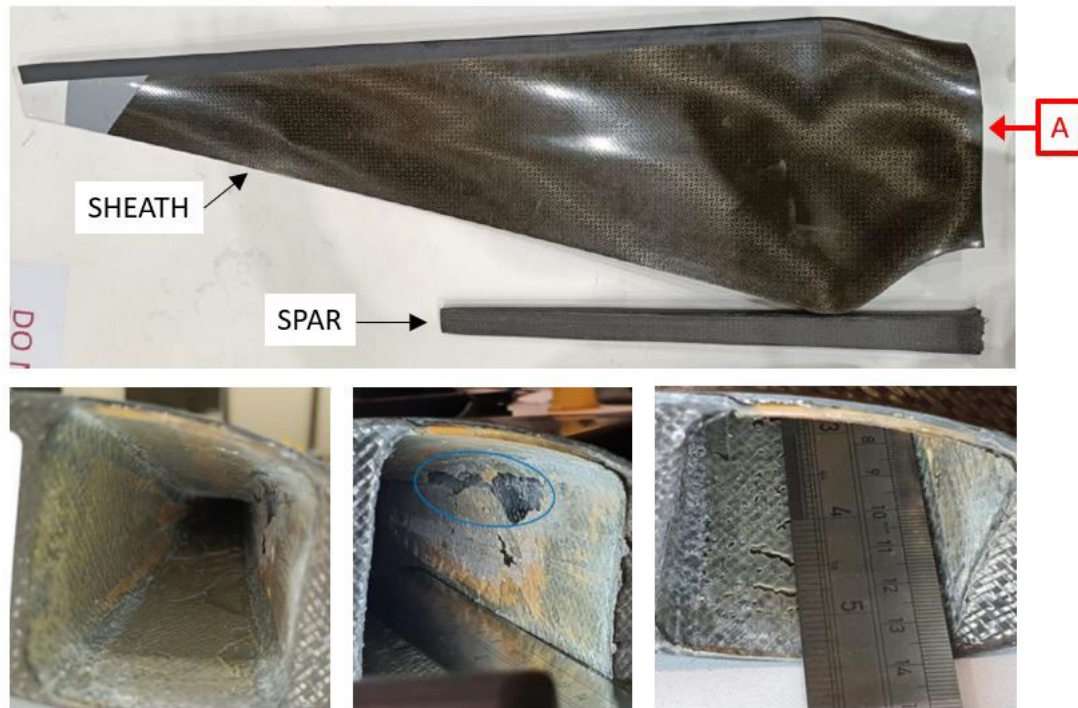
Figure 3

The blade sheath that released during flight showed evidence of poor bonding between the sheath and the blade spar (Figure 3). Most of the adhesive remained attached to the internal sheath surface with very little present on the blade spar.

Released propeller blade including failed spar-to-sheath adhesive bond (lower three images, viewed in direction 'A')
(courtesy of manufacturer)

The released propeller blade was operating within its normal rpm and loading levels when it detached, without any increased vibration or foreign object impact prior to release. The blade sheath detached due to failure of the adhesive bond between the blade sheath and spar. Stress analysis performed by the manufacturer showed that only 5% of the spar-to-sheath bond area was required to retain the sheath at the centrifugal loading condition when the bond failed. It is therefore likely that progressive degradation of the bond occurred during operation prior to the blade release.

The manufacturer inspected two other similar propeller blades from its spares pool using CT scanning. Voids were widespread in the bond line in both blades, as were variations in the shape of the blade spar cross section. A review by the manufacturer determined that the blade structural design, and the relevant manufacturing control, quality assurance processes and verification programme were contributory factors to the blade release.

- The remaining 'Generation 1' propeller blades were withdrawn from use and, subject to a satisfactory inspection, will only be used for ground testing.
- The manufacturer was in the process of introducing a new 'Generation 2' propeller blade when the accident occurred that, amongst other things, eliminated the bonding failure mode that caused the blade release.
- Having completed its internal accident investigation, the manufacturer identified 36 product and process improvements. These include improvements in quality control, supplier qualification, design and verification processes, flight control laws, CAN bus architecture and the routing of wiring harnesses.
