2. Protection of track workers from moving trains

Purpose of this summary

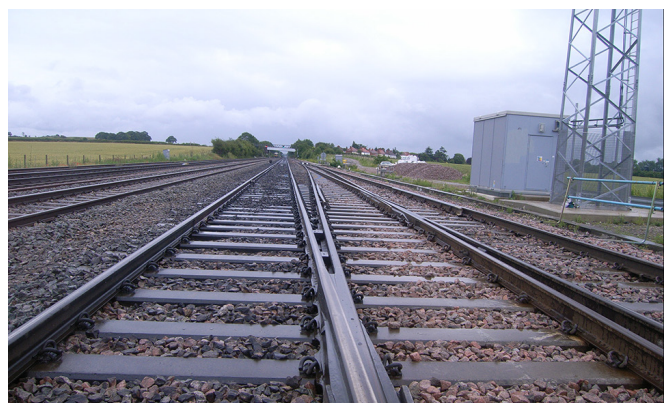
At Ruscombe in 2007 ([report 04/2008](#)) three people were involved in welding repairs to a crossing: a welder, a lookout, and a Controller of Site Safety (COSS). The COSS and the lookout deferred to the seniority and experience of the welder, who was very reluctant to interrupt his work to move clear of the line when trains passed on adjacent lines. As a result, the welder was taken unawares when a train was routed from an adjacent line through a crossover towards the place where he was working, and he was struck and killed.

The site of the fatal accident at Ruscombe Junction.

The issues identified during the investigation included the influence of peer pressure, the interaction between the welder and his less experienced colleagues, leadership and authority in small teams, and communications within the team.

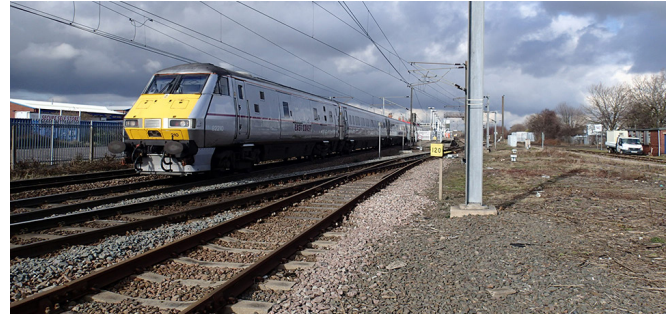
At Newark on the East Coast Main Line in 2014, the person who was acting as lookout moved into the path of an approaching train and was killed. There had been a breakdown in safety discipline and vigilance at the work site, and the COSS who was in charge of the work was not monitoring the actions of the team ([report 01/2015](#)).

The site of the fatal accident at Newark.

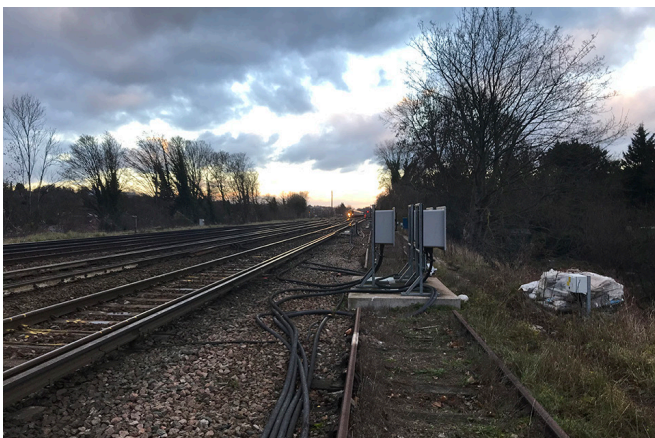
At Stoats Nest Junction, on the line between London and Brighton, near Purley in November 2018, a member of staff was killed by a train shortly after they had placed protection equipment for a routine possession, and had then moved outside the protected area onto an open line ([report 07/2019](#)).

Outside the limits of protection at Stoats Nest Junction.

The person who was killed at Stoats Nest Junction ([report 07/2019](#)) was working on a 'zero hours' contract for a contingent labour supplier. The labour supplier did not carry out any checks on the hours of work of such staff. RAIB believes that better measures are needed to ensure that zero hours staff are suitably supervised and monitored, particularly in relation to hours of work.

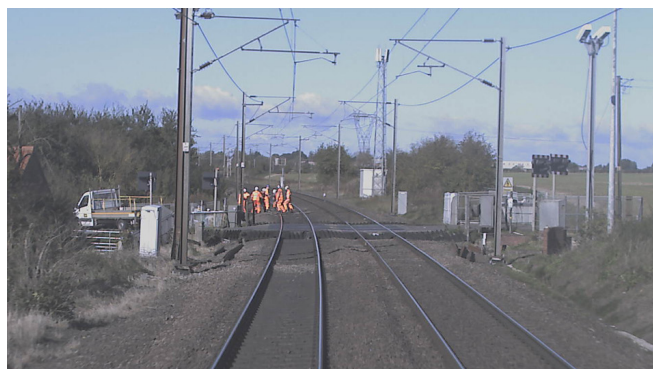
At Egmonton in 2017 ([report 11/2018](#)), contract staff working on lifting and packing ballast on the East Coast Main Line under the direction of a Network Rail team leader had little confidence in the systems of work that the team leader was adopting. However, they felt unable to challenge him because they feared losing work, and because of peer pressure from the rest of the group to continue working. A series of misunderstandings and miscommunications resulted in the group working without anyone acting in the role of lookout, and having to jump clear of the line with less than 2 seconds to spare when a train approached at 125 mph.

The work group clearing the line at Egmonton, less than 2 seconds before a train reached the place where they had been working.
