2. Protection of track workers from moving trains

Purpose of this summary

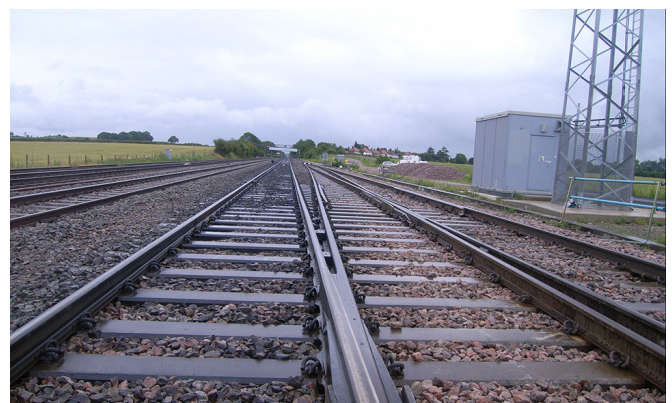
At Ruscombe in 2007 ([report 04/2008](#)) three people were involved in welding repairs to a crossing: a welder, a lookout, and a Controller of Site Safety (COSS). The COSS and the lookout deferred to the seniority and experience of the welder, who was very reluctant to interrupt his work to move clear of the line when trains passed on adjacent lines. As a result, the welder was taken unawares when a train was routed from an adjacent line through a crossover towards the place where he was working, and he was struck and killed.

The site of the fatal accident at Ruscombe Junction.

The issues identified during the investigation included the influence of peer pressure, the interaction between the welder and his less experienced colleagues, leadership and authority in small teams, and communications within the team.

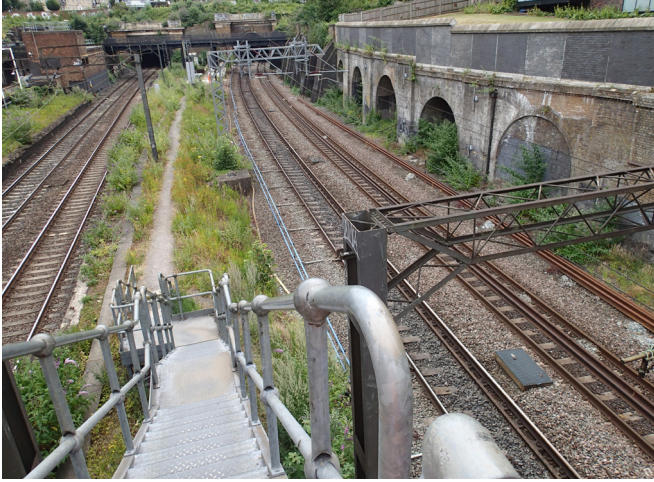
The view of the two sets of lines at South Hampstead from the access steps.

At South Hampstead in 2018, there was no signage at the access point used by a work group to get onto the track. The staff therefore had no visual indication of which lines were which, and placed equipment on the fast lines, which were open to traffic, instead of on the slow lines, which were under possession. While they were doing this, a train approached on the fast lines, and the staff managed to move their equipment and themselves clear of the line with around two seconds to spare ([report 20/2018](#)).

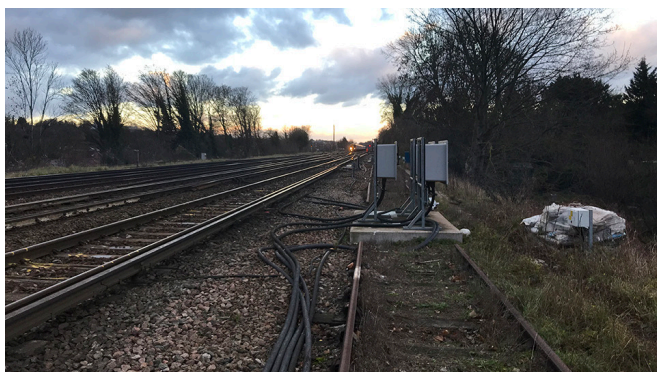
At Stoats Nest Junction, on the line between London and Brighton, near Purley in November 2018, a member of staff was killed by a train shortly after they had placed protection equipment for a routine possession, and had then moved outside the protected area onto an open line ([report 07/2019](#)).

The person who was killed at Stoats Nest Junction ([report 07/2019](#)) was working on a 'zero hours' contract for a contingent labour supplier. The labour supplier did not carry out any checks on the hours of work of such staff. RAIB believes that better measures are needed to ensure that 'zero hours' staff are suitably supervised and monitored, particularly in relation to hours of work.

Outside the limits of protection at Stoats Nest Junction.

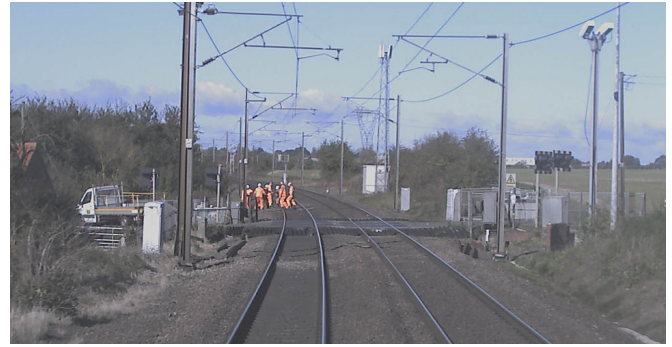
At Egmonton in 2017 ([report 11/2018](#)), contract staff working on lifting and packing ballast on the East Coast Main Line under the direction of a Network Rail team leader had little confidence in the systems of work that the team leader was adopting. However, they felt unable to challenge him because they feared losing work, and because of peer pressure from the rest of the group to continue working. A series of misunderstandings and miscommunications resulted in the group working without anyone acting in the role of lookout, and having to jump clear of the line with less than two seconds to spare when a train approached at 125 mph.

The work group clearing the line at Egmonton, less than two seconds before a train reached the place where they had been working.
