## 3. Managing risk at the platform-train interface

### Purpose of this summary

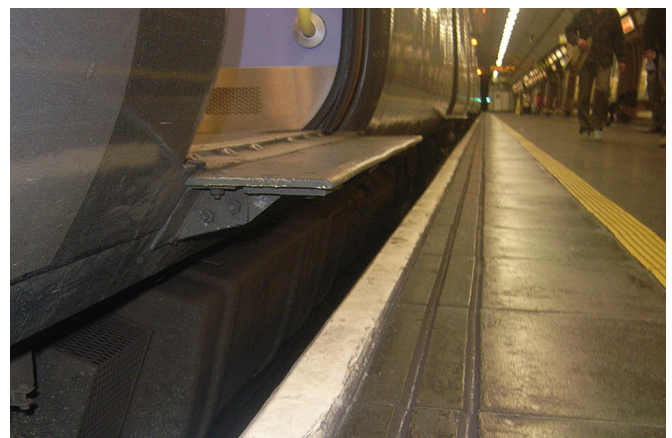
Train doors, step, gap and platform - a hazardous area.

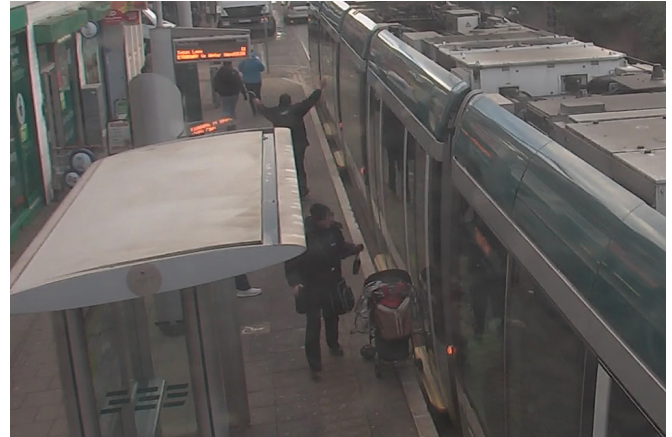
Pushchair trapped in tram doors at Radford Road, Nottingham in 2017.

At Radford Road, Nottingham, in 2017, a pushchair, fortunately unoccupied, became trapped in tram doors and was dragged all the way to the next stop ([report 15/2018](#)). We recommended that the tram operator should review all aspects of its arrangements for minimising the risk of this happening. We found that there was a lack of understanding of risk in this area, which may extend across the tram industry.

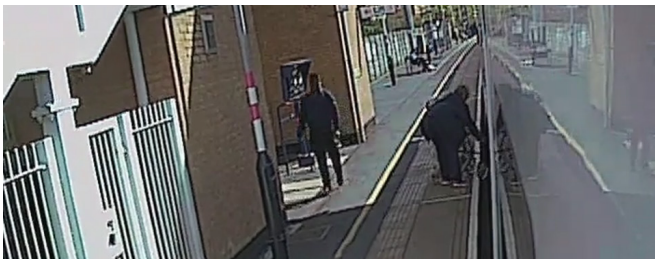
Passenger tries to free dog trapped in train doors at Elstree & Borehamwood.

At Elstree & Borehamwood in 2018 ([report 03/2019](#)), a passenger and their dog were boarding a train. The doors closed in front of the passenger and the dog's lead became trapped in the doors. The train departed, dragging the dog off the platform and leading to its death, while the passenger remained on the platform. The driver was in the habit of carrying out the final safety check in significantly less time than other drivers on the same route and did so on this occasion. Carrying out the check in a shortened time meant that even a slight loss of attention could have led to the driver missing the passenger and their dog in the CCTV image.

We have recommended measures to support train and tram drivers in maintaining attention and awareness, particularly when associated with automatic train operations (Notting Hill Gate, Archway and Chalk Farm, Stratford), and research and development of technology to assist staff responsible for train dispatch to determine that passengers are clear of the train (Elstree & Borehamwood, Archway and Chalk Farm).

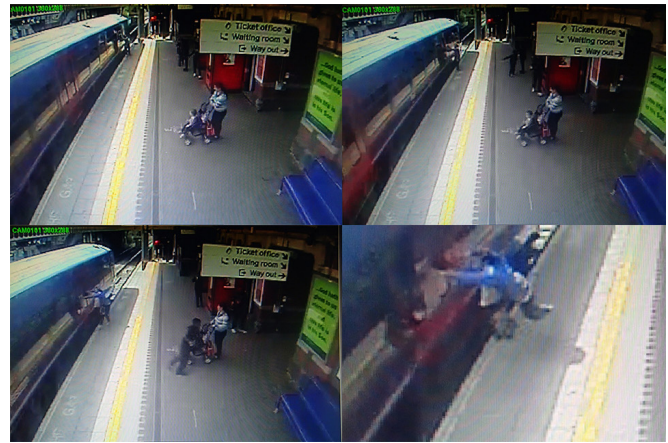
We saw another example of behaviour influenced by this belief at Hayes & Harlington in 2015, when a passenger placed their hand between the closing doors in the expectation that they would reopen and was subsequently dragged along the platform. In our report on this accident, we recommended research to better understand the way that passengers interact with rail vehicle/tram doors. At Wood Street and Enfield Town stations, as described above, the passengers involved attempted to board the train after the door closing sequence had begun. As the passenger attempted to board the train, they placed their hand between the closing doors.

Passenger trapped in closing doors and dragged along the platform at Hayes & Harlington.

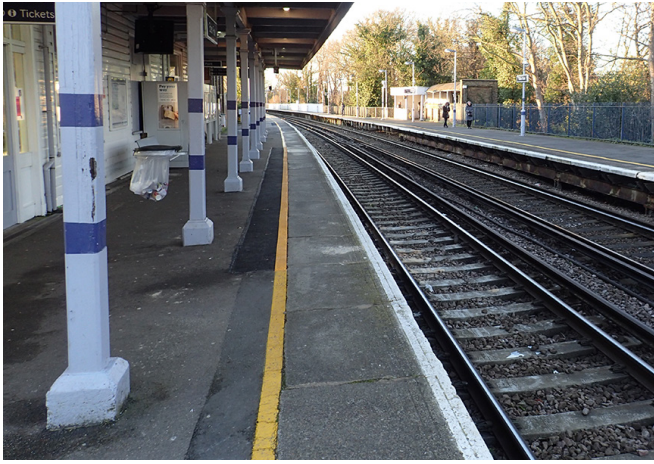
Platform with no tactile surface markings at Eden Park.

At Eden Park ([report 01/2021](#)), a visually and mobility impaired person fell from the edge of a platform into the path of an approaching train. The platform had no tactile surface markings which could have alerted the person to how close they were to the edge, and our investigation found that the railway industry's approach to the provision of tactile surfaces had been ineffective. We recommended that the railway industry and the Department for Transport review their approach to the installation of tactile surfaces and management of risk to visually impaired passengers on station platforms.

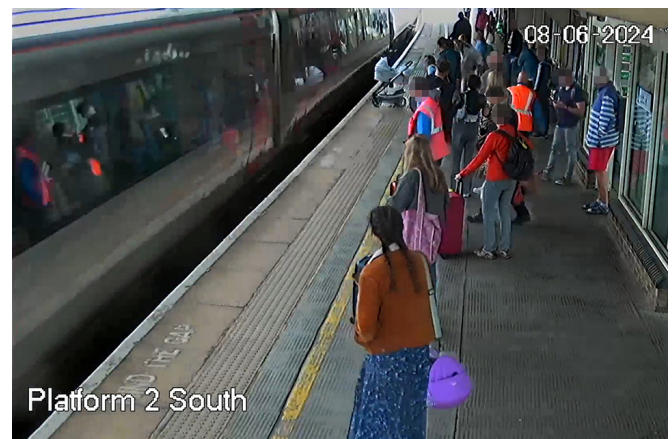
At Banbury station ([safety digest 10/2024](#)), a pram, carrying an infant, rolled towards the platform edge and came into contact with the bodyside of a train. This contact occurred while the train was moving at an estimated 35 mph and caused the pram to spin and tip over, resulting in the infant falling onto the platform surface. The infant sustained a minor injury. The accident demonstrated the importance of station operators taking appropriate steps to understand and effectively mitigate platform hazards and working collaboratively with infrastructure managers to understand and control the risks.

CCTV footage from Banbury station showing the pram and train moments before the accident occurred (courtesy of Chiltern Railways).
