Accident

Aircraft Type and Registration:	Piper PA-18-150, G-CLYI	
No & Type of Engines:	1 Lycoming O-320-A2B piston engine	
Year of Manufacture:	1981 (Serial no: 18-8109006)	
Date & Time (UTC):	13 May 2023 at 1415 hrs	
Location:	Sleap Aerodrome, Shropshire	
Type of Flight:	Private	
Persons on Board:	Crew – 1	Passengers – None
Injuries:	Crew – None	Passengers – N/A
Nature of Damage:	Damage to propeller, rudder strut and windscreen	
Commander's Licence:	Private Pilot's Licence	
Commander's Age:	22 years	
Commander's Flying Experience:	610 hours (of which 32 were on type) Last 90 days – 35 hours Last 28 days – 10 hours	
Information Source:	Aircraft Accident Report Form submitted by the pilot.

Synopsis

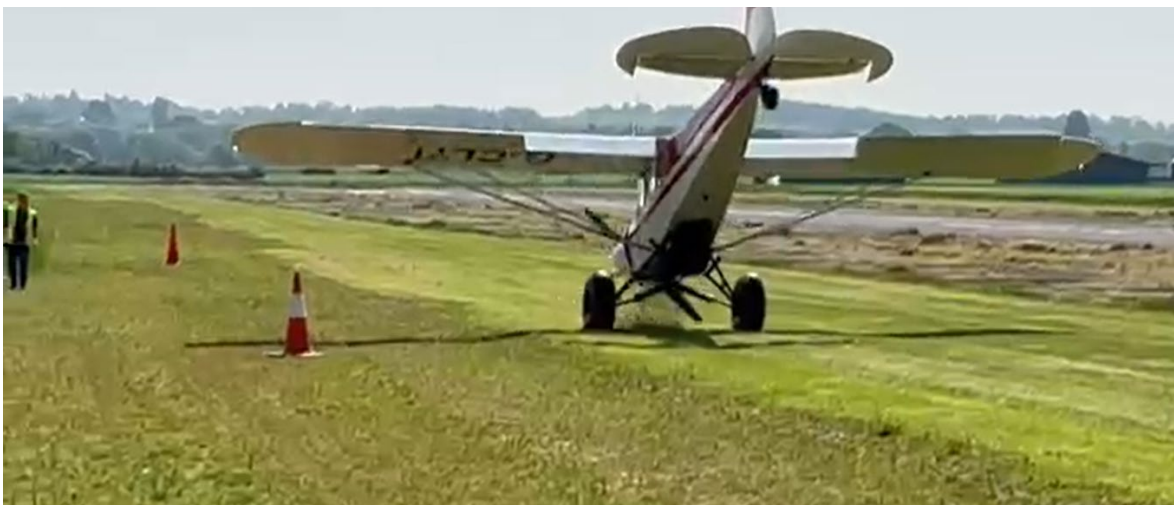
A video (from which Figure 1 is a still image) showed two people adjacent to a line of cones at the point the aircraft touched down and two further people where the aircraft tipped over onto its back. These people had been adjudicating the STOL event.

Video screenshot of G-CLYI after landing

It is likely the aircraft landed with a tailwind and that this, combined with the application of brakes while attempting to perform a landing in as short a distance as possible, caused the loss of control. Persons adjudicating the STOL event were positioned beyond the limit of the runway edge strip for Runway 18. However, the use of the grass strip eroded the effectiveness of the measures in place to assure suitable separation between persons and aircraft operating on it.

It is likely the aircraft pitched over because of a combination of a light tailwind and braking to achieve a short landing.
