AAIB Bulletin

5/2024

Serious Incident

Aircraft Type and Registration:	Beech 400A, N709EL
No & Type of Engines:	2 Pratt & Whitney Canada JT15D turbofan engines
Year of Manufacture:	1992 (Serial no: RK-52)
Date & Time (UTC):	7 October 2022 at 1100 hrs
Location:	Newquay Airport, Cornwall
Type of Flight:	Private
Persons on Board:	Crew – 2 Passengers – 1
Injuries:	Crew – None Passengers – None
Nature of Damage:	Damage to mainwheel tyres
Commander's Licence:	Airline Transport Pilot's Licence
Commander's Age:	40 years
Commander's Flying Experience:	5,263 hours (of which 2,692 were on type) Last 90 days – 150 hours (of which 30 on type) Last 28 days – 47 hours (of which 4 on type)
Information Source:	AAIB Field Investigation

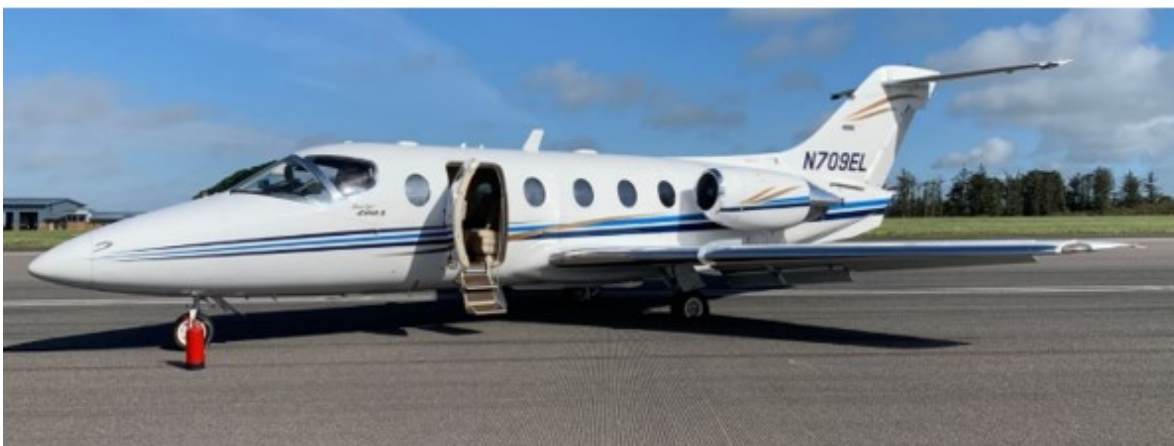
Figure 1

Immediately after touchdown the flight crew noticed the deceleration was greater than normal. Reverse thrust and speed brakes were applied, and as the aircraft slowed below about 50 kt the aircraft started to drift towards the right side of the runway. A combination of weathercocking into the wind and applying left pedal brought the aircraft back to the runway centreline where it came to rest angled about 45° to the left of the centreline, with the mainwheel tyres deflated and the brakes seized.

Incident aircraft Beech 400A after it came to rest off the runway centreline

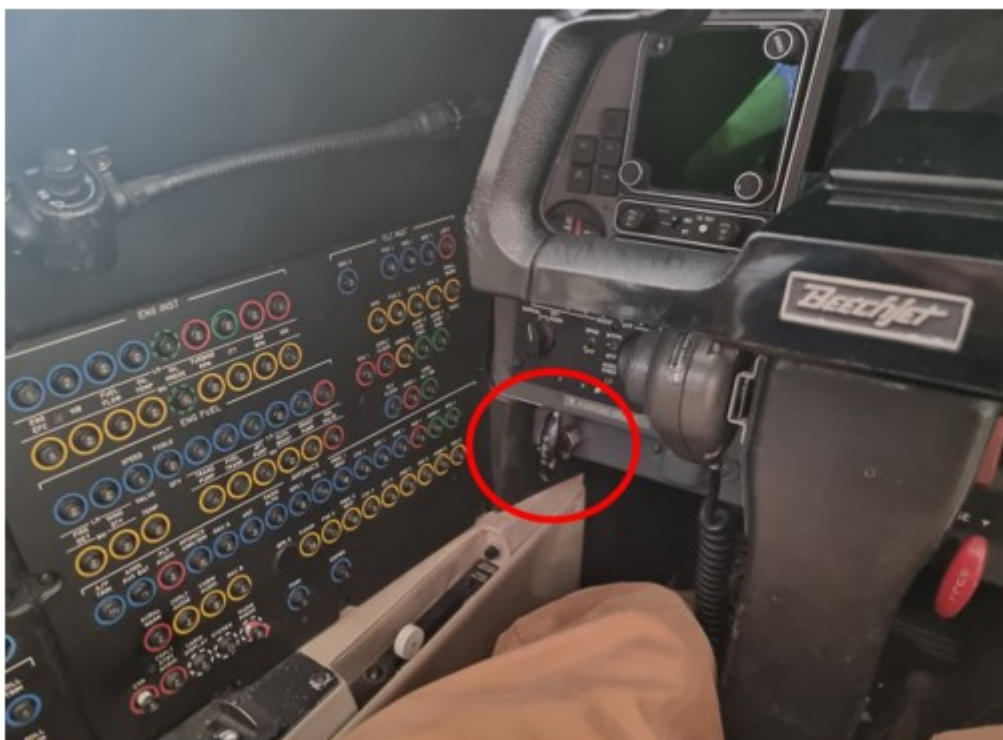
Figure 2

The parking brake handle is located on the lower left side of the instrument panel (Figure 2). The parking brake is set by pulling the handle fully out and depressing the toe brakes. The hydraulic brake pressure applied by the toe brakes is then locked in the system when the toe brakes are released. Accordingly, the pressure applied when the parking brake is set is not a fixed value but varies depending on the instantaneous pressure applied at the toe brakes when the parking brake handle is pulled. Pilots can therefore set an intermediate (partial) pressure between zero and the maximum achievable brake pressure. The parking brake is released by pushing the handle in, which releases the brake pressure.

Parking brake handle location

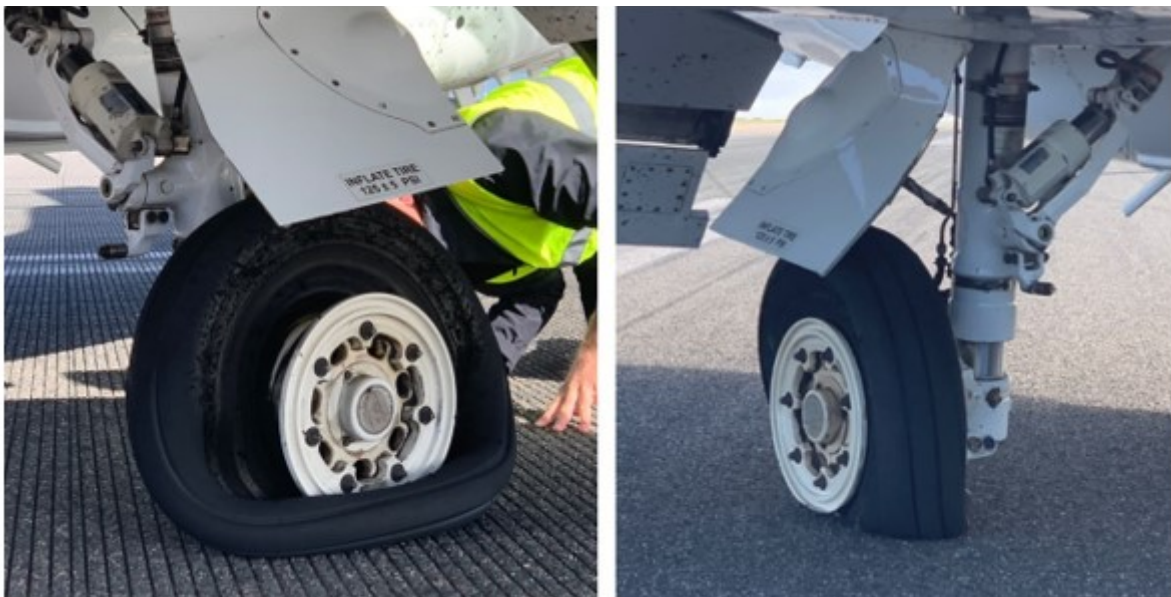
Figure 3

The rapid deceleration on touchdown was caused by either the tyres having already deflated due to the fuse plugs having melted, or the brakes being seized, or a combination of both. This was the result of the brakes having been heated during the takeoff run because the parking brake had been left on with partial pressure applied.

Both mainwheel tyres were intact but had partially separated from their wheel rims (Figure 3). The fuse plugs on both mainwheels were found to have melted, and both brake units had seized.

Left and right mainwheel tyres after the incident landing

It is recommended that Textron Aviation Inc. amend the checklists for the Beech 400 series of aircraft to include a 'release parking brake' item in the 'Before Takeoff' checklist.

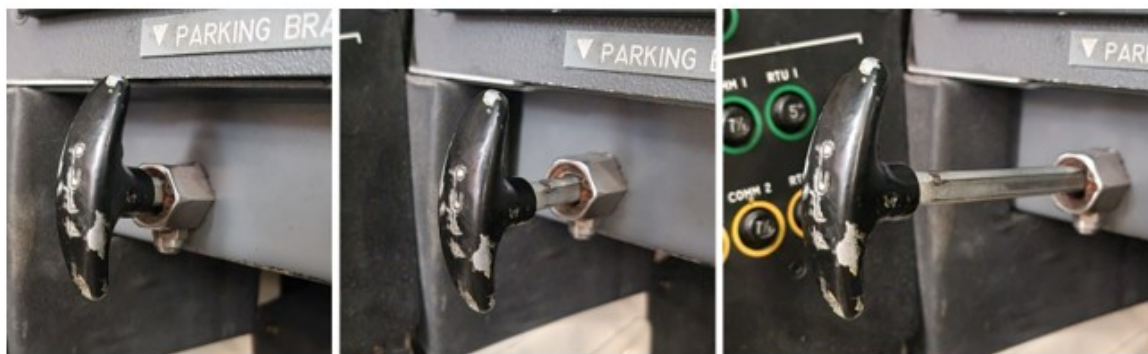
Figure 4

The operator's maintenance organisation examined the parking brake system and did not find any faults. It then carried out tests to determine at what parking brake handle position the brake pressure was released. When the handle was pushed fully in, there was 7 mm of metal shaft exposed, and when it was pulled fully out there was 77 mm of shaft exposed (Figure 4). When the handle was slowly pushed inwards from the fully out position the parking brake remained on until it reached a position where 28 mm of shaft was exposed, at which point pressure started to release (Figure 5). The total travel of the handle from 'out' to 'in' was 70 mm, but the travel from brakes ON to OFF was only 21 mm. The first 49 mm of inwards travel did not change the brake pressure.

Parking brake handle on N709EL: left image, fully in (OFF); centre image, 28 mm out (ON); right image, fully out (ON)

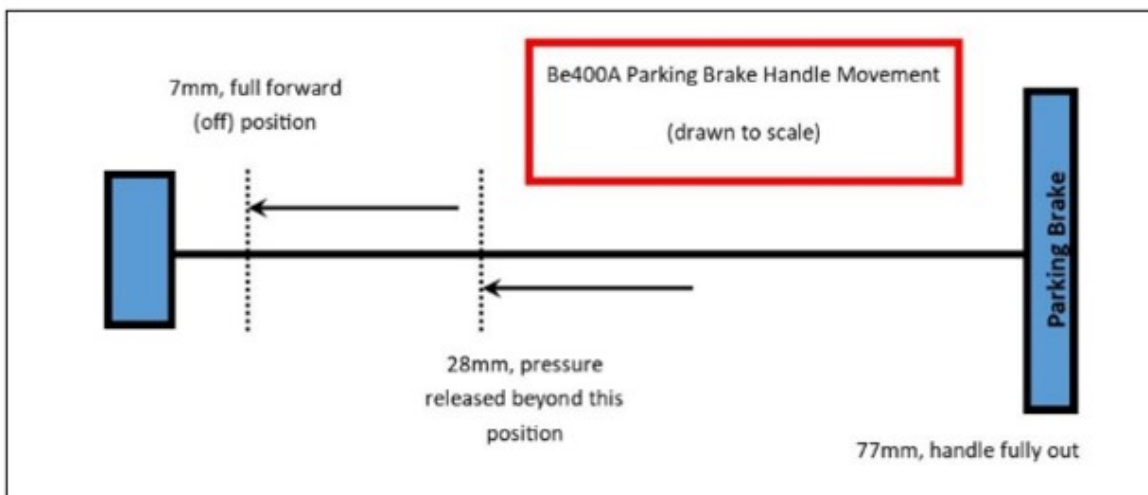
Figure 5

Measurements of parking brake handle position

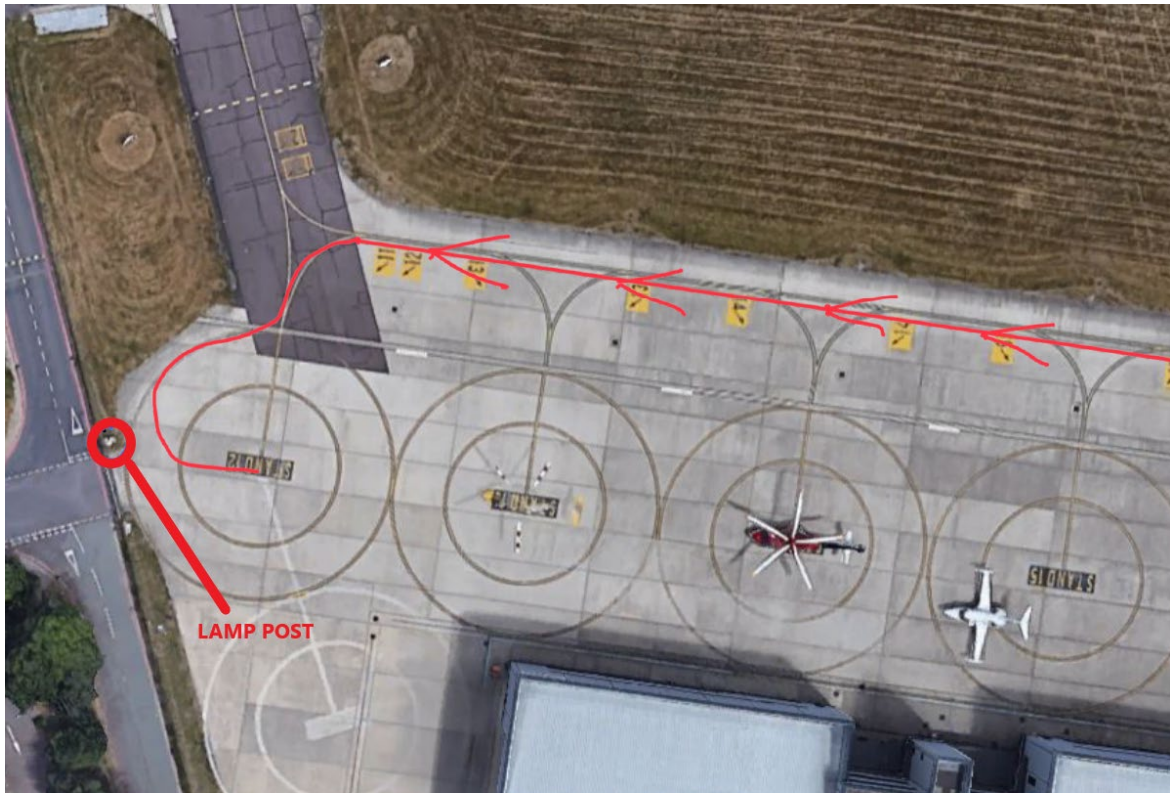
Figure 3

The commander believed that following the outer line would give the helicopter clearance from obstacles. However, as the helicopter turned left toward the centre of Stand 12 the main rotor blades struck a lamp post that was located on the street just outside the airfield perimeter. The path followed by the helicopter is illustrated in a sketch provided by the commander (Figure 3).

Sketch of taxi path provided by commander

After the blade strike, the commander turned further left to move the helicopter away from the obstacle. The helicopter was then shut down on Stand 12. All five main rotor blades were damaged and there was impact damage on the lamp stanchion. Some small pieces of debris were scattered all around the vicinity of Stand 12. No personnel were injured.

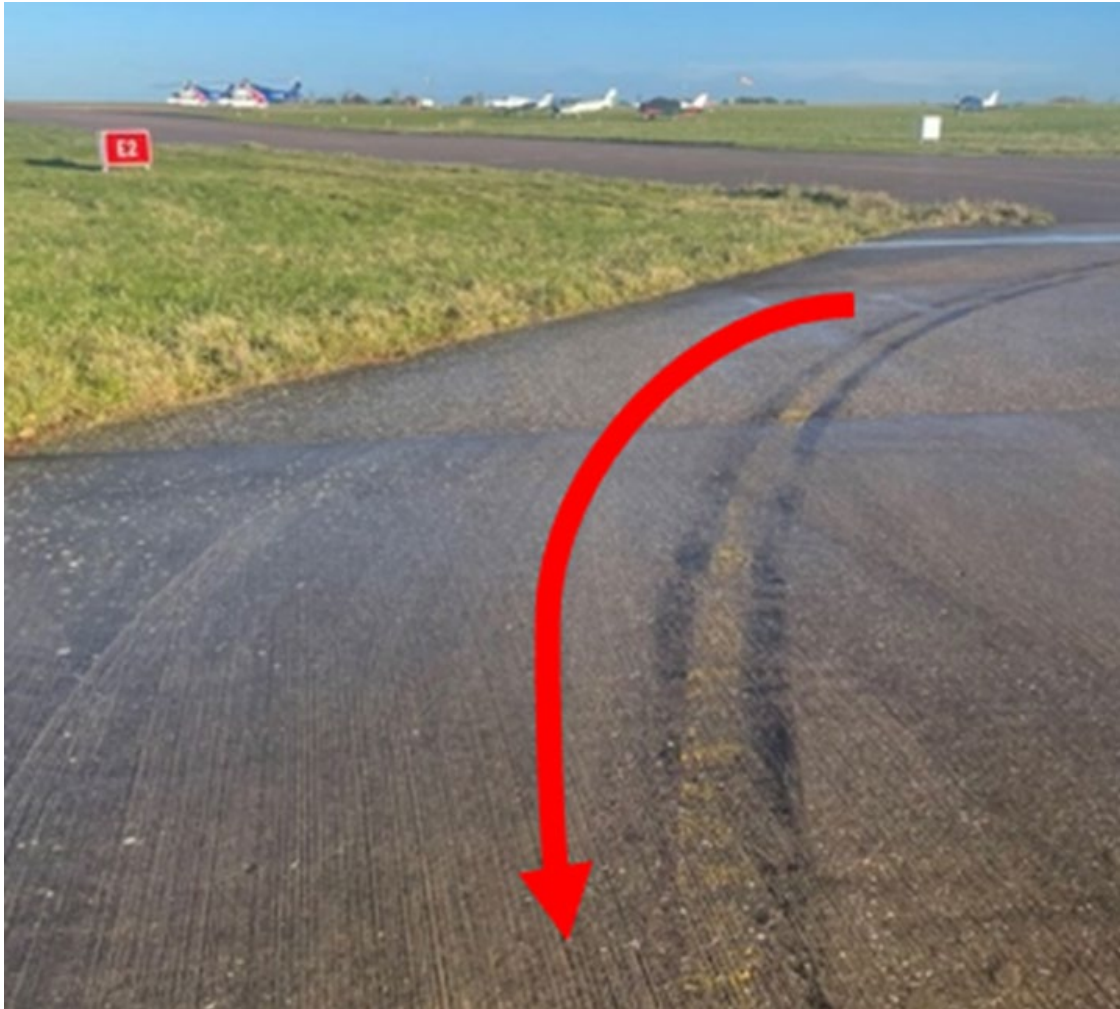
Figure 5

A photograph supplied by the handling agent (Figure 5) shows that the surface markings at Norwich were somewhat faded. The red arrow indicates the helicopter direction of travel round the outer circle of the stand.

Norwich stand markings. The commander stated that he was familiar with the markings for a stand as described in Annex 14

The stands would be resized for different helicopters in the early part of 2024 and the stand markings would be erased and replaced with new painted surface markings.

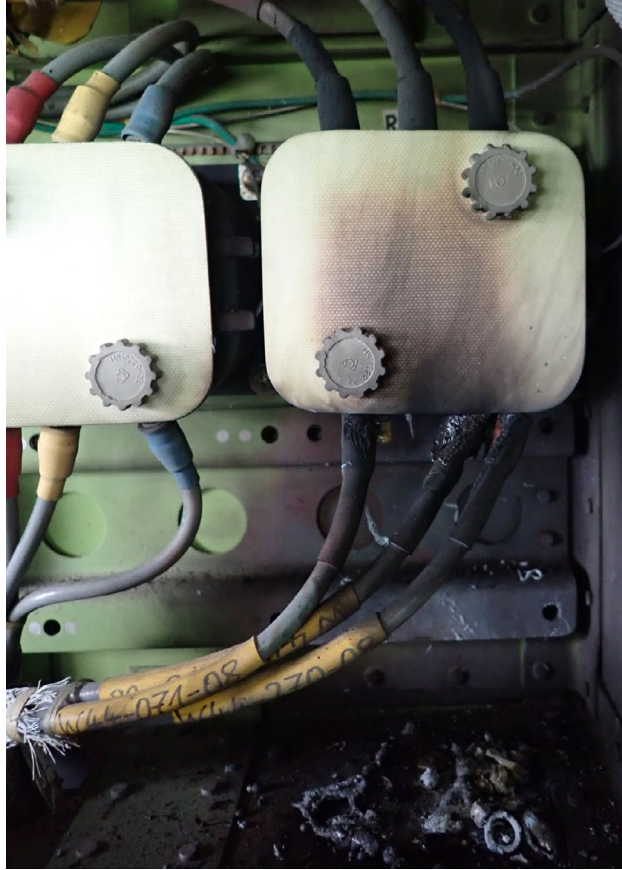
Figure 2

After the incident, the aircraft was shut down and batteries disconnected. The fire was identified as having been behind the P6-2 circuit breaker panel, behind the co-pilot's seat. The panel was lowered and the R61 contactor (Figure 2), was found to be melted. This contactor which, when the galley switches were set to ON, switched power to the forward galley from the left 115 V AC bus. Molten material and debris from the contactor had fallen from it and came to rest in the bottom of the compartment. Paint on the underside of the compartment floor had blistered.

R61 forward galley contactor

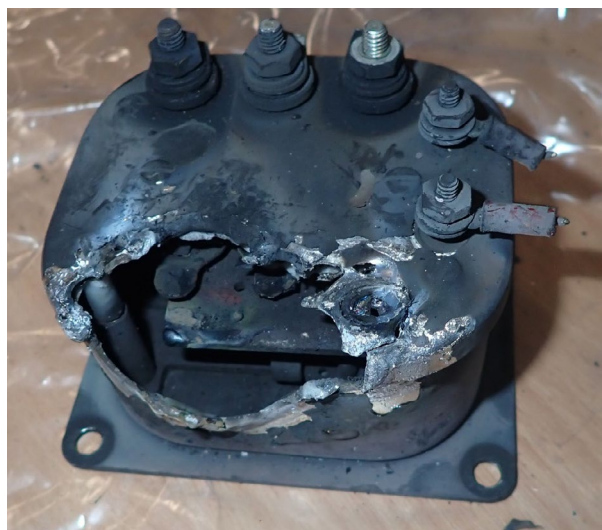
Figure 3

When the contactor was removed it was evident that the contactor housing had been breached and the three input terminals had been destroyed during the fire. (Figure 3).

R61 Contactor, Part Number 9124-8073, after removal showing melted housing and loss of input terminals

Due to the nature of the damage to the contactor, the cause of the failure could not be determined. It is possible that either the hermetically sealed contactor housing failed, allowing ambient conditions to enter the body resulting in the possibility of arcing within the unit, or the input terminal connectors had become loose, allowing external arcing and heat generation.

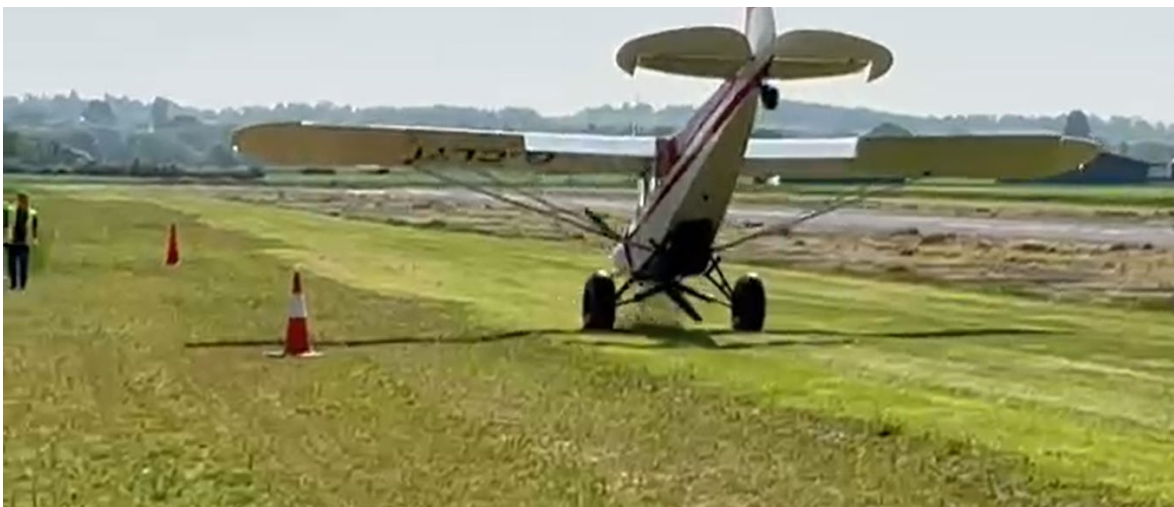
A video (from which Figure 1 is a still image) showed two people adjacent to a line of cones at the point the aircraft touched down and two further people where the aircraft tipped over onto its back. These people had been adjudicating the STOL event.

Video screenshot of G-CLYI after landing

It is likely the aircraft landed with a tailwind and that this, combined with the application of brakes while attempting to perform a landing in as short a distance as possible, caused the loss of control. Persons adjudicating the STOL event were positioned beyond the limit of the runway edge strip for Runway 18. However, the use of the grass strip eroded the effectiveness of the measures in place to assure suitable separation between persons and aircraft operating on it.
