Rail Accident Investigation Branch

Rail Accident Report

Uncontrolled evacuation of a partially platformed train at Clapham Common London Underground station, 5 May 2023

Report 03/2024
May 2024

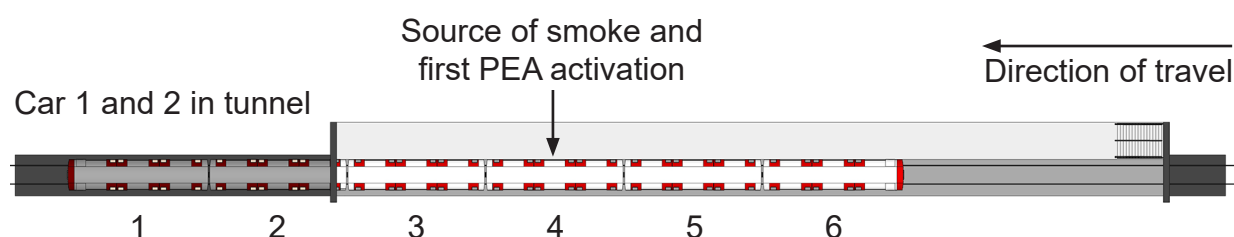
- 35 Around 17:42 hrs, train 065 stopped at the Clapham Common station platform. CCTV from the station platform shows smoke emanating from underneath the fourth car from the front (car 4) as it stopped. As passengers began to board and alight, some can be seen on CCTV images reacting to the smoke and looking in the direction where the smoke was emanating from.
- 36 Around 17:43 hrs, train 065 departed from the station, but was brought to a halt within seconds by a passenger pulling a PEA in car 4. The train had travelled about 35 metres before stopping, with its first two cars in the northbound running tunnel (figure 9). Around 23 seconds later, train 241 stopped on the southbound side of the platform and passengers began to board and alight from this train.

Figure 9: Detailed view of train 065 and its position on the northbound platform after coming to a halt (following a PEA activation).

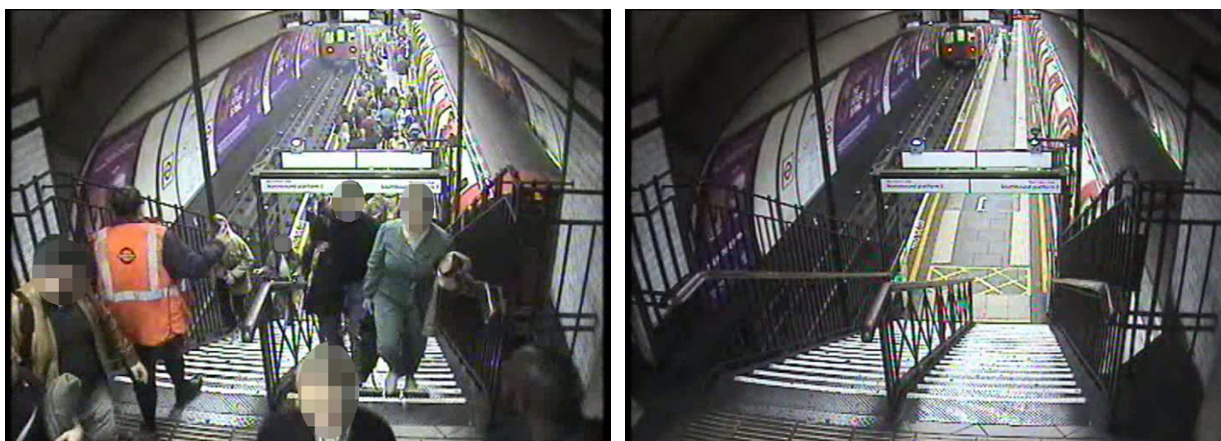
Figure 10: CCTV footage from the top of the stairs leading to the platform. Left-hand image shows CSA(A) moving down the stairs to access the platform during the incident with smoke visible. Right-hand image shows the platform after the incident and after smoke had cleared. Courtesy of LUL.

- 61 CCTV also shows the smoke had spread around the platform and was present when CSA(A) went to investigate the passenger's report of smoke (figure 10). Data from the train's on-train data recorder (OTDR) shows that seconds after the train departed the platform, a PEA was activated in car 4. This was followed by multiple PEA activations in other cars within the train.
