Serious Incident

Aircraft Type and Registration:	ATR 72-202, G-NPTF	
No & Type of Engines:	2 Pratt & Whitney Canada PW121 turboprop engines	
Year of Manufacture:	1990 (Serial no: 192)	
Date & Time (UTC):	17 January 2023 at 0425 hrs	
Location:	East Midlands Airport	
Type of Flight:	Commercial Air Transport (Cargo)	
Persons on Board:	Crew - 2	Passengers - None
Injuries:	Crew - None	Passengers - N/A
Nature of Damage:	None	
Commander's Licence:	Airline Transport Pilot's Licence	
Commander's Age:	37 years	
Commander's Flying Experience:	5,264 hours (of which 583 were on type) Last 90 days - 74 hours Last 28 days - 28 hours	
Information Source:	AAIB Field Investigation

Synopsis

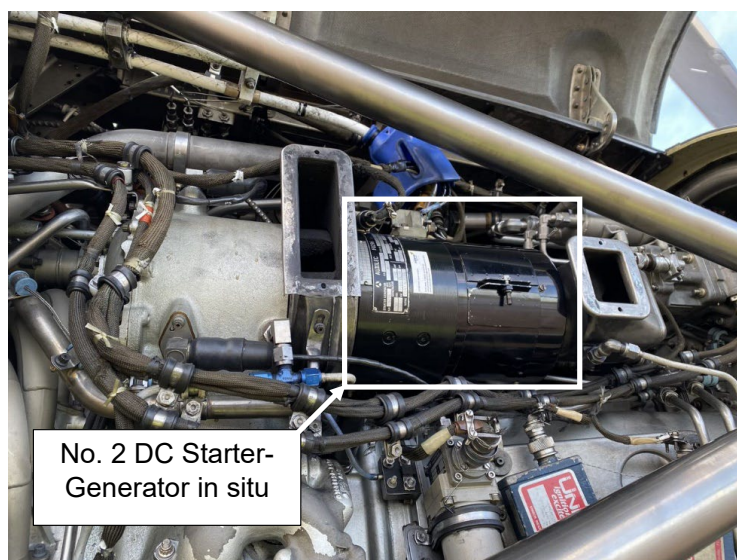
Figure 8

The DC Gen 2 was examined in-situ (Figure 8) for signs of external damage or faults, and none were found.

G-NPTF No 2 DC Starter-Generator

DC Gen 2 was replaced, and further engine ground runs were conducted. The CNTR BPCU fault reset itself, indicating the fault's causal condition had been removed. No further faults were logged on the GCUs and no other electrical anomalies were observed.

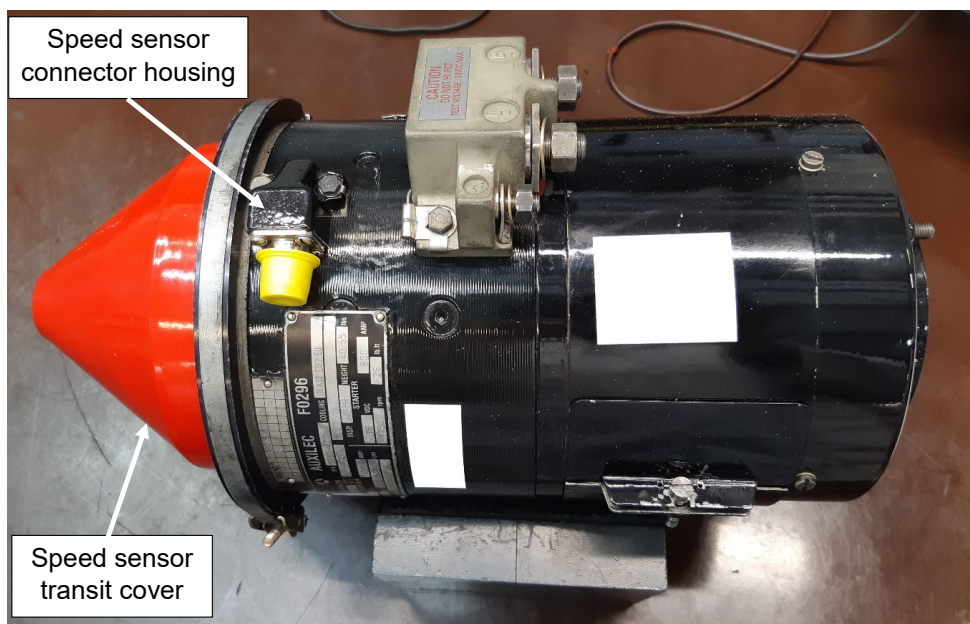
Figure 9

DC Gen 2 starter-generator removed from G-NPTF

The starter-generator (Figure 9) was visually inspected and considered to be in a satisfactory condition in line with its recent overhaul. There was no sign of external damage of the speed sensor or generator shaft.

Resistance tests of the shunt winding, starter-generator insulation, and speed sensor insulation were all compliant. A resistance test of the speed sensor resulted in an open circuit (infinite measured, criteria $130 \Omega \pm 10 \Omega$) and was considered to fail the test.

The starter-generator was mounted to a test rig for dynamic testing where it failed the test due to speed sensor signal measurement. No signal was measured at the beginning of the dynamic test (five minutes); it was then intermittent (one minute), and then recovered and remained stable.

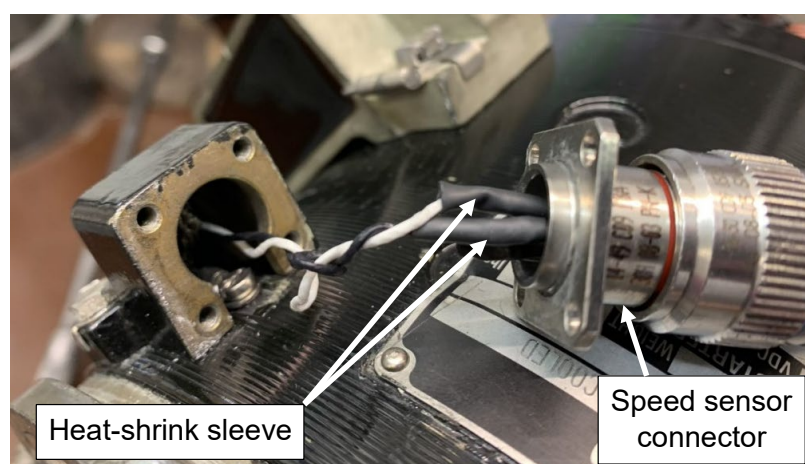
Figure 10

Speed sensor connector and wires

During light manual manipulation of the connector, the resistance measurement fluctuated between the correct value ($130\ \Omega$) and open circuit. Activating an open circuit was repeatable through gentle pressure on the speed sensor connector wiring.

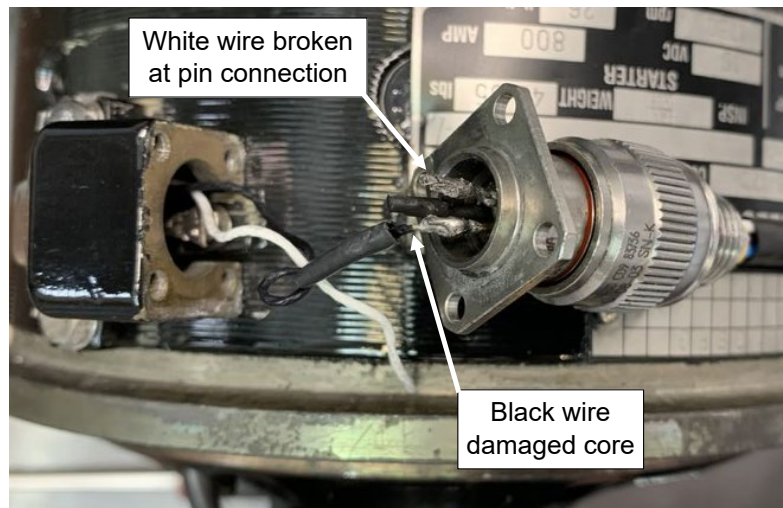
Figure 11

The wires are soldered to pins at the rear face of the connector, and the soldered joint covered with heat-shrink sleeve. Removing the heat-shrink sleeve from the white wire showed the wire to be completely broken but, whilst held in place by the heat-shrink sleeve, close enough to make intermittent contact. Removing the heat-shrink sleeve on the black wire showed damage to the wire core (Figure 11).

Speed sensor connector with heat-shrink sleeve removed from wires

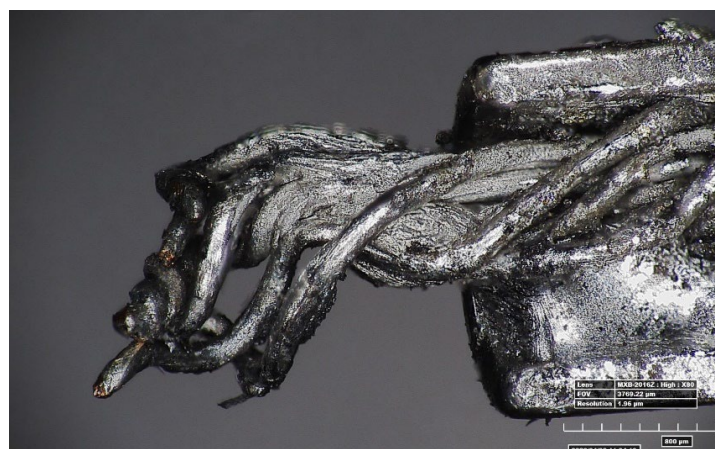
Figure 12

Further microscopy analysis by the AAIB of the white wire showed partial unravelling of the core and breakage damage at the pin connection soldered joint (Figure 12), and evidence of mechanical insulation removal (Figure 13).

Speed sensor connector soldered pin and broken white wire conductors

The partially-connected, damaged wiring at the speed sensor connector pin joints resulted in a rapid, intermittent speed measurement signal being sent to the GCU. The GCU interpreted this as a fault and indicated a DC GEN2 caution to the crew. It also led to the electrical system GCU rapidly opening and closing contactor 23PA causing power fluctuations and "flashing" of displays.

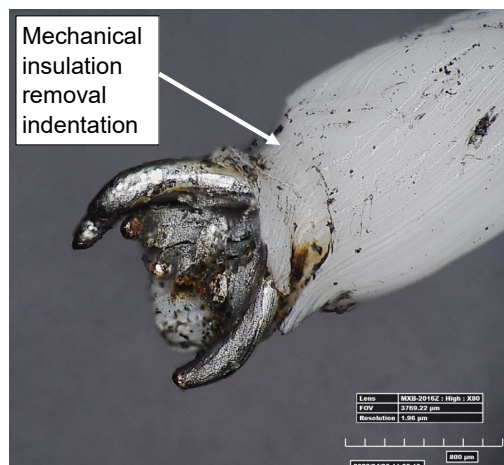
Figure 13

Speed sensor white wire broken conductors

The appearance of the insulation on both connector wires at the soldered joint end is indicative of a mechanical cutting-type insulation stripping tool being used during the unit's previous overhaul process and this was confirmed by the overhaul provider. It is possible to damage the internal core with this type of tool if the wire is misaligned with the correct wire gauge on the tool, and it is probable that this is how the damage occurred.

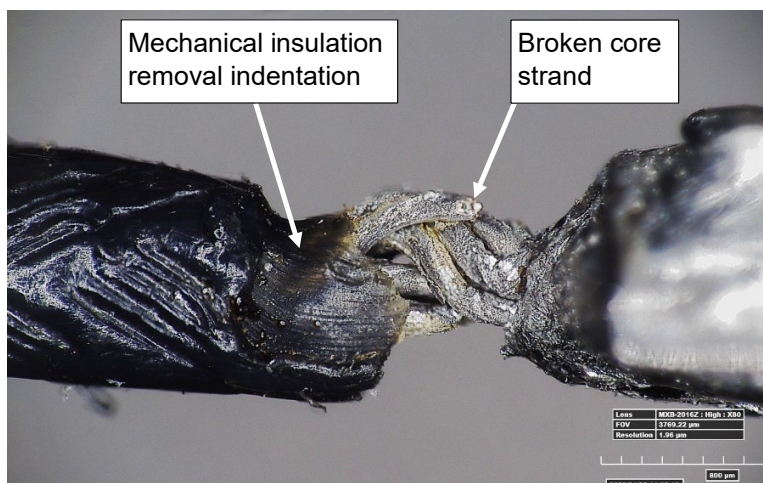
Figure 14

The core of the black wire had two broken strands at the soldered pin joint and evidence of mechanical insulation removal (Figure 14).

Speed sensor black wire damaged core at connector pin

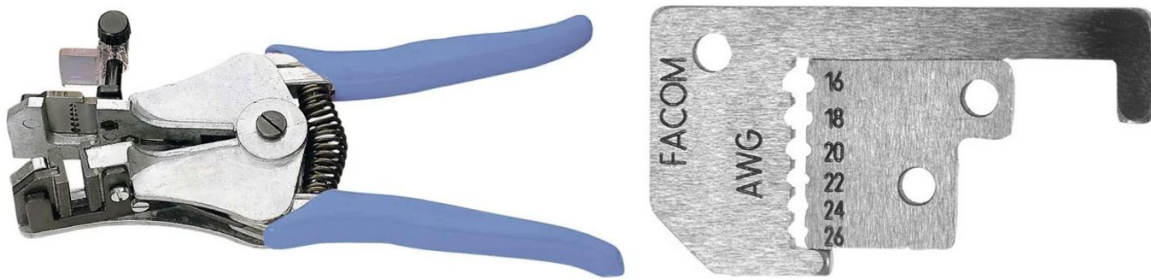
Figure 15

The starter-generator was overhauled, in accordance with the manufacturer's CMM, at a third-party provider. The type of tool required to strip wire insulation is not specified within the CMM and the provider used a standard mechanical stripping tool (Figure 15). To strip

the insulation, a wire is inserted through the correct gauge for the wire in accordance with the markings on the tool. The tool handles are squeezed together, and this action clamps the wire whilst the two cutters (shown on the right of Figure 15) close to cut the insulation to the correct depth and then strip it from the wire. Misalignment of the wire with the correct wire gauge on the tool will result in either the insulation not being stripped, or the conducting wires being part-severed by the two cutters as they come together.

Mechanical wire stripping tool used at overhaul

The wiring defect was probably caused by incorrect use of wire stripping tools at the third-party organisation that had overhauled the starter-generator.

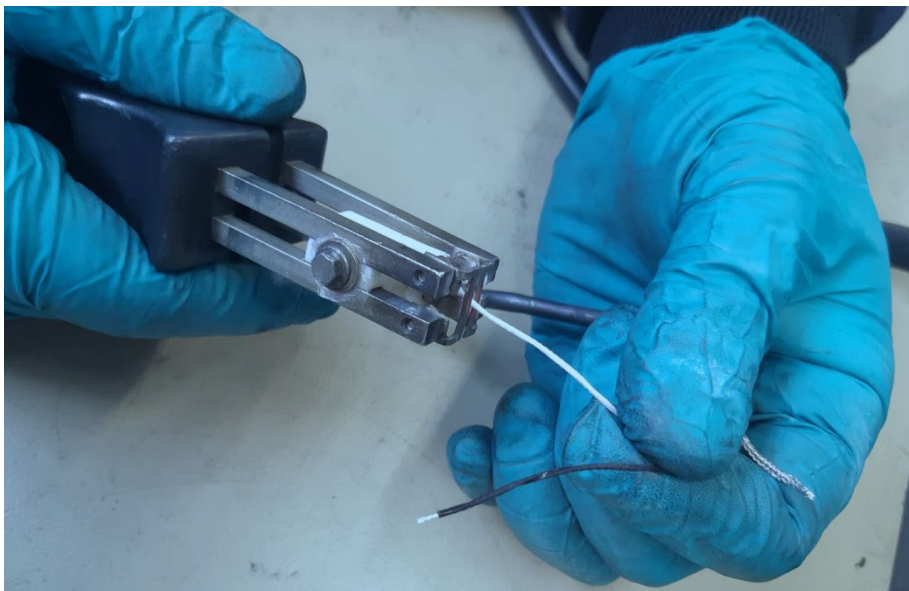
Figure 16

In contrast to the third-party provider, the manufacturer of the starter-generator confirmed that it uses thermal insulation stripping tools (Figure 16) in its facility as it had previously observed the potential for wire damage by using mechanical tools.

Thermal wire insulation stripping tool

- To modify the CMM procedure for this unit to highly recommend the use of thermal wire strippers.
- Extend the use of thermal wire strippers to all other applications.
