Rail Accident Investigation Branch

Rail Accident Report

Runaway wagon at Kineton, Warwickshire 25 May 2023

Report 04/2024
May 2024

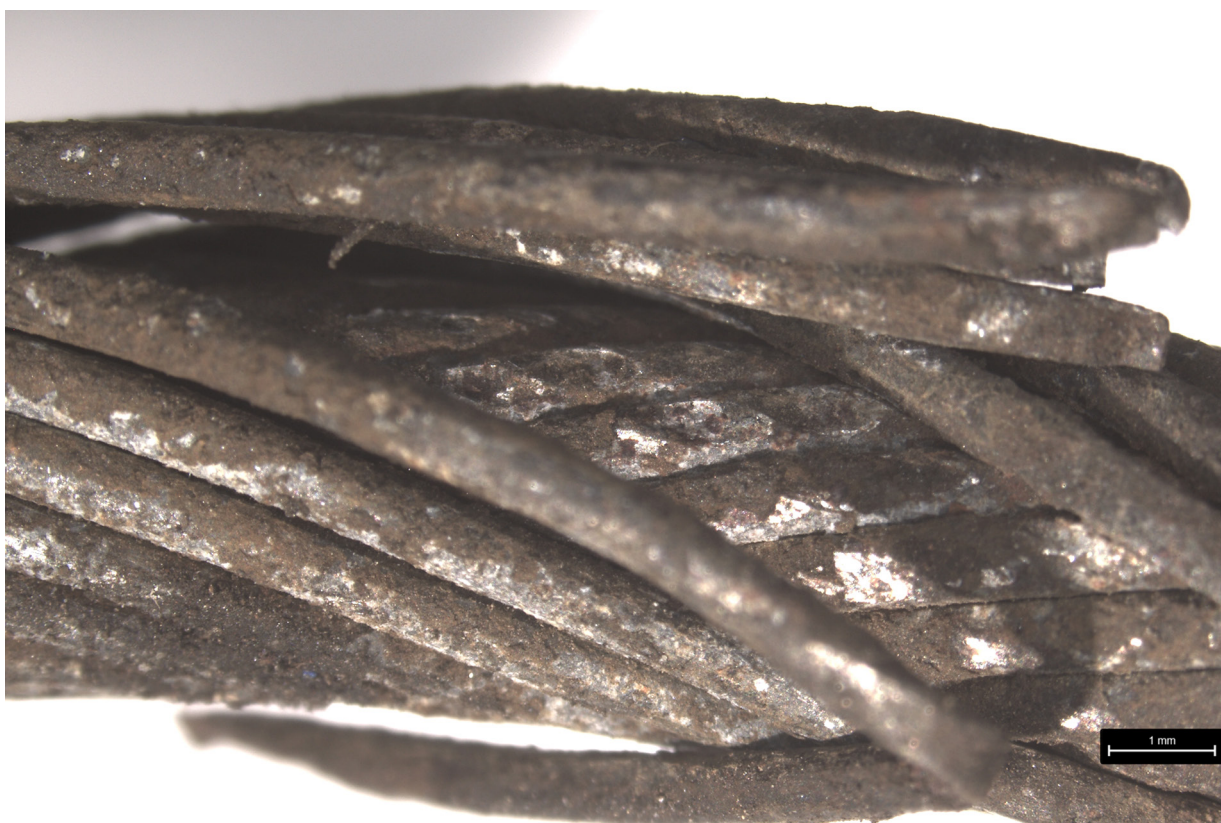
- 106 The detailed examination of the snapped cable by the metallurgist identified areas of wear damage to the strands, including areas remote from the location of failure, which in their opinion, are indicative that the service life of the cable had been exceeded (figure 12). These areas of wear took the form of indentations on the steel core strands where they had been pressing against one another over the repeated application of high tensile force in the cable. RAIB calculated that these indentations could increase the localised stresses in the affected strands by up to 100% (dependent on the depth of the indentation).

Figure 12: Deformation of the individual cable strands caused by the cable crushing itself due to high tensile loads.

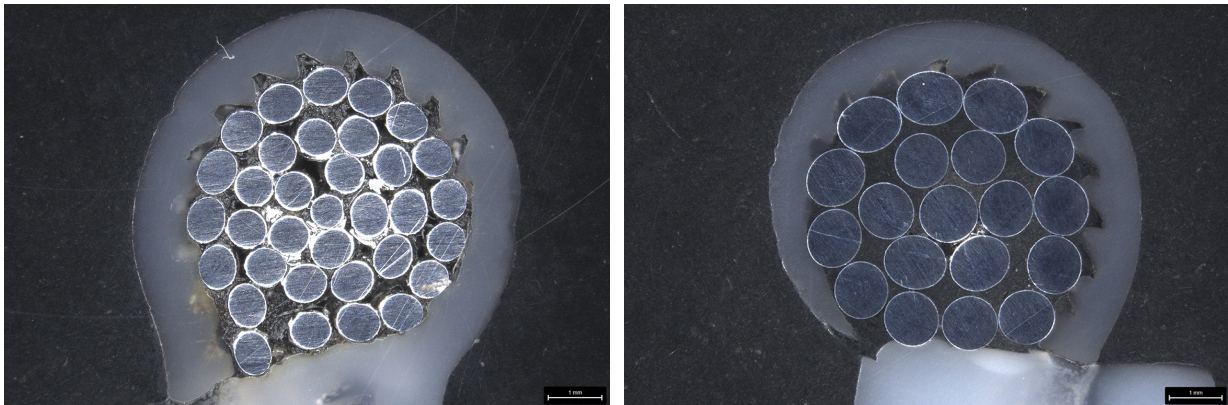
- 110 Had the cable been replaced during the wagon's service life, it is likely that a more modern cable design would have been used in its place. This is because the original cable make-up (5x11x17) is not available to purchase in the UK, leading to DB Cargo specifying a replacement design of cable. Although the cable to the new design has the same nominal diameter as the original cable (5 mm), it is manufactured to a diameter of 5.12 mm, whereas the original cable was manufactured to a diameter of 4.75 mm. Overall, this means that a modern cable has a 19% larger cross-sectional area than an original cable (16.77 mm² for a modern cable compared to 14.09 mm² for the original cable, figure 13). As well as having a larger cross-sectional area, a modern cable is manufactured of a higher strength steel than the original cable (approximately 55% stronger than the original cable).

Figure 13: Original equipment manufacturer's cable (left), compared to a cable of more modern design (right).
