Report on the investigation of the
grounding of the roll-on/roll-off passenger ferry

Alfred

at Swona Island, Pentland Firth, Scotland

on 5 July 2022

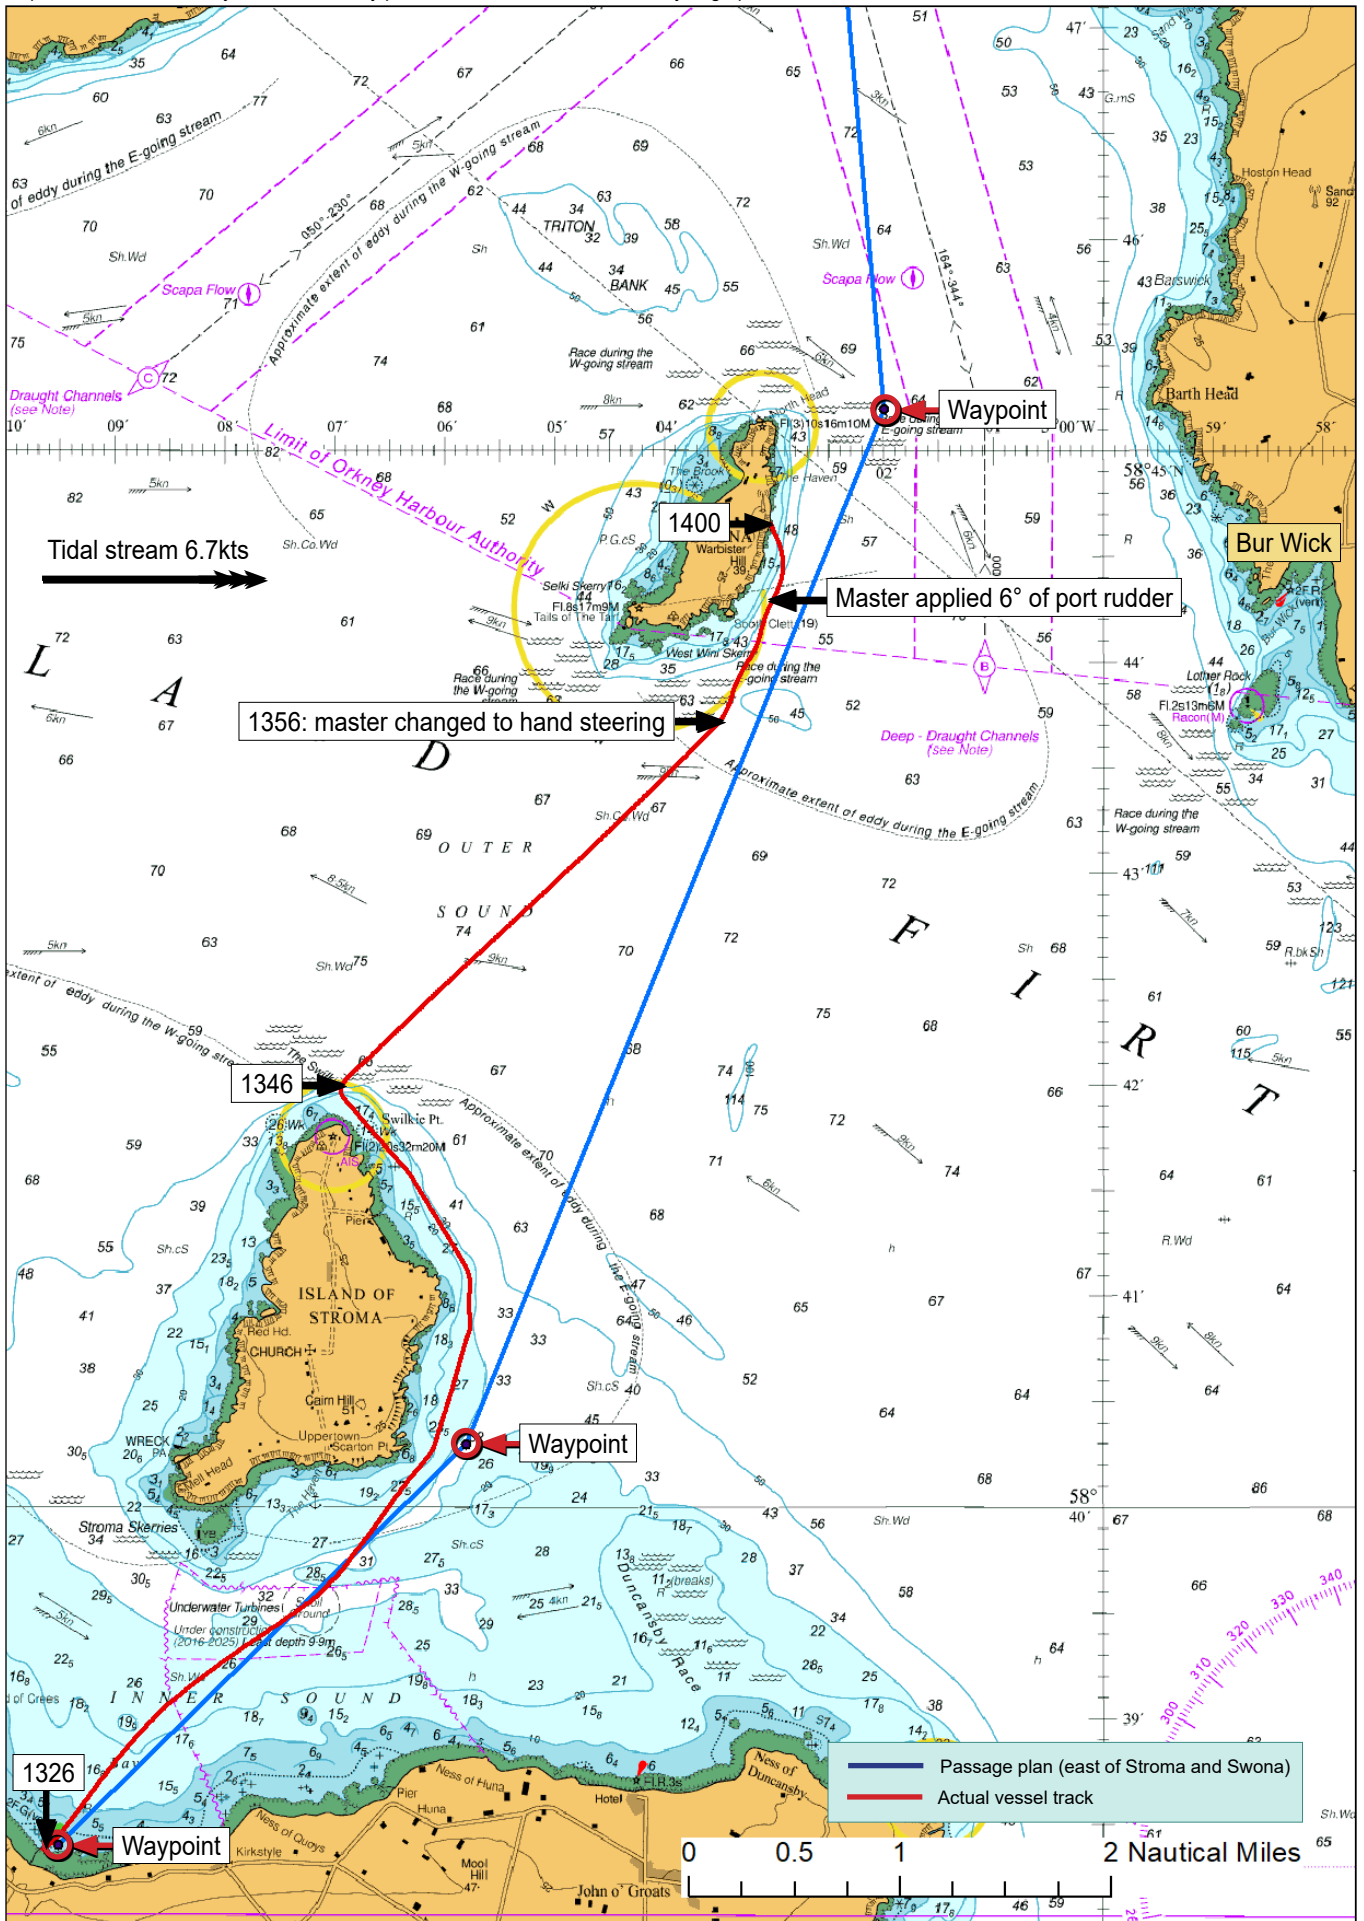
Figure 3: Alfred's navigational track before the grounding

Although *Alfred* started to turn away from the island when the master applied 60° of starboard rudder, his actions were too late and the vessel's port bow struck the rocky coast at a speed of about 13kts. This resulted in significant damage to the vessel's port bulbous bow, almost all of the vehicles on board, and injuries to more than 40% of the crew and passengers.

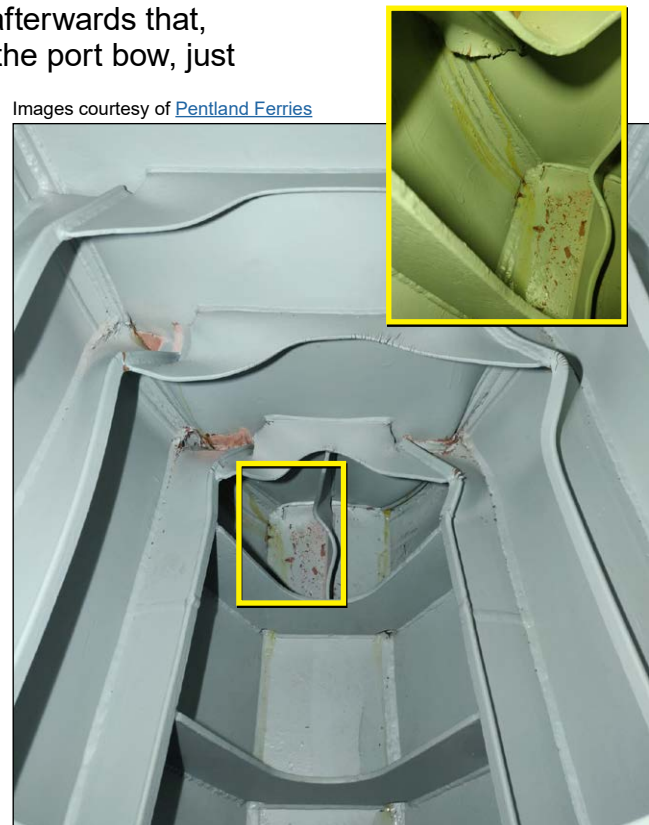
Figure 4: Post-grounding hull damage, showing slight water ingress behind the collision bulkhead

The C/O informed the master shortly afterwards that, other than a small amount of water in the port bow, just behind the collision bulkhead that had taken the impact of the grounding (**Figure 4**), he had found nothing else to indicate that the watertight integrity of the vessel had been breached. The C/E informed the master that the starboard outer engine had shut down and he was unable to restart it. The master informed the Pentland Ferries Designated Person Ashore (DPA) of the grounding. The DPA then cascaded this information to the other members of the Pentland Ferries emergency response team (ERT) ashore.

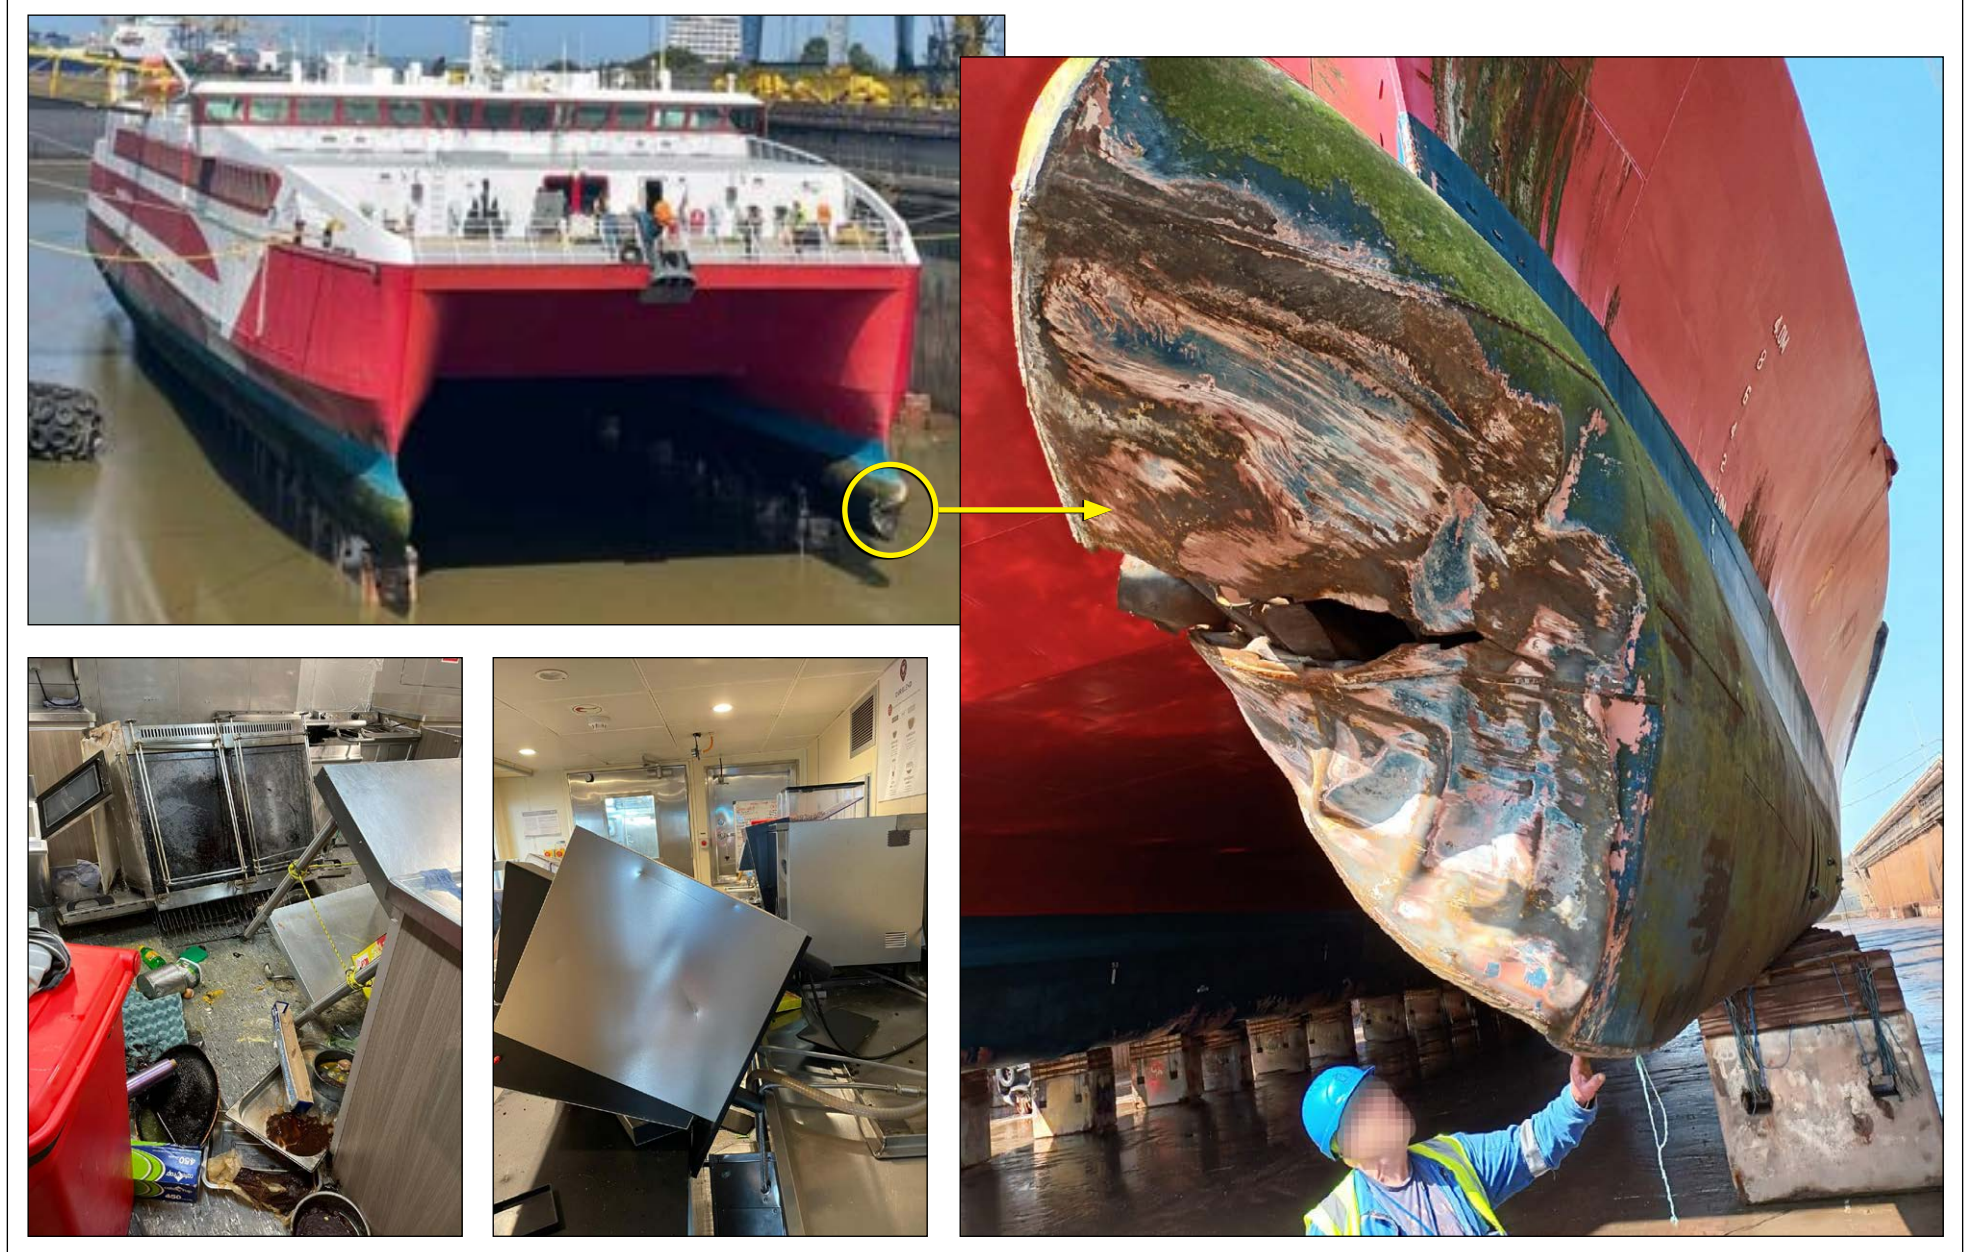
Figure 6: Post-grounding internal and external damage to *Alfred*

Alfred was taken out of service and entered dry-dock for four weeks, during which the port side bulbous bow, including the damage around the collision bulkhead, was cut out and replaced (**Figure 6**). Heavy items such as the galley range, catering equipment and vending machines were resecured to their mountings. A technical inspection of *Alfred's* steering system found no defects.

The grounding caused extensive external damage to *Alfred's* port bulbous bow. The impact also caused interior items such as part of the galley range, catering equipment and vending machines to break free from their welded mountings, which posed a risk of serious injury to the passengers and crew.

This damage revealed a need for Pentland Ferries to critically survey *Alfred's* internal fixtures, similar to the best practice promulgated by CLIA after the *Pacific Sun* incident, to ensure that heavy items were properly secured for sea.

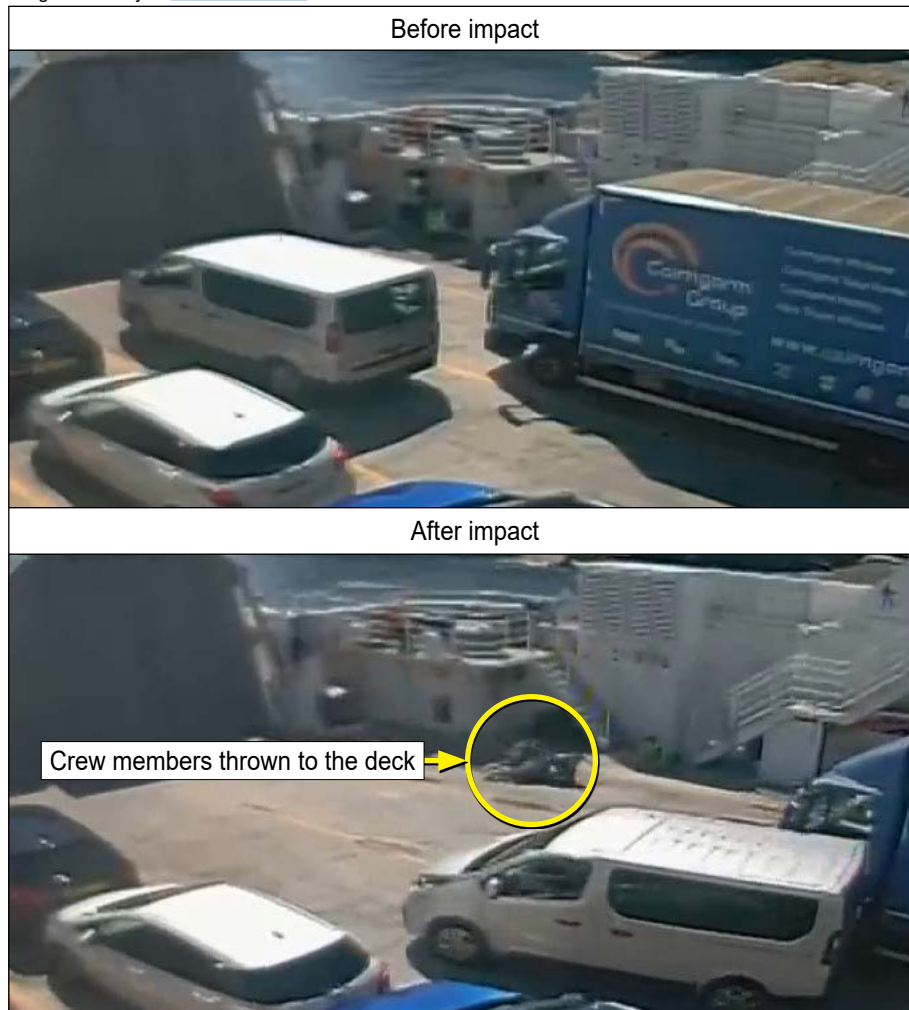
Figure 7: CCTV images, showing vehicle movement as *Alfred* grounds on Swona Island

CCTV imagery of *Alfred's* vehicle deck showed cars and lorries rolling forward on impact (**Figure 7**) and 35 of the 37 vehicles on board were damaged due to striking either adjacent vehicles or the ferry's superstructure during the grounding.

Alfred's CCTV imagery showed significant vehicle movement when the ferry grounded. This indicated that the crew had not ensured that vehicles were secured in accordance with the CSM, probably because the weather conditions were perceived as benign and little motion was expected. The CSM required crew to ensure that drivers left their vehicles in a high gear with the handbrake on. Further, the CSM also required lorries over 3.5 tonnes, like the one in **Figure 7**, to be secured using two lashings on each side of the vehicle. Additionally, the vehicle

deck signs only directed drivers to apply the handbrake but did not advise them to leave their vehicles in a high gear. Consequently, although the ferry's structure was intact, in a similar manner to the *Stena Voyager* incident, almost all vehicles were damaged.

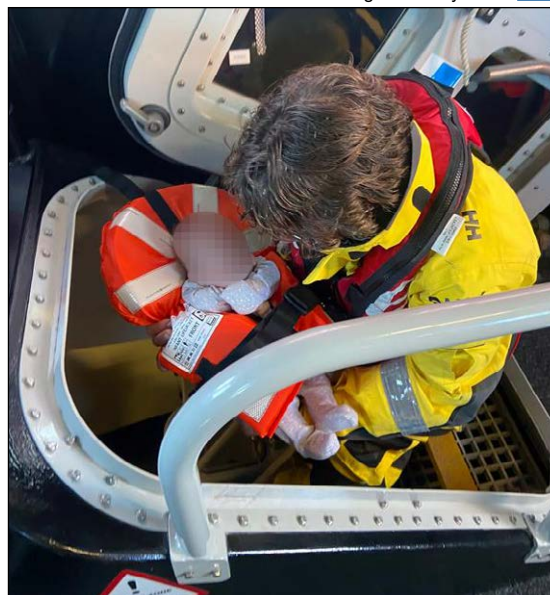
Figure 11: Baby on board the Longhope all-weather lifeboat, wearing an incorrectly fitted infant lifejacket

- 55% of the respondents felt the master's announcement was unclear and that the procedures described in the passenger safety video were not followed.
- Over 40% of the respondents reported that they were injured by the grounding and several commented that they were not warned of the impending impact before the vessel struck the island.
- Some passengers with babies reported that the crew were unsure how the infant lifejacket they had provided should be worn (**Figure 11**).

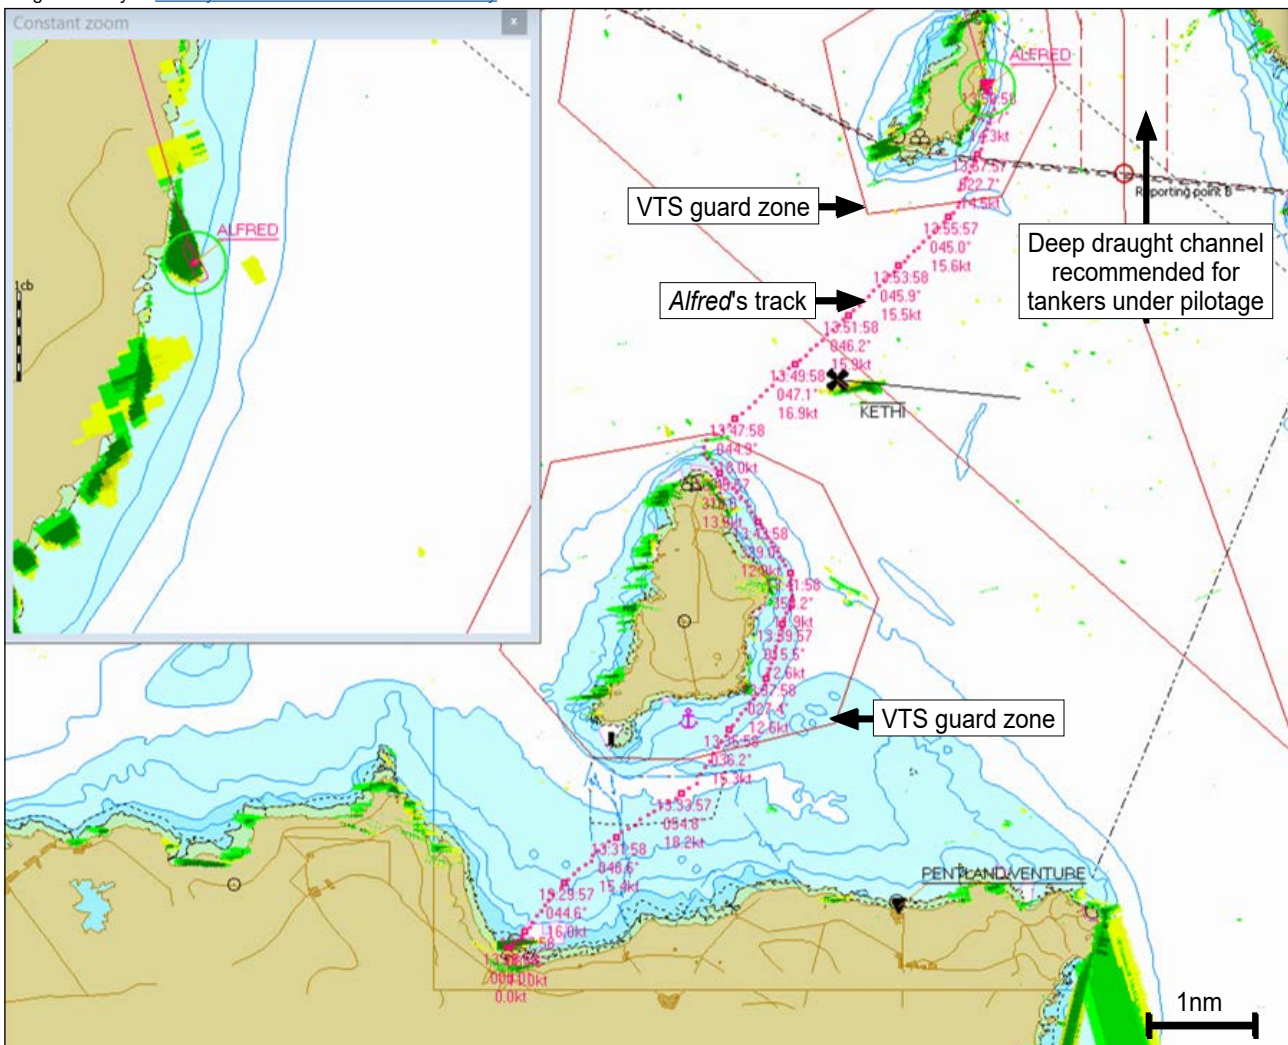
Figure 13: VTS replay of Alfred's track, showing the recommended route and the guard zones

Orkney Islands Council Harbour Authority had created VTS guard zones approximately 1000m from the coast around the islands of Stroma and Swona (**Figure 13**). The VTS system automatically alerted the VTS operator if either a vessel or its heading vector entered the guard zone. This provided the VTS operator with the opportunity to warn the vessel's crew of the *development of unsafe situations*. These guard zones were not marked on navigational charts. *Alfred's* track routinely triggered the VTS guard zones around the islands of Stroma and Swona, as it did on this occasion; the VTS operators did not call the ferry.
