Interim report on the investigation of the loss of the port inner propeller shaft and subsequent grounding of the roll-on/roll-off passenger ferry *Pentalina* at St Margaret’s Hope, South Ronaldsay, Scotland on 29 April 2023

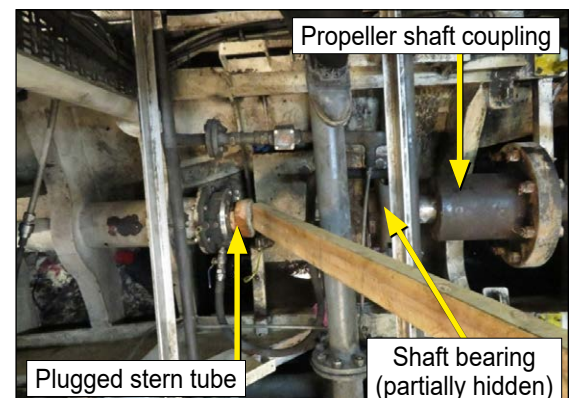
View of port inner shaft line, showing the missing propeller shaft
