Rail Accident Investigation Branch

# Rail Accident Report

## Uncontrolled evacuation of a partially platformed train at Clapham Common London Underground station, 5 May 2023

Report 03/2024  
May 2024

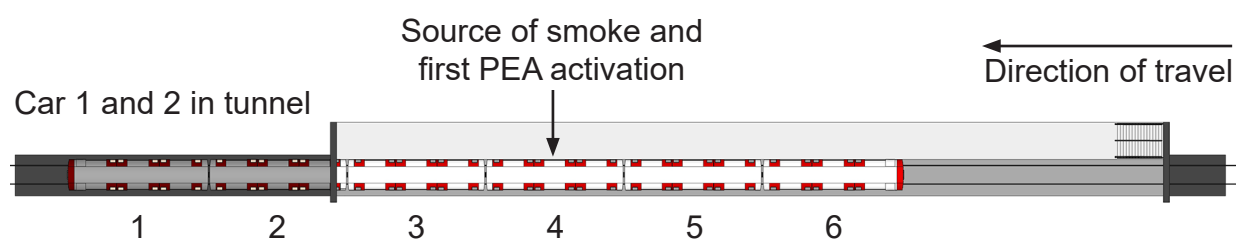
- 35 Around 17:42 hrs, train 065 stopped at the Clapham Common station platform. CCTV from the station platform shows smoke emanating from underneath the fourth car from the front (car 4) as it stopped. As passengers began to board and alight, some can be seen on CCTV images reacting to the smoke and looking in the direction where the smoke was emanating from.
- 36 Around 17:43 hrs, train 065 departed from the station, but was brought to a halt within seconds by a passenger pulling a PEA in car 4. The train had travelled about 35 metres before stopping, with its first two cars in the northbound running tunnel (figure 9). Around 23 seconds later, train 241 stopped on the southbound side of the platform and passengers began to board and alight from this train.

Figure 9: Detailed view of train 065 and its position on the northbound platform after coming to a halt (following a PEA activation).
